GROUP	MODEL
Voluntary Service Campaign	2023-2024MY Sorento (MQ4a, MQ4a PE)
NUMBER	DATE
SC298	March 2024

## VOLUNTARY SERVICE CAMPAIGN

### COWL WATER INTRUSION REPAIR (SC298)

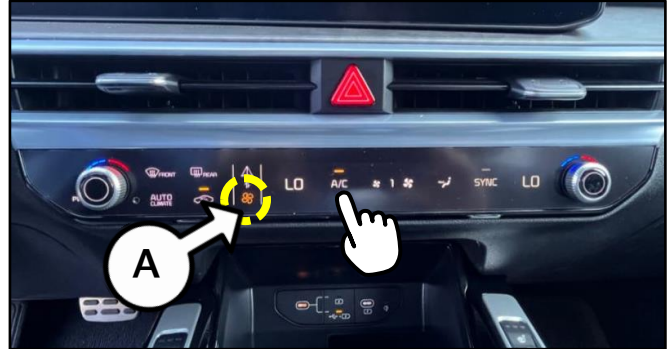
1. Press the engine 'START/STOP' button to the vehicle 'ON'.
2. Select the fan function (A) on the HVAC controller.

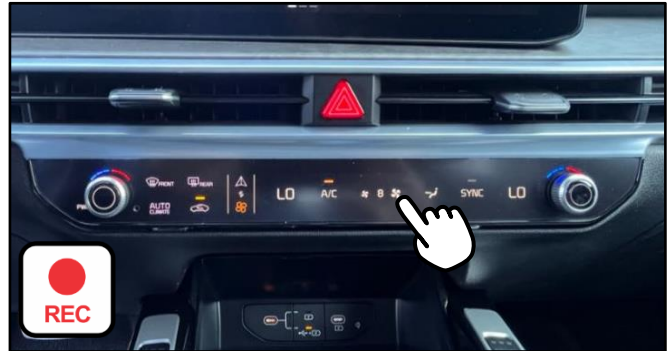
3. Cycle through the HVAC controller fan speeds (low → high).

- If normal the blower fan is operating normally (**OK**), proceed to the Cowl Sealer 'Repair Procedure' on page 3.
- If blower motor does not operate normally (**NG**), then record a KVID video starting from the VIN label on the door and then showing the **NG** condition of the blower motor. Proceed to step 4.

4. For a (**NG**) inspection result, complete the following steps:

- Blower Motor 'Replacement Procedure' on page 4.
- Cowl Sealer 'Repair Procedure' on page 3.
