TECHNICAL SERVICE BULLETIN

Soft Top Roof - Paint Damage On Rear Quarter Panel Due To Contact With Rear Window

24-2040

Ford 2021-2024 Bronco

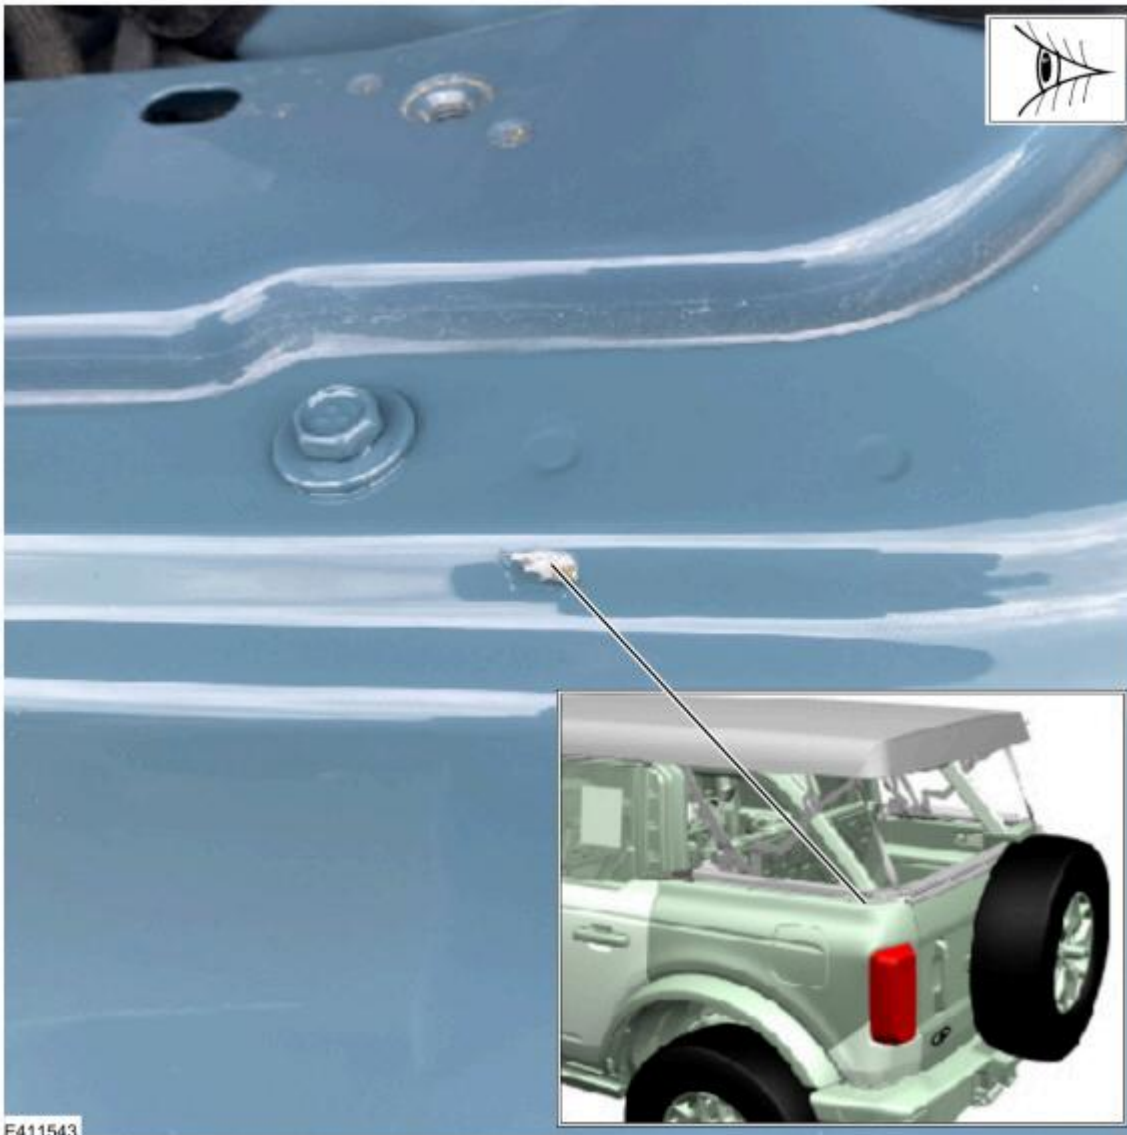
Issue: Some 2021-2024 Bronco vehicles may exhibit paint damage on the rear quarter panel due to contact with the soft top rear window. This may be due to a contact condition that can occur during extreme off-road driving between the soft top rear window and the rear quarter panel. To correct the condition, follow the Service Procedure to modify the rear window.

Figure 1 – Damage location is displayed. Left side shown, right side similar.

1. Does the vehicle have paint damage on the left or right rear quarter panels? (Figure 1)

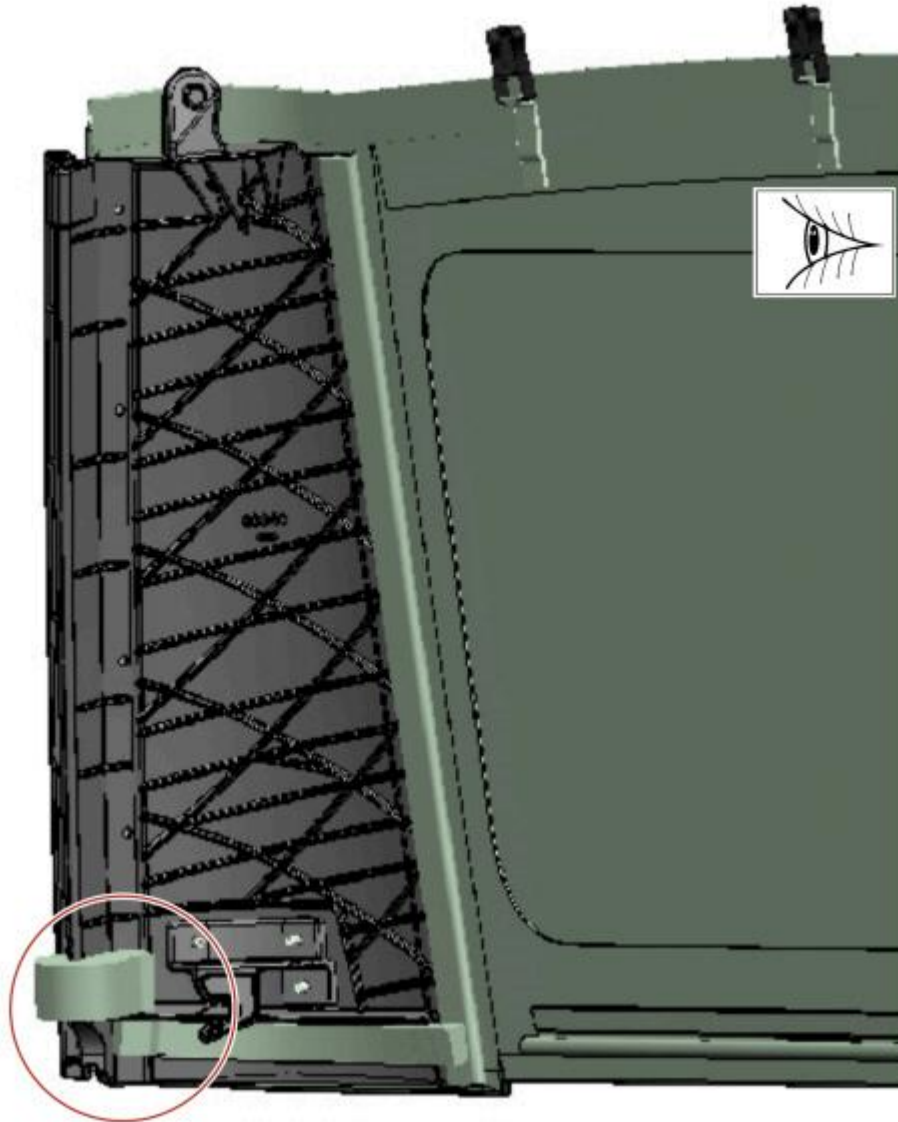
Figure 2 – Showing the lower inside corner of the rear window. Right side shown, left side similar.

4. Identify the lower, inside corner of the rear window. (Figure 2)

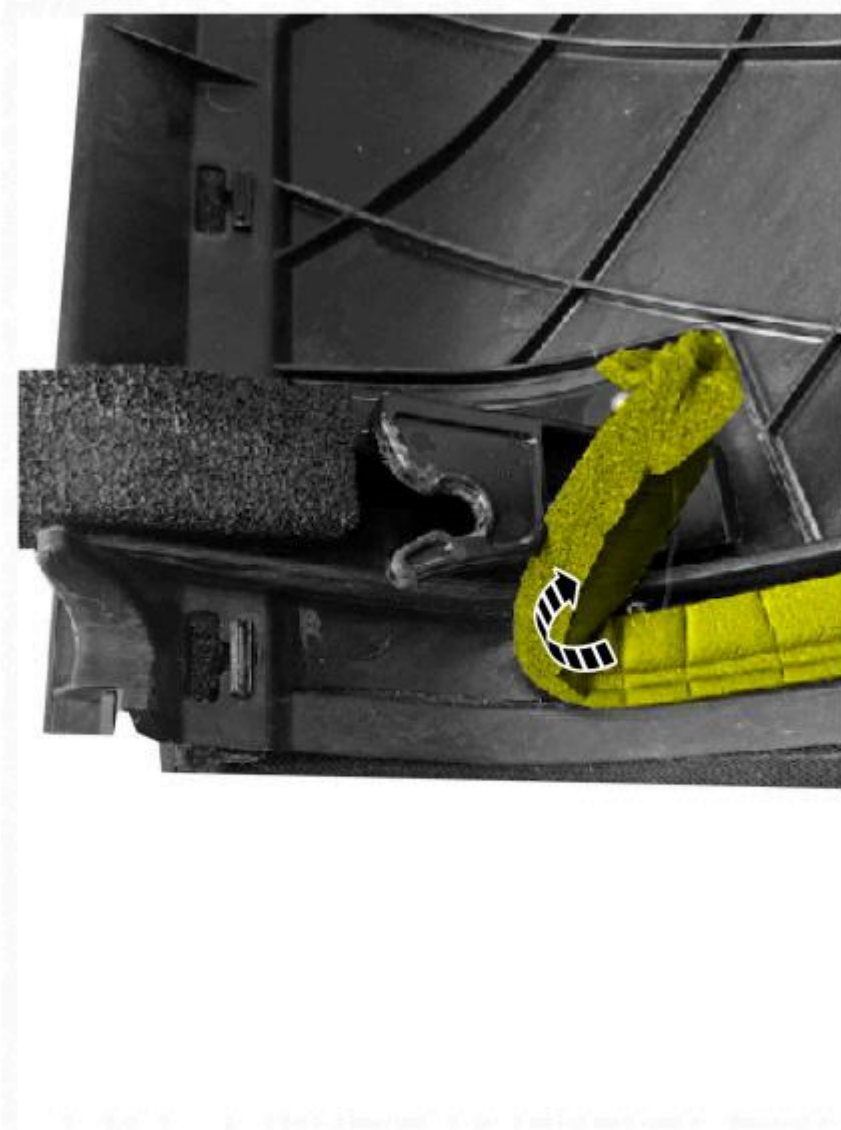
Figure 3 – Showing the lower foam seal correctly pulled back and tucked out of the way. Right side shown, left side similar.

5. Gently pull back the lower foam seal 2 in. (50 mm) and tuck it out of the way (Figure 3). This foam seal will be reattached at the end of the procedure. If the foam or its adhesive is damaged, rear window replacement would be required. If the rear window is replaced, the new window must be reworked following this article.

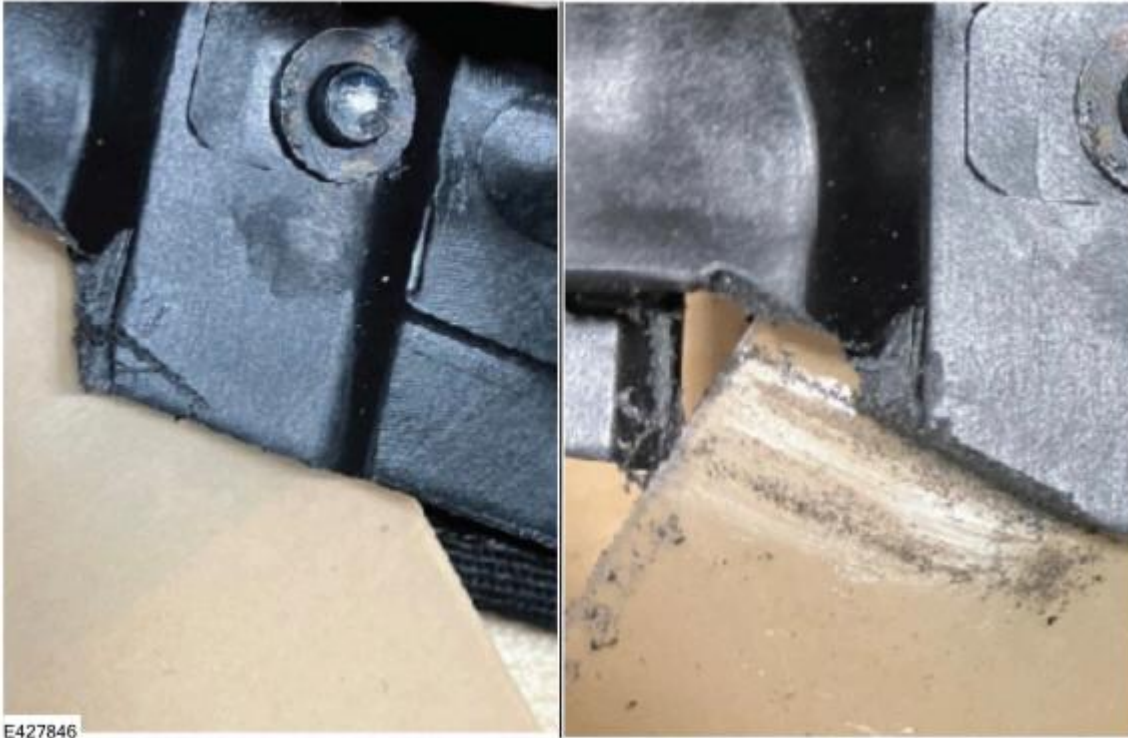
Figure 7 – Showing proper placement of the protective material and before and after view of the plastic corner removed. Right side shown, left side similar.

9. Slide a piece of thin protective material such as a manilla folder or similar item between the plastic and fabric in the area that was marked/cut in Step 8. With the fabric now protected, use a small file to carefully remove the triangular section of the plastic up to the line that was scored in Step 8 as the guide. (Figure 7)

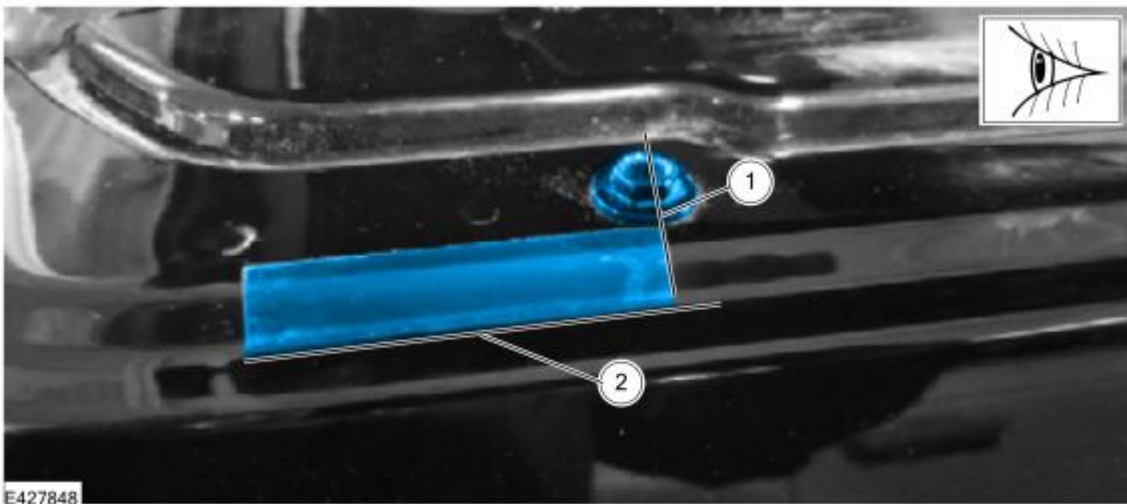
Figure 9 – Showing correct installation location of the UHMW clear tape. Right side shown, left side similar.

16. Install the UHMW clear tape.
 - (1). Peel the backing from one piece of trimmed UHMW clear tape and place it on the rear quarter panel as shown in Figure 9. The bottom edge of the UHMW clear tape must align with the channel of the rear quarter panel (Figure 9, Callout 2) and the forward-facing edge of the tape must be behind the center point of the bolt on the rear quarter panel (Figure 9, Callout 1). Do not install any portion of the UHMW clear tape onto the bolt located nearby as this will prevent proper adhesion.

- (2). Apply firm pressure to the UHMW clear tape once installed to complete the adhesion process.
 - (3). Perform Steps 16(1) and 16(2) on the rear quarter panel on the opposite side regardless of whether the quarter panel had damage or was painted.

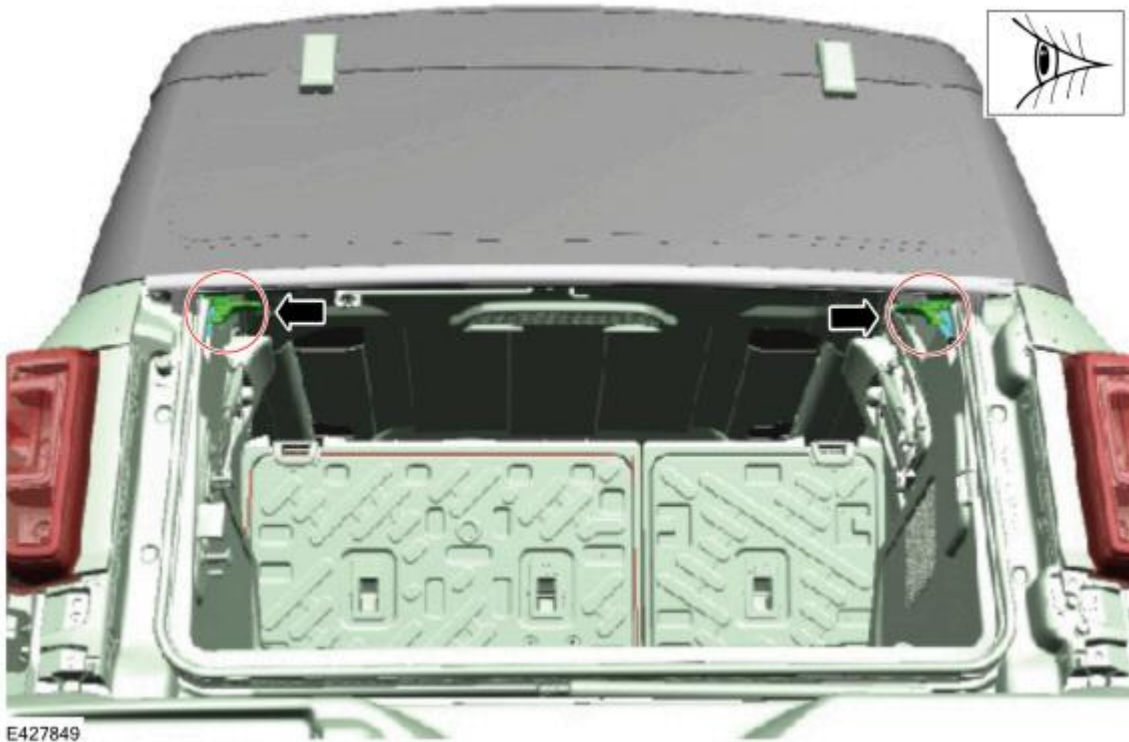
Figure 10 – Showing the location of the tension bow latch receivers. Rear door has been removed for demonstration purposes only.

17. Completely open the rear door and place the rear of the soft top in the raised position. Refer to the Owner's Manual > Removable Vehicle Components > Removable Soft Top > Opening and Closing the Soft Top > Accessing the Rear Cargo Area. The prop rod must not be used to stow the soft top in position. Use a large soft rolled up blanket or similar item to keep the rear section soft top in the up position.
18. Identify the two tension bow latch receivers on each side of the vehicle. (Figure 10)
