Technical Service Bulletin

01 Car jerks/bucks or hesitates while driving DTCs P023600 and/or P010600 are stored in the ECM
01 24 11 2062323/3 March 4, 2024. Supersedes Technical Service Bulletin Group 01 number 21-13 dated October 20, 2021 for reasons listed below.

Model(s)	Year	VIN Range	Vehicle-Specific Equipment
A6	2019 – 2022	All	2.0l engine

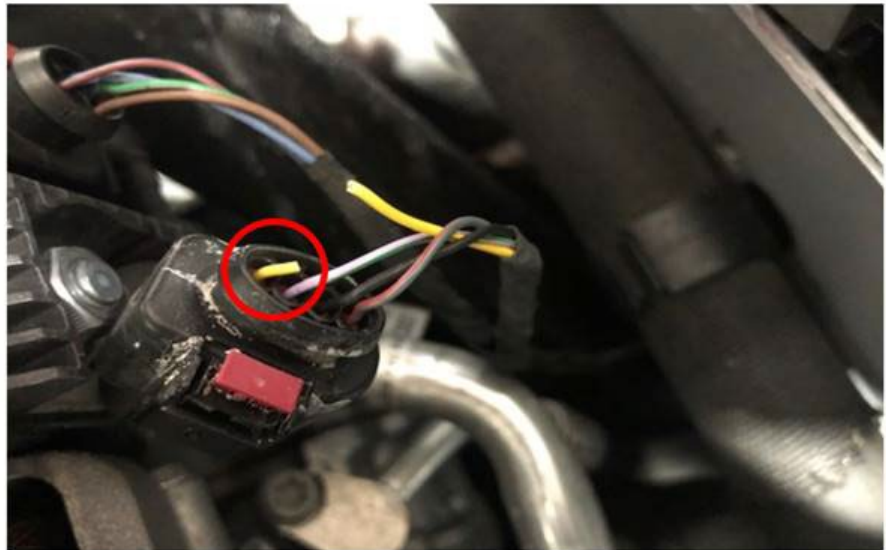
- The yellow wire on the electrical connector of the charge pressure sender is damaged.

Due to the routing of the wiring and the length of wiring that is uncovered, the wiring may become damaged due to vibrations.

Figure 1. Wire is broken at G31 sensor.

1. If damage is found to the pins or wire at the G31 boost pressure sensor, repair the harness using VAS 1978B (Figure 1).

Please use gold-plated contacts to repair the damaged wire(s) (000 979 025 EA).

Ensure there is sufficient slack in the harness to prevent future issues.

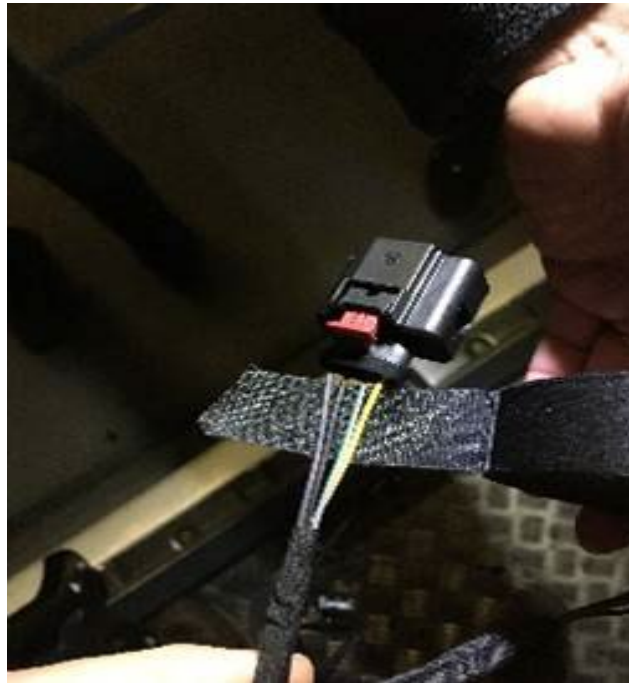
Figure 2. Harness is wrapped using textile tape 105 920 02.

2. Following repairs, the harness must be wrapped with textile tape **N 105 920 02**.

Apply the textile tape starting at the wiring below the connector. Ensure the wires are kept flat to avoid over stressing the pins (Figure 2).

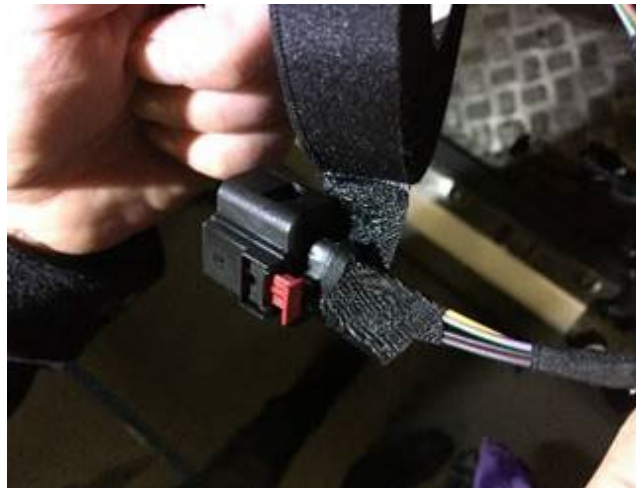
Figure 3. Wrapping the connector base.

3. Wrap the tape in the direction of the connector keeping it **flat** (Figure 3).

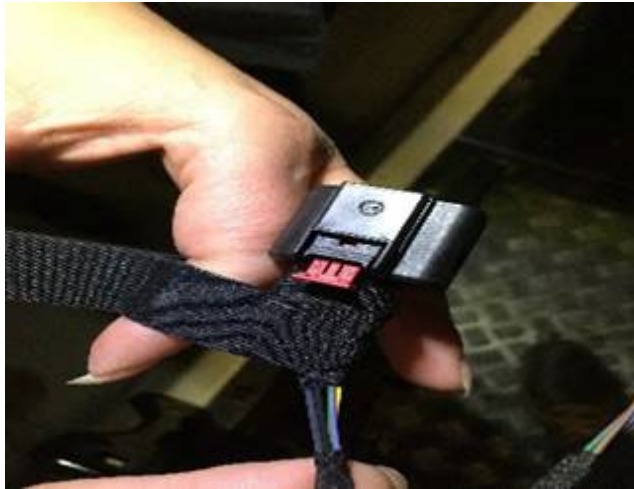
Figure 4. Wrapping the connector base part 2.

4. The tape must extend far enough to cover the connector base (Figure 4).

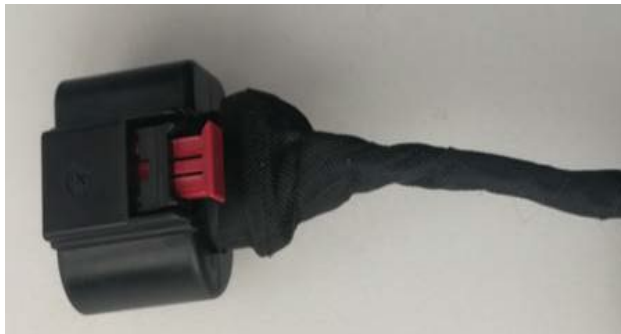
Figure 5. Completed harness wrapping.

5. Continue to wrap the exposed wires down the harness and slightly overlap the existing harness tape (Figure 5).
