# Technical Service Bulletin

## 55 Guide to finding water ingress on the rear lid structure

55 24 93 2073283/1 March 5, 2024.

| Model(s) | Year | VIN Range | Vehicle-Specific Equipment |
|---|---|---|---|
| Q4 e-tron, and Q4 Sportback e-tron | 2022 – 2023 | All | Not Applicable |

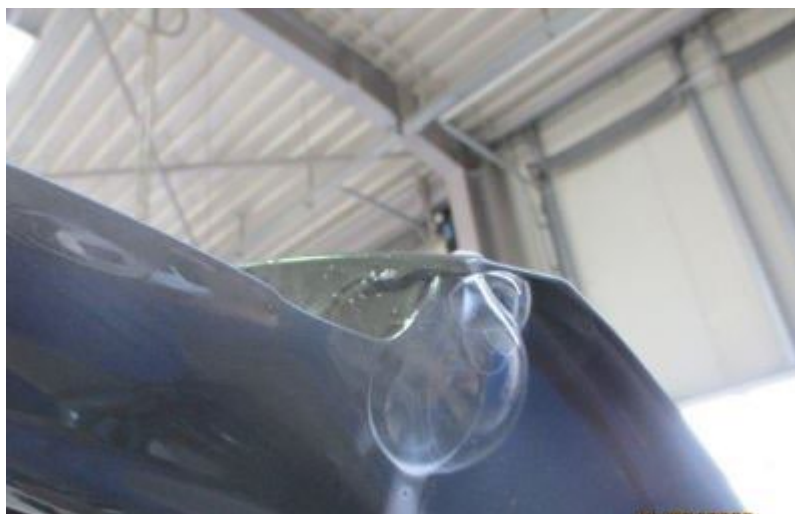
The seam sealer used to seal adjoining panels may have a flaw causing a small opening that can allow water to enter the rear lid shell. This TSB shows areas of the rear lid shell where sealer flaws may exist.

**Figure 1.** Bubble formation with compressed air applied internally.

1. Remove the rear lid trim and perform a leak test on the rear lid. With the lid trim removed visual and physical access to the rear lid structure can be gained. Mix a solution of dish detergent and water and add to a spray bottle. Spray the solution on the area shown in Figures 1, 2 and 3 while blowing compressed compressed air from the inside of the rear lid structure and watch for bubble formation.

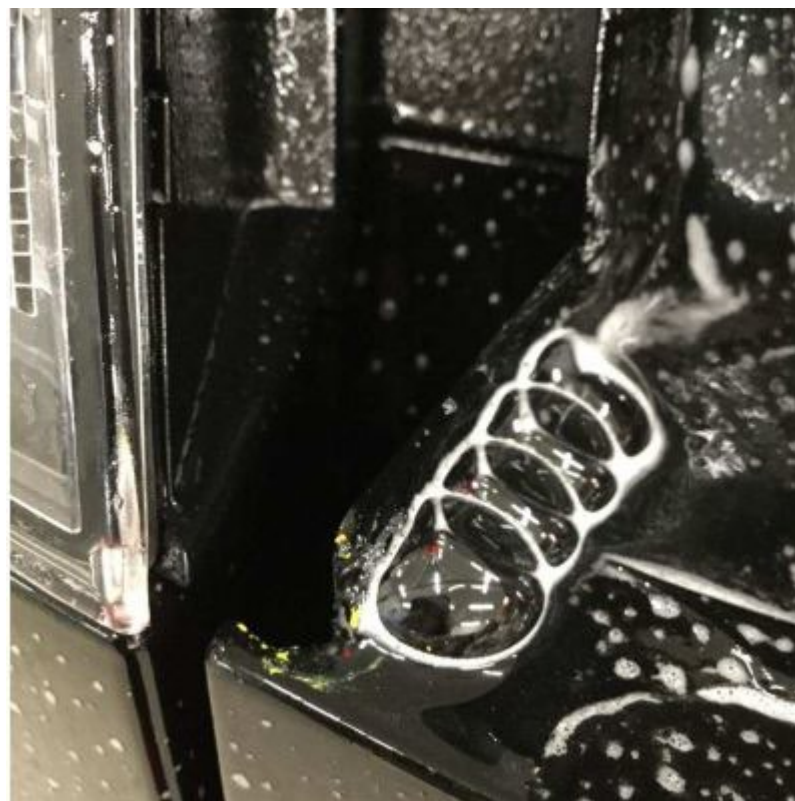
**Figure 2.** Bubble formation with compressed air applied internally.

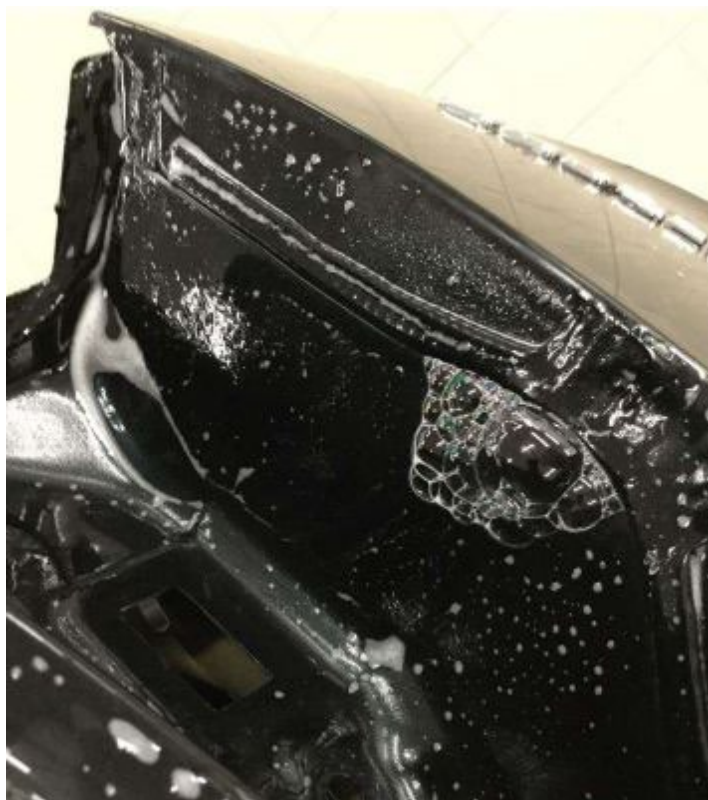
*Figure 3. Bubble formation with compressed air applied internally.*

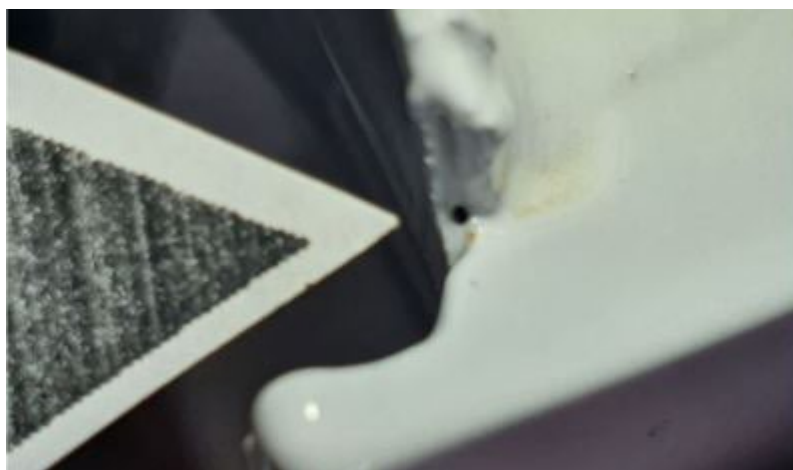
4. Figure 4 shows a possible location of insufficient sealant.

*Figure 4. Area where sealant may be missing.*

5. In cases where the sealer flaw is in a concealed area (e.g., behind a tail lamp) the openings can be repaired by applying D 476KD1M2 or D 476KD1M3 sealant to the openings with a brush. To the corresponding area on the inside of the rear lid shell apply D 321M16M2 cavity preservative using a brush. Ensure the application area is thoroughly clean and allow the sealant to cure as instructed. Touch up painted surfaces as necessary.

6. If the sealer flaw is in a visible area send the vehicle to your body shop for repair as finish paintwork will be required.

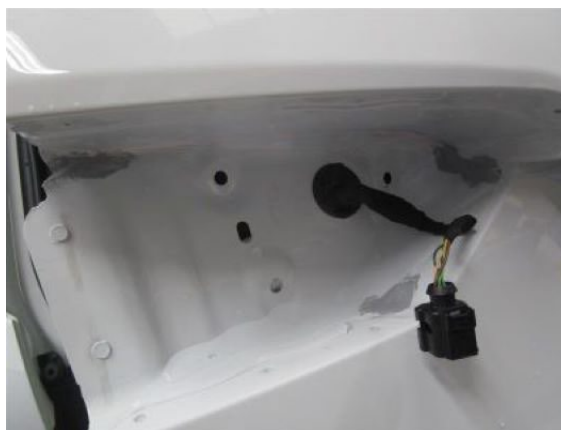
**Figure 5.** Concealed areas repaired with D 476KD1M2 or D 476KD1M3 sealant.
