## Technical product information

| <b>Topic</b> | New Continental GT and GTC - Window drop glass operation |
| <b>Transaction No.</b> | 2070497/7 |

Retailer glass reset procedure for GT/GTC

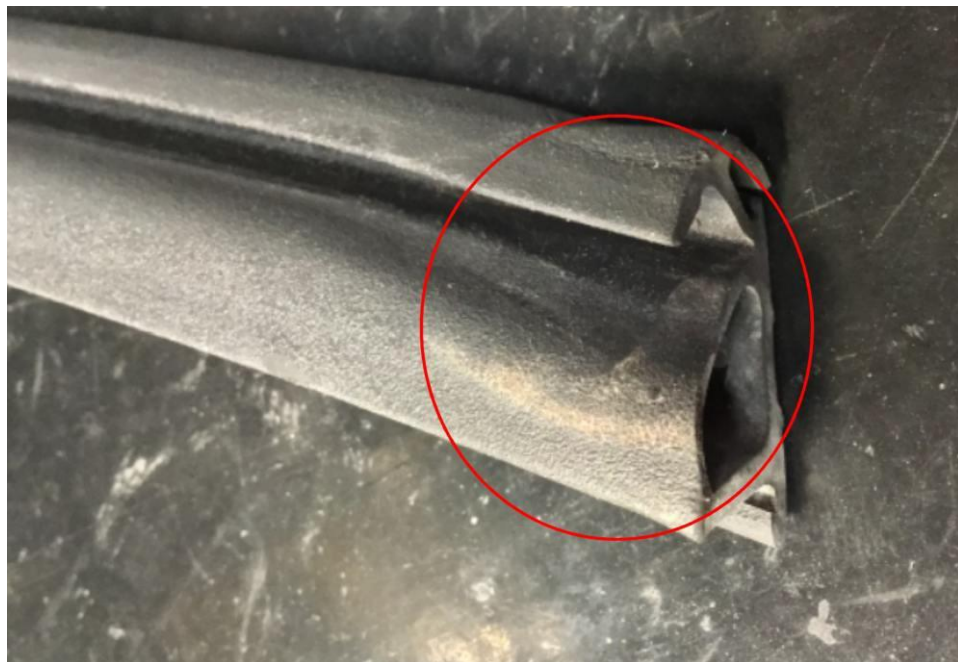
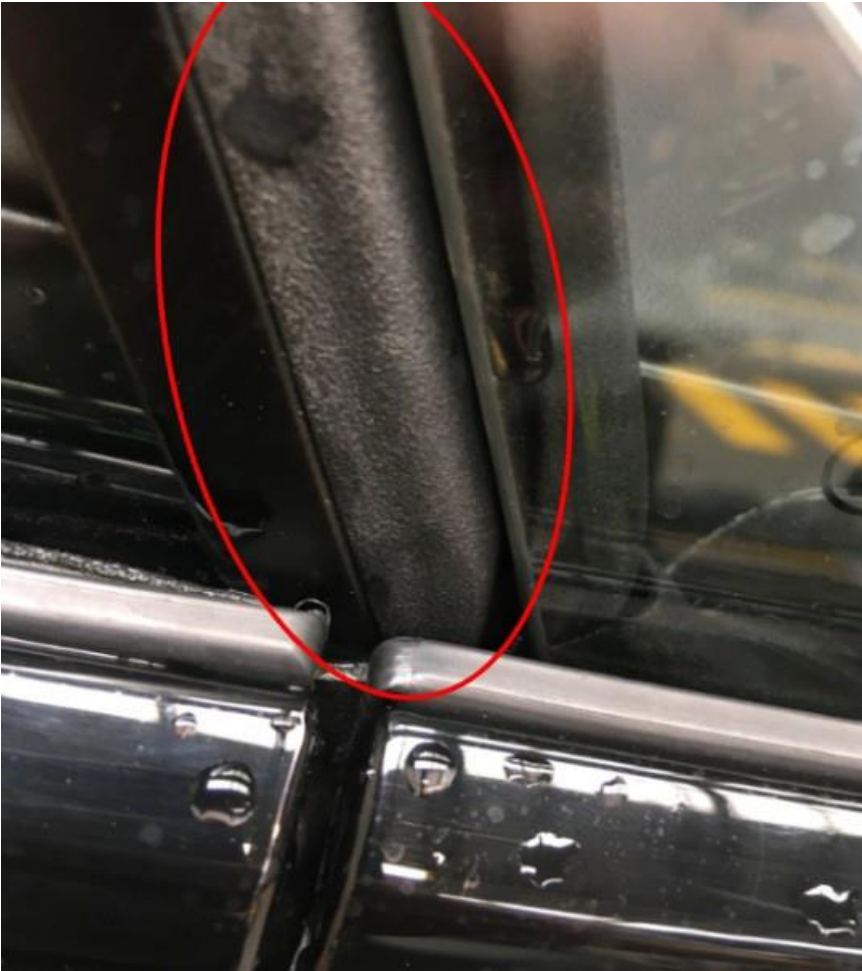
- Damage
- Splits
- Tears
- Misalignment
- Incorrectly fitted/located
- Drop glass seal deformation (see Figures 9 and 10 as examples)

NOTE: Any issues found with the window seals must be rectified before conducting the remaining steps

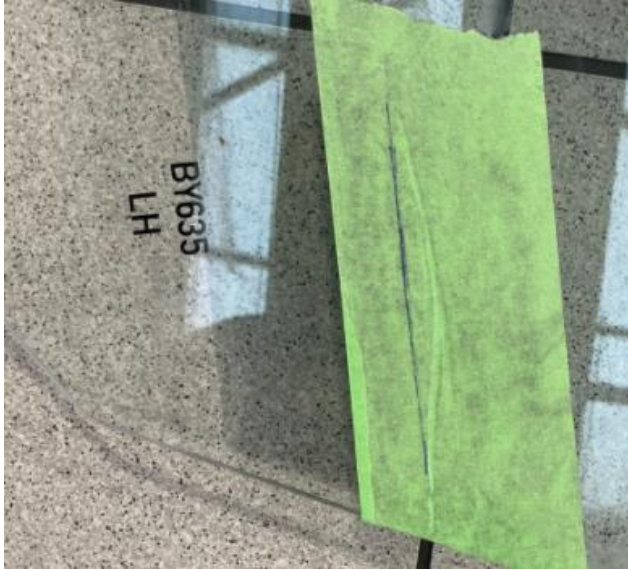
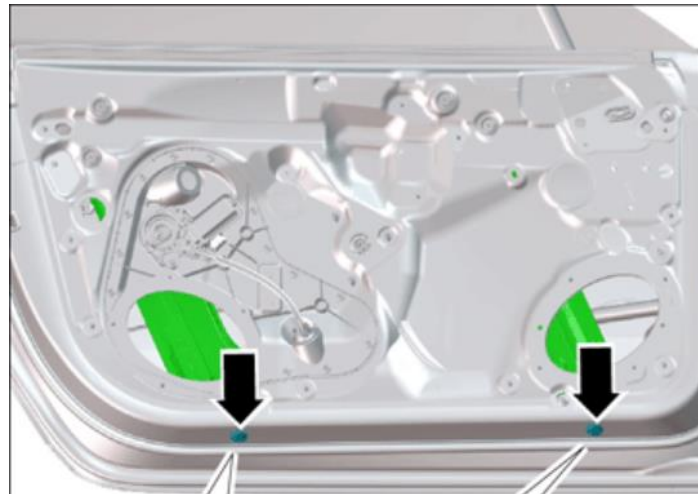
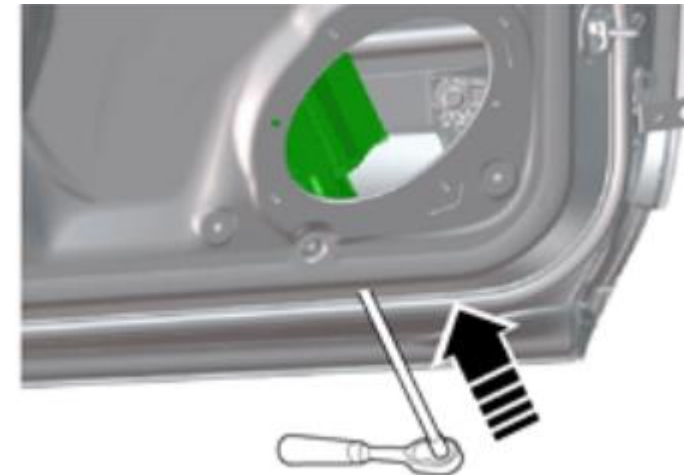
- Z Axis height adjustment on front drop glass

Example: Front drop glass Z axis not adjusted correctly. Bottom of tape was level with waist rail seal, after slackening pinch bolt (3 in bottom left image) front drop glass lowered 14mm to where pen marked line is.

Z-axis adjusters (bottom middle and right images) had not been used, pinch bolt had been slacked and glass lifted out of the regulator to achieve specification. This has a knock on effect of altering the 10mm division bar intrusion seen in previous slide as glass is loose and can be accidentally moved in X-axis.

This also creates a risk that the window will bottom out on the cant rail seals rather than the regulator bump stops meaning that the glass can raise further as the seals soften over time and affect end stop learning.

## Z-Axis height should only be adjusted by the 4mm Allen key adjusters as per ELSAPRO

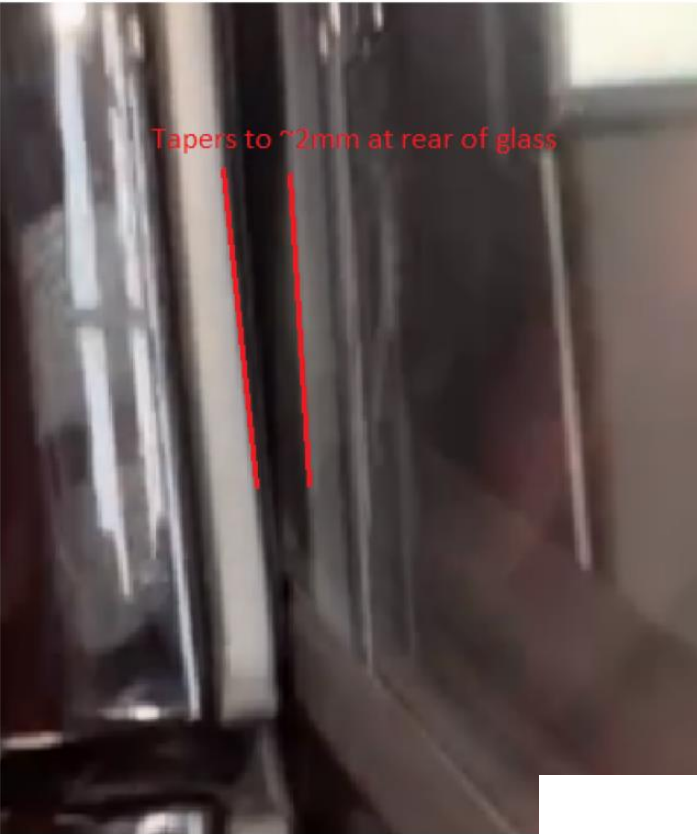
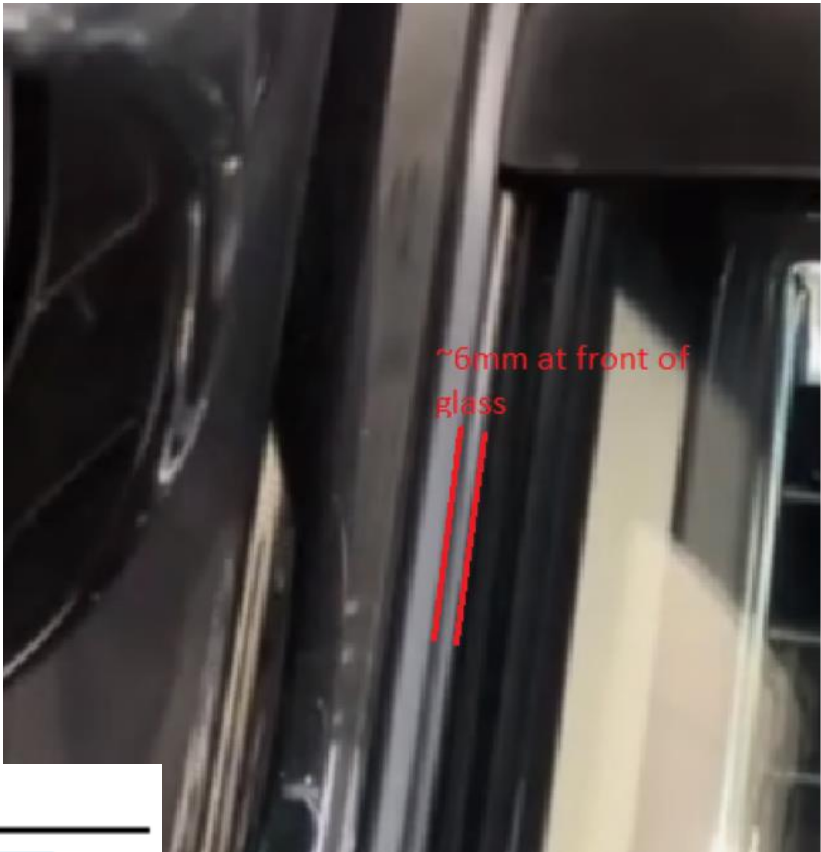
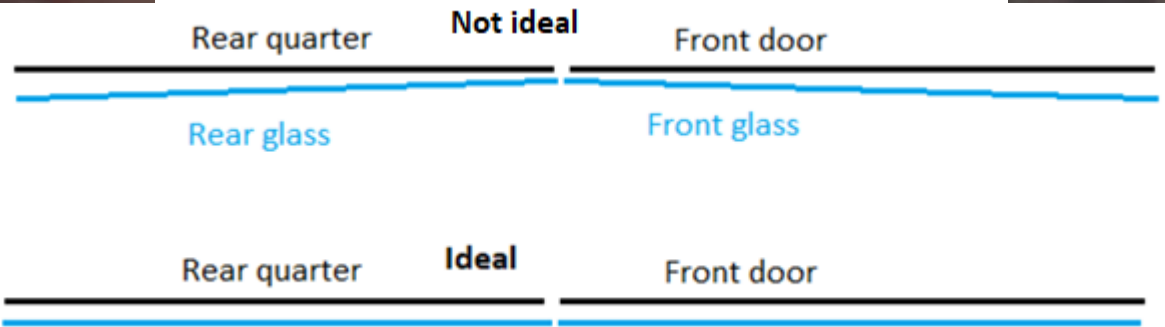
- **Wastrail measurement checking/resetting**

Images show a poor setting.  
Circa 6mm at front edge (near wing mirror)  
closing up to 2mm at the rear edge.

2mm at rear edge would have been set to achieve specified flush/2mm underflush profile condition between front and rear glasses, the rear quarter glass mirrors this taper condition. This potentially increases the risk of false anti trap as rear window/seal does not engage with front window at the correct angle. Suggested to set to specification on problem vehicles as per next slide. If both windows are set between 4-6mm then the flush/2mm underflush profile can be easily achieved.

Set waist rail gapping to between 4-6mm as mentioned in Glass setting guide videos on E-Academy and also check for parallelism along front and rear windows to door/quarter. 50mm from edge of Waistrail seal, roughly underneath the Bentley wings.
