# Service Bulletin

Bulletin No.: 22-NA-144

**Subject:** Service Door Latch, Power Windows, Door Locks and Outside Mirrors Inoperative, Unwanted Theft Alarm Activation, Random Messages Displayed on Driver Information Center (DIC)

Brand:	Model:	Model Year:		VIN Breakpoint:		Engine:	Transmission:
		from	to	from	to		
GMC	HUMMER EV	2022	2024

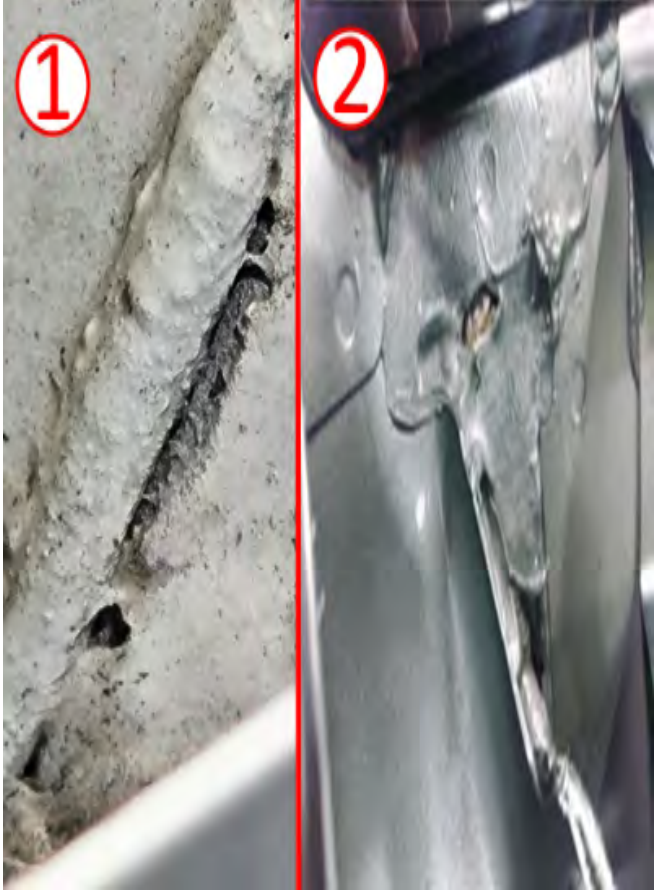
<p style="text-align: right;">6103692</p> <p><b>Note:</b> The image above depicts a close-up of a failed seal below the driver side (1) and passenger side (2) windshield area.</p> <p>This condition may be caused by the driver’s front door X500 in-line electrical connector and/or the passenger front door X600 in-line electrical connector, that may have corroded terminals due to a water leak entering inside the upper A-pillar through the panels not sealed properly.</p>
<p>Correction</p>	<p>Open the X500 and X600 to inspect for corroded terminals. Perform a water leak test on suspected sheet metal area, reseal, and re-test for leaks.</p> <p>Repair and/or replace the X500 and/or X600 terminals as required.</p>

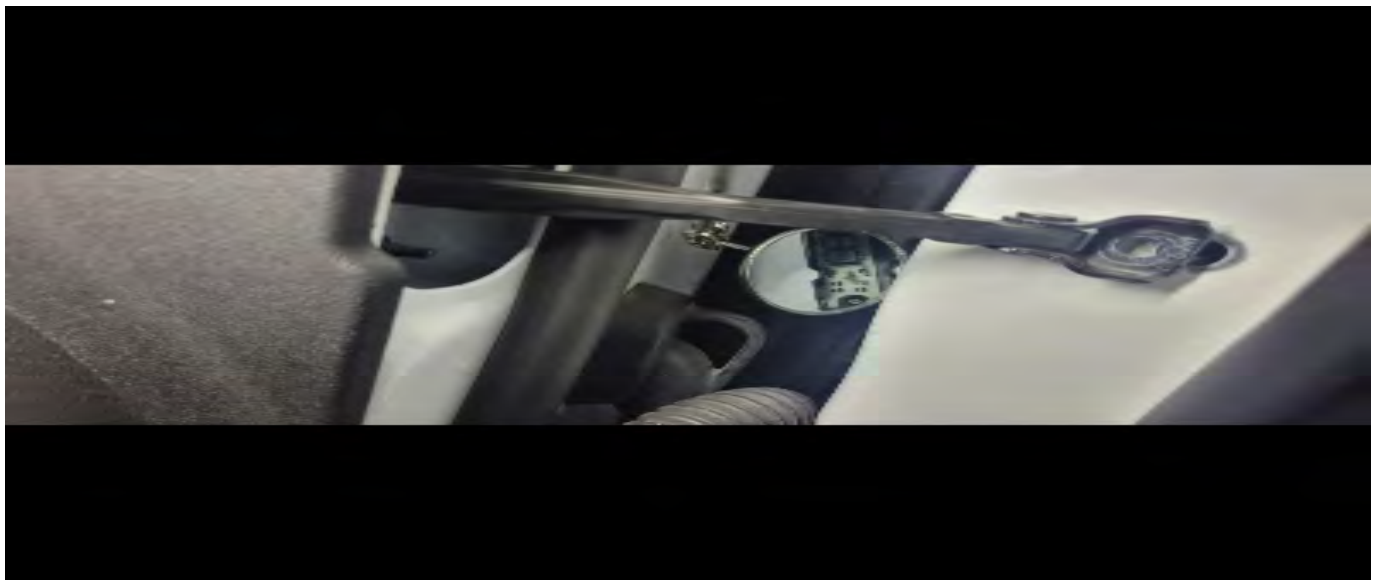
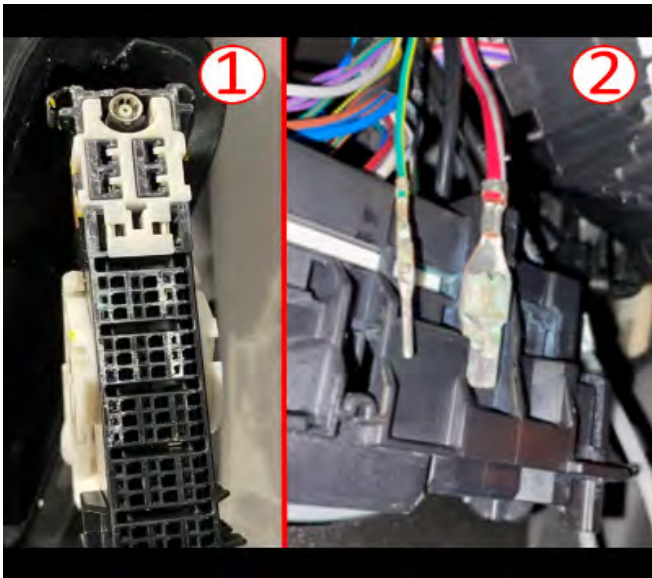
**Note:** The graphics above are an example of what the corrosion may look like in the X500 connectors, X600 similar.

- If corrosion is found at the door side connector (1) or the instrument side connector (2), continue to step 7.
- If corrosion is not found on the connectors, refer to step 14.

**Note:** Clean the terminals if at all possible. Only replace the terminals if corrosion has entered the wire.

8. Clean or repair the terminals that **only** require attention. Refer to *Connector Repairs* in the Service Manual.
