# TECHNICAL SERVICE BULLETIN

Classification: EL23-021	Reference: NTB24-012	Date: February 9, 2024
-----------------------------	-------------------------	---------------------------

## DTC P18B1 STORED IN THE SHIFT CONTROL UNIT

**APPLIED VEHICLES:** 2018-2022 LEAF (ZE1)

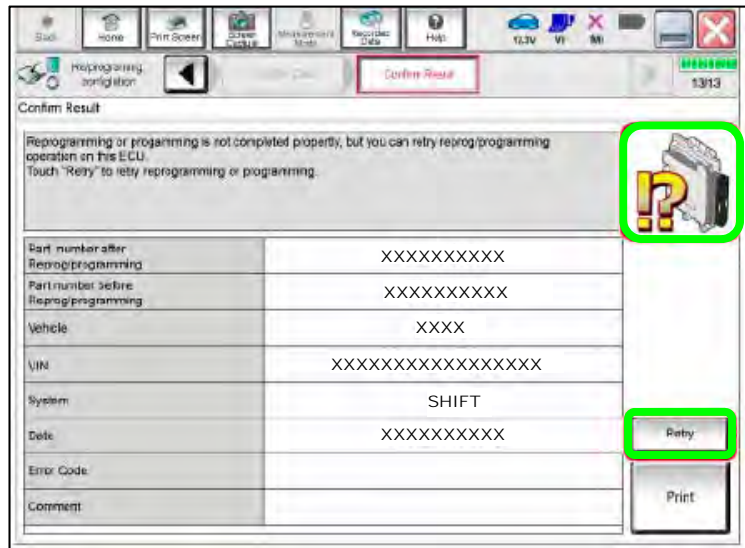
Figure 24

If reprogramming does not complete and the “!?” icon displays, as shown in Figure 24:

- Check battery voltage (12.0 V – 15.5 V).
- EV system is ON (Not Ready).
- External Bluetooth® devices are OFF.
- All electrical loads are OFF.
- Select **Retry** and follow the on screen instructions.
- Retry may not go through on first attempt and can be selected more than once.

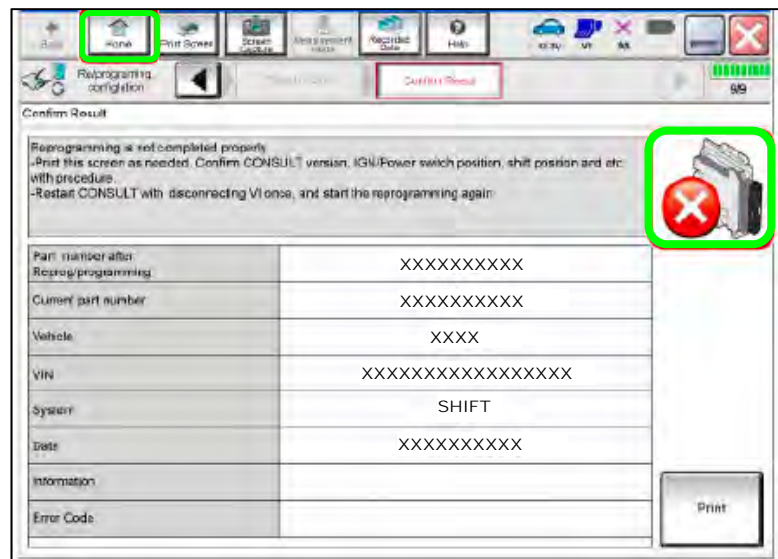
Figure 25

If reprogramming does not complete and the “X” icon displays, as shown in Figure 25:

- Check battery voltage (12.0 V – 15.5 V).
- CONSULT A/C adapter is plugged in.
- EV system is ON (Not Ready).
- Transmission is in Park.
- All C-III plus / VI cables are securely connected.
- All C-III plus updates are installed.
- Select **Home**, and restart the reprogram procedure from the beginning.
