Vehicle Quarantine Notice

Action No.: N871 UPS1024-1

Subject: **Righthand Side Lower A-Pillar Bolt**

Model(s):	Model/Variant	Model Year(s)	
		from	to
	Discovery Sport (LC)	2024	2024

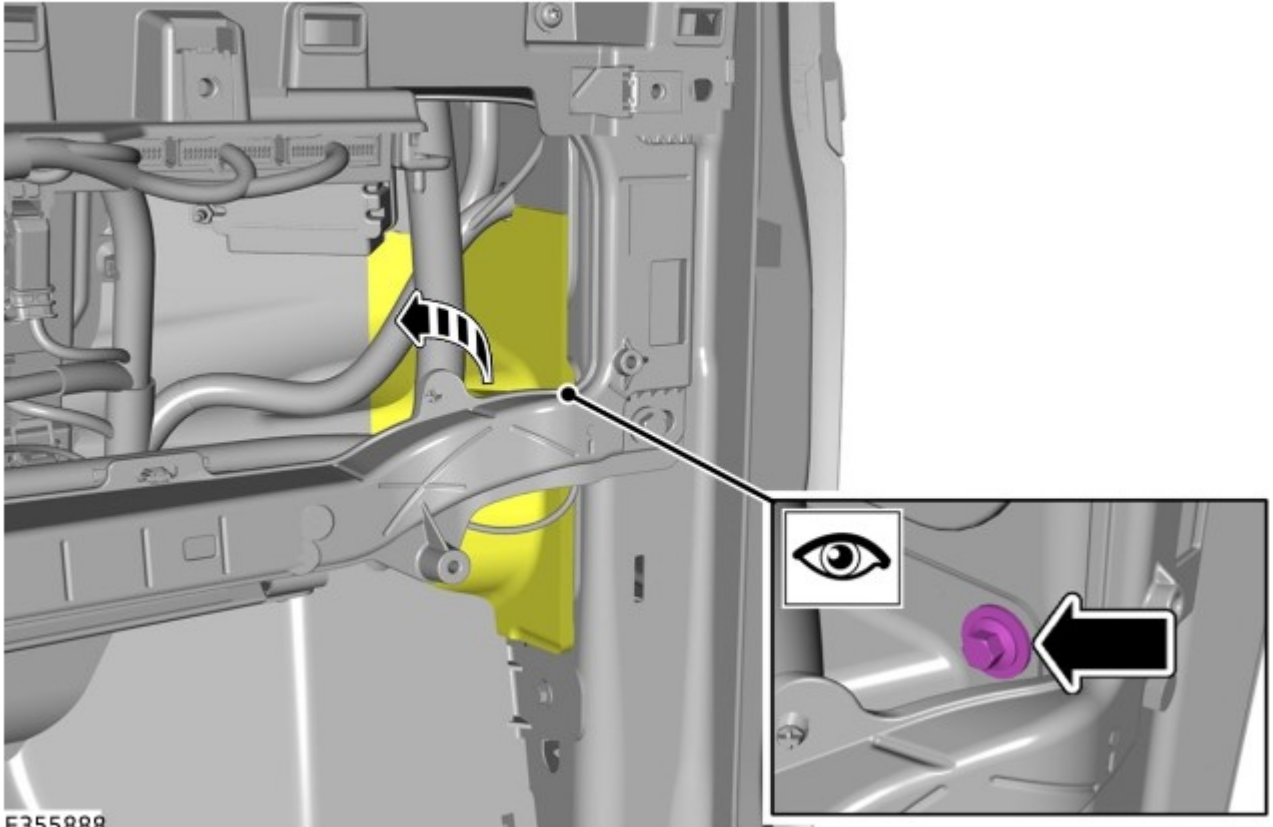
3. Reposition the **Noise, Vibration and Harshness (NVH)** material to access the lower A-pillar bolt.

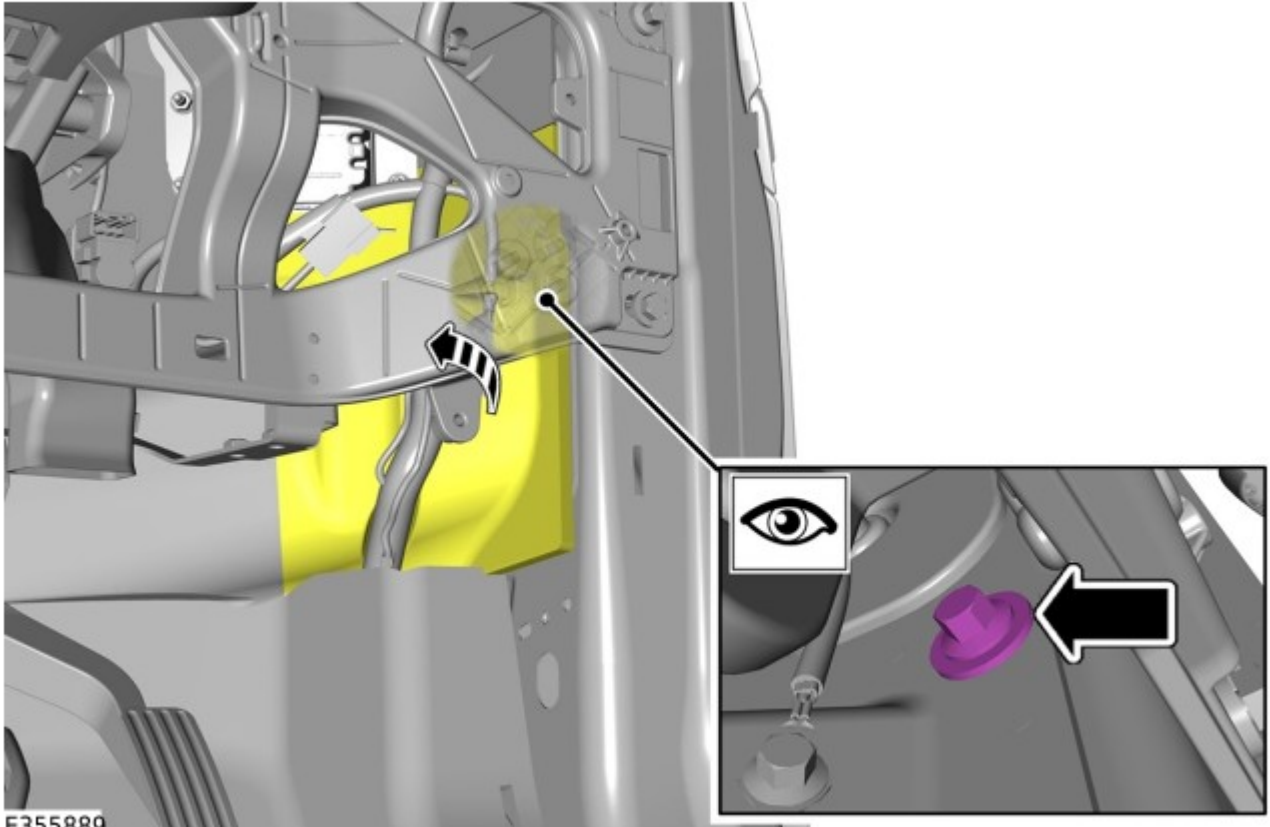
E355889

3. Reposition the [NVH](#) material to access the lower A-pillar bolt.
