# XOS Technical Service Bulletin

Bulletin No.: TSB- 002-24

Subject: Updating Vehicle VCU Software

Applicability: All 2021-2022 Xos SV05 Trucks

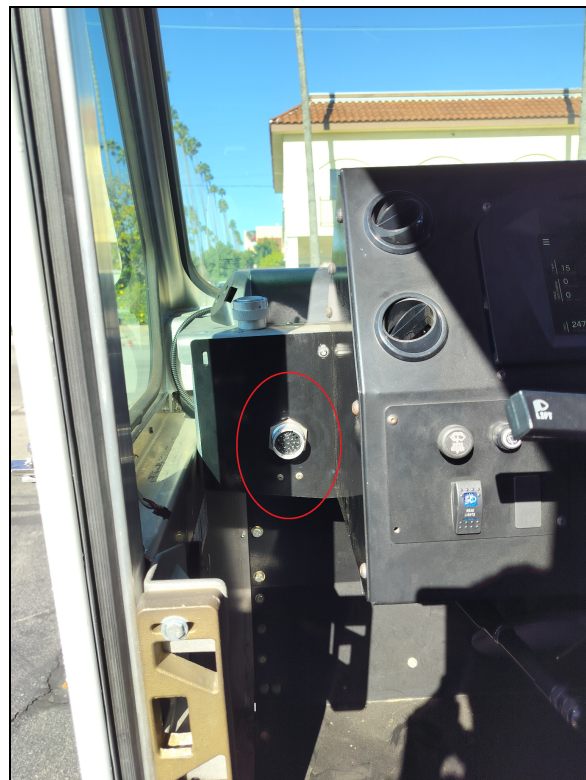
**The harness needs to be connected to the diagnostic port of the vehicle which is located on the left hand side of the instrument cluster by the driver seat. Please refer to the image below for context.**

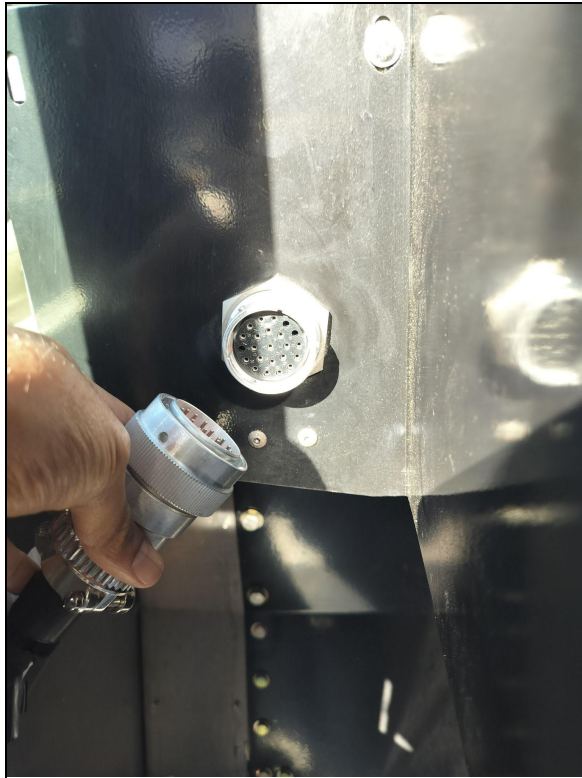
**Plug in the harness to the diagnostic port.**

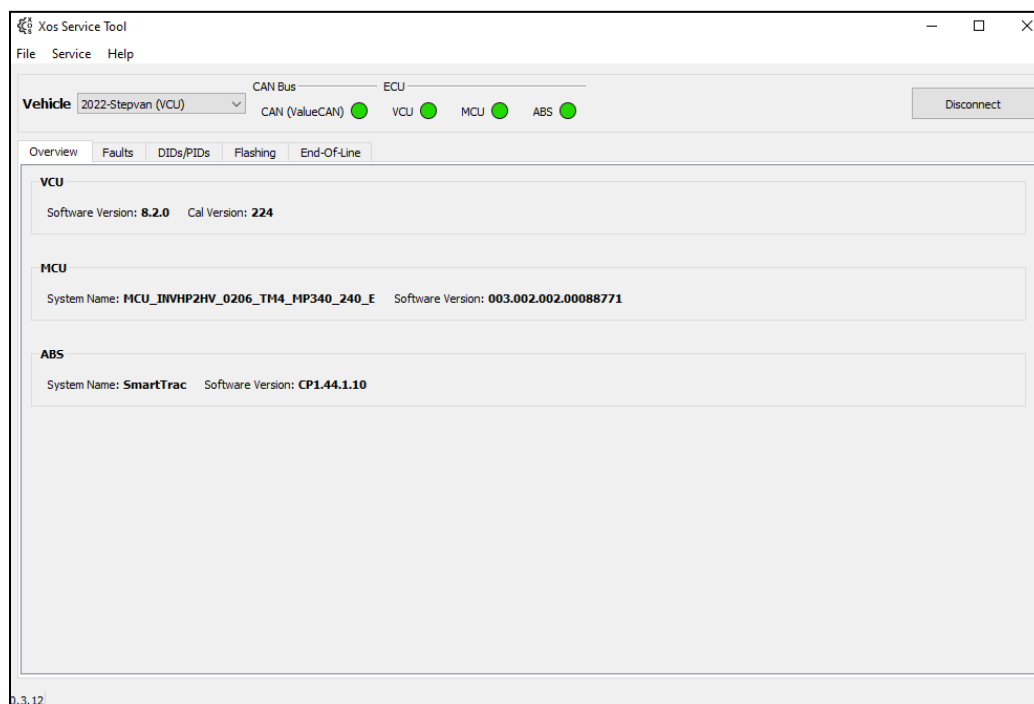
On pressing 'Connect' on this window, the Service Tool will connect to the vehicle and you should see the following controllers active for the vehicle.

All controllers should appear in green on the Service Tool. Please check the harness connection if any of the controllers appear in red. Make sure that you are connected to 'Connector 1'.

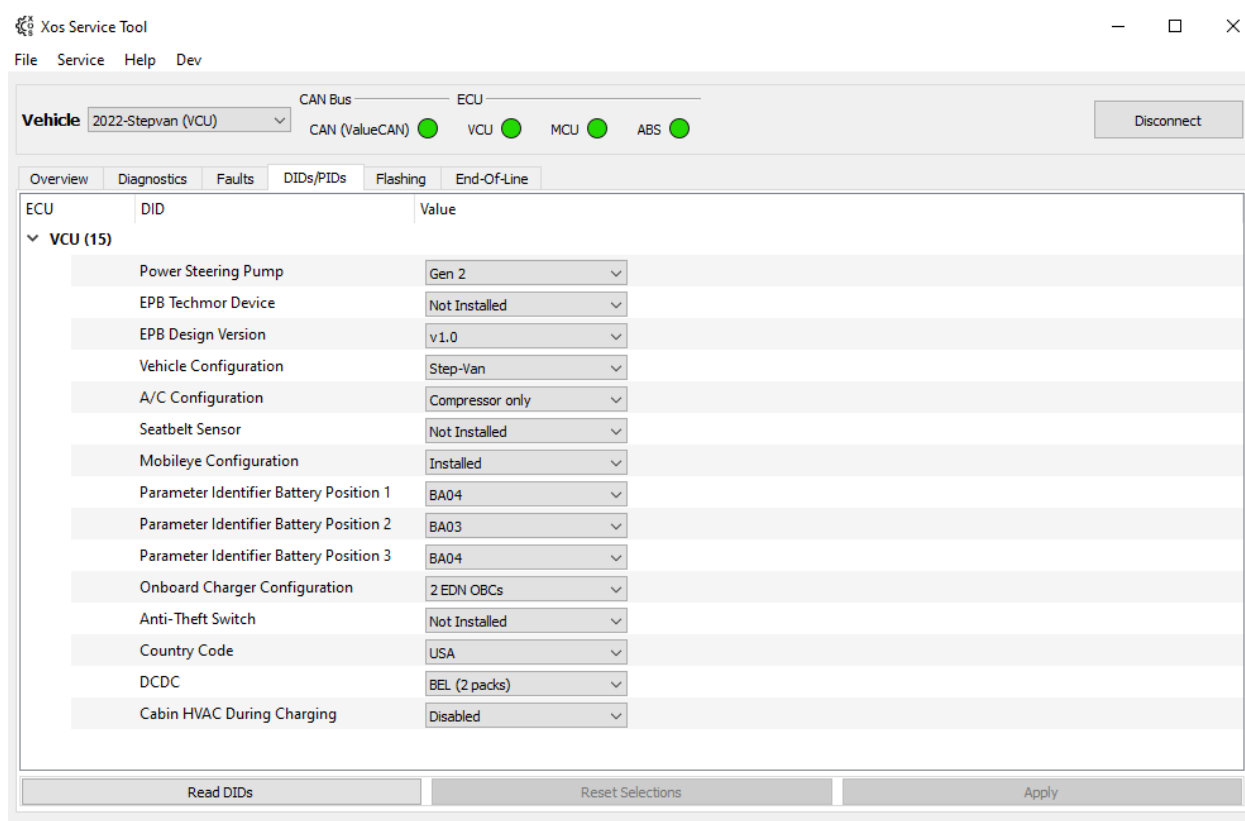
Click on the 'Connect' button once again, and click on 'Read DIDs' to read the current configuration of the vehicle. After flashing, if there is any DID that is reading as 'unconfigured', it will stop the vehicle from being driven.

If flashing from a 8.2.0 or 8.4.0 version of the software, the DID for 'Cabin HVAC During Charging' will read as Unconfigured. In that case, set the 'Cabin HVAC During Charging' DID to Disabled. Then click on 'Apply' to apply the changes and to allow the vehicle to be driven.

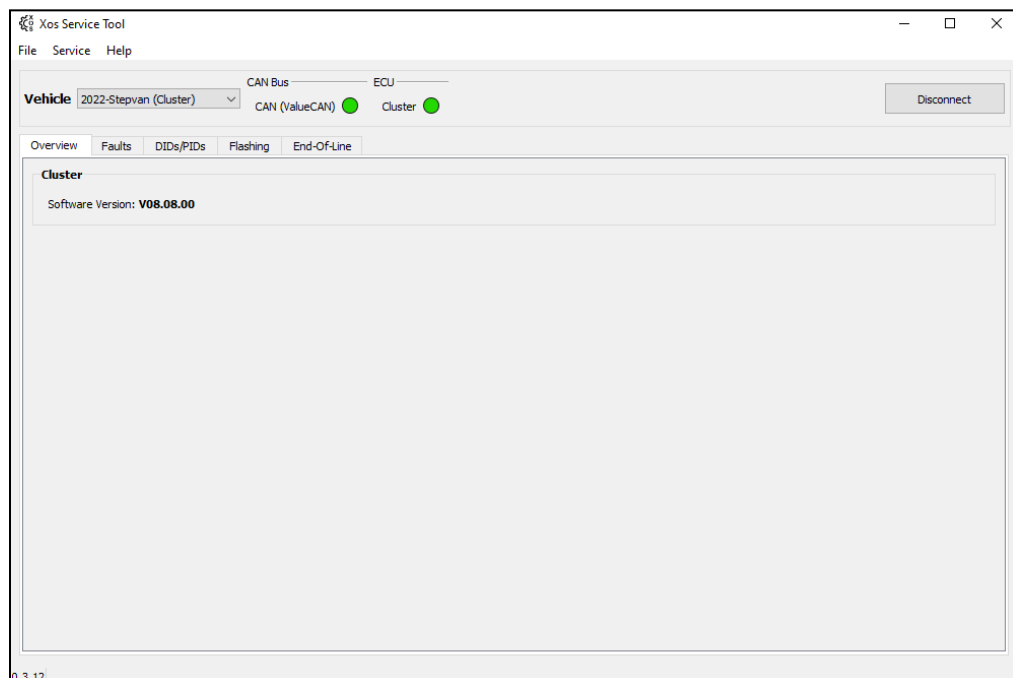
Click on 'Connect' to connect to the cluster. If the software version for the cluster reads anything other than V08.08.00, the cluster will have to be flashed.

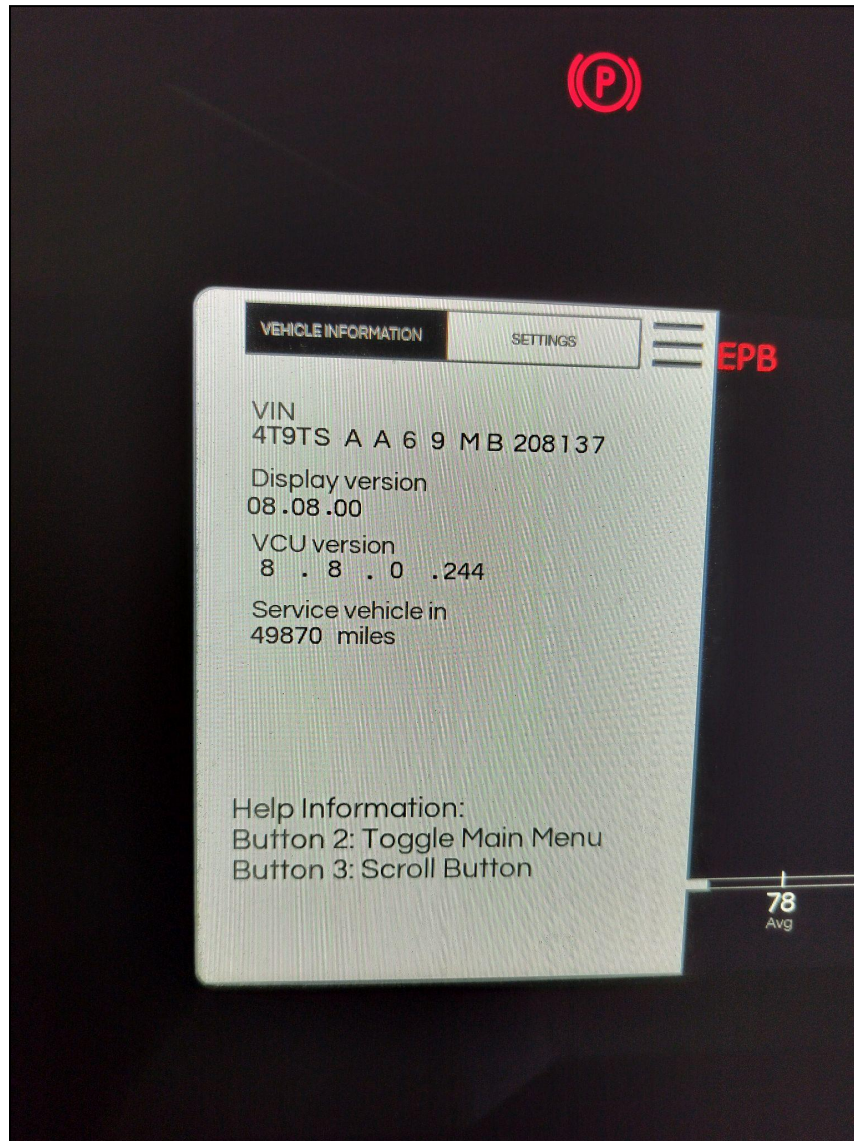
If the VCU Version displays as '8.8.0.244' and the Display version appears as '08.08.00' then both the controllers are flashed successfully. Please refer to the image below for context.
