Subject: N242436241 - Customer Satisfaction Program
Multiple Module Reprogramming

Models: 2024 Chevrolet Blazer EV

Customer Satisfaction Program

N242436241 Multiple Module Reprogramming

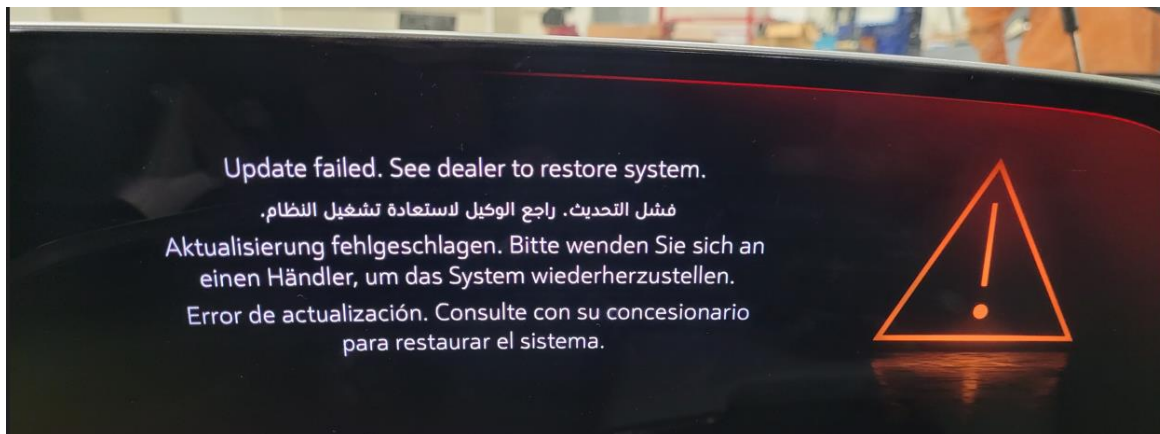
6554772

1. There is a chance for an error to be encountered during the USB update portion of the procedure right around 60% completed.
 - 1.1. This happens once the USB is in the vehicle and the progress bar can be seen on screen.
2. If the error occurs the screen will look like below

3. In this case pull the USB from the vehicle and reformat again as shown in step 7 under service procedure.
4. Access the Service Programming System (SPS) and follow the on-screen instructions.
5. On the SPS Supported Controllers screen, select A11 Radio – USB Copy/USB File Transfer.
6. Upon completion of the file transfer, properly eject the USB drive from the computer.
7. Connect the USB drive to the USB port in the vehicle.
 - 7.1. If the screen fails to show a progress bar once reinserted, pull out and reinsert again.
