March 5, 2024

Version 2

MIL is On with DTC P2DE1

Supersedes 23-100, dated December 8, 2023, to revise the information.

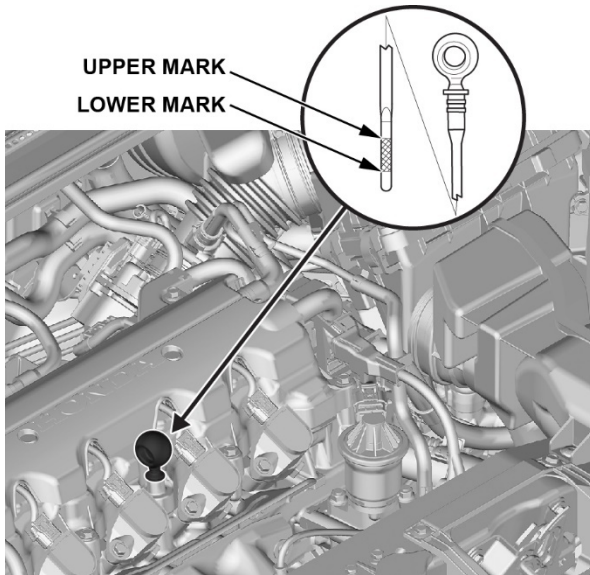
3. Park the vehicle on level ground and start the engine. Hold the engine speed at 3000 RPM with no load until the radiator fan comes on, then turn off the engine and wait more than **3 minutes**.
4. Remove the dipstick, and wipe off the dipstick, then reinstall the dipstick.
5. Remove the dipstick and check the engine oil level. It should be between the upper mark (A) and the lower mark (B).

Is the engine oil level above the upper mark?

YES – Continue to step 6.

NO – No engine oil change is needed. Go to SOFTWARE UPDATE PROCEDURE and update the PGM-FI software.
