CADILLAC
DCS6813
URGENT - DISTRIBUTE IMMEDIATELY

Subject: N232428540 - Customer Satisfaction Program
Multiple Module Reprogramming

Models: 2023 Cadillac LYRIQ

N232428540 Multiple Module Reprogramming

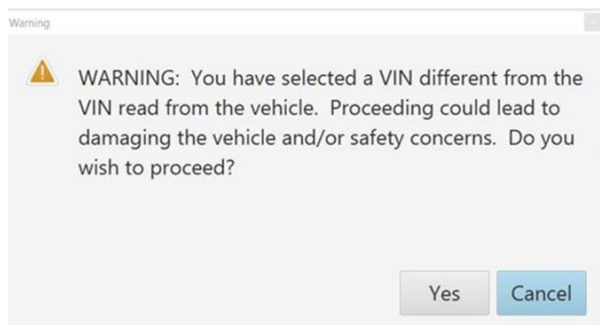
5877000

Important: If the vehicle VIN DOES NOT match, the message below will be shown.

- If the VIN that shows up in the TLC top center window after correctly reading the VIN from the vehicle does not match the VIN plate of the vehicle, manually type in the VIN characters from the vehicle VIN plate into the TLC top center window and use these for programming or reprogramming the subject module with the correct vehicle VIN and software and/or calibrations.

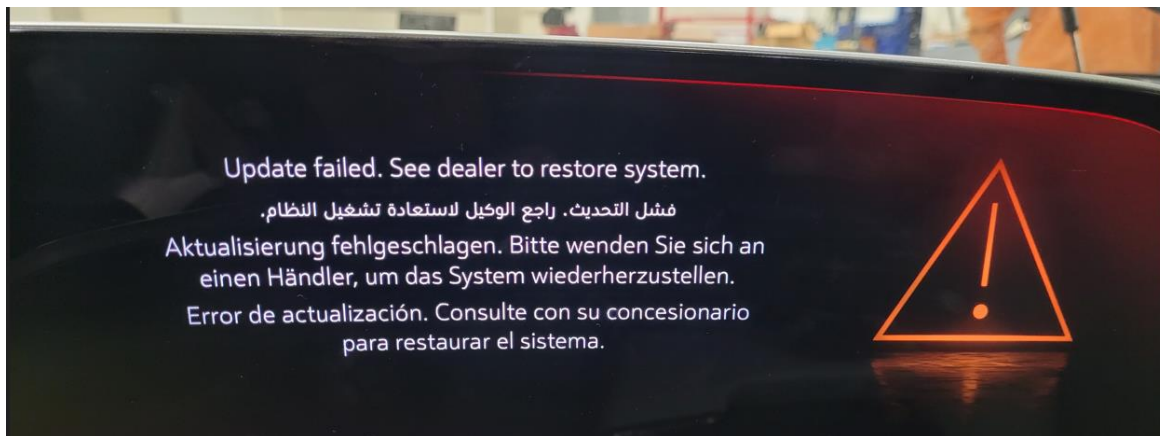
6554772

1. There is a chance for an error to be encountered during the USB update portion of the procedure right around 60% completed.
 - 1.1. This happens once the USB is in the vehicle and the progress bar can be seen on screen.
2. If the error occurs the screen will look like below

3. In this case pull the USB from the vehicle and reformat again as shown in step 7 under service procedure.
4. Access the Service Programming System (SPS) and follow the on-screen instructions.
5. On the SPS Supported Controllers screen, select A11 Radio – USB Copy/USB File Transfer.
6. Upon completion of the file transfer, properly eject the USB drive from the computer.
7. Connect the USB drive to the USB port in the vehicle.
 - 7.1. If the screen fails to show a progress bar once reinserted, pull out and reinsert again.
8. These steps should allow the progress bar to restart and complete successfully.
9. If you require further assistance, or would like verbal instructions in addition to this part of the service procedure please contact Techline Customer Support Center 1-800-828-6860 for English or 1-800-503-3222 for French (Canadian) for assistance.
