21-18-02 - Frozen Charge Air Cooler - Engine Will Not Start

Release date: 3/7/2024

Engine will not start after standing in cold weather below 0°C (32°F), MIL may be illuminated with various induction and/or boost system faults stored in ECM.

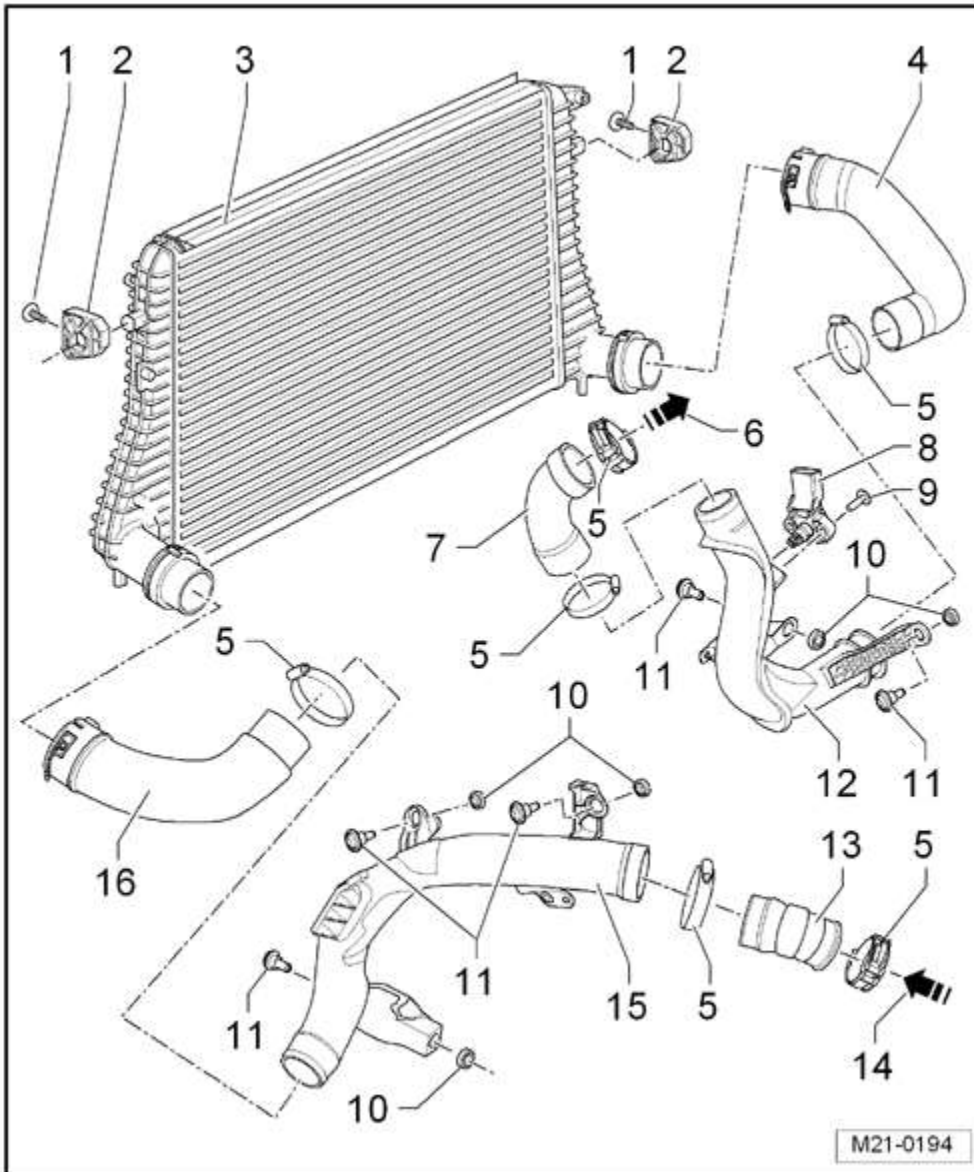
**Figure 1**

- Lock carrier in service position. See Repair Manual Group 50 in Elsa.
- Separate A/C condenser from charge air cooler.
- Remove radiator and radiator fan assembly.
- Remove the original charge air cooler (item 3 in figure 1) from the vehicle.

- Remove the lower charge pressure hoses ( items 4 and 16 in figure 1) and clean of any moisture, ice crystal formation or sludge. See Repair Manual Group 21, Turbocharger/G-Charger, Description and Operation, Component Overview, in Elsa.

- Remove cold side charge air pipe (item 12 in figure 1) and pressure hose to throttle valve (item 7 in figure 1).
- Separate the A/C condenser from the charge air cooler.
- Remove the radiator and radiator fan assembly.
- Separate the charge air pressure sensor –G31-- from cold side charge air pipe.
- Install charge air pressure sensor -G31- from kit to cold side charge air pipe.

- Install the cold side charge air pipe (item 12 in figure 1) and connect the charge air pressure sensor - G31- electrical connector.

- Cut vacuum source hose where indicated in figure 7, and install splice.
- Install the revised charge air cooler (item 3 in figure 1) with regulating flap and connect the regulating flap vacuum hose.
- Re-assemble all charge air pipe connections.
- Connect A/C condenser to charge air cooler using fasteners from kit, and install radiator with fan assembly.
- Reassemble front carrier.
- Re-aim headlights.

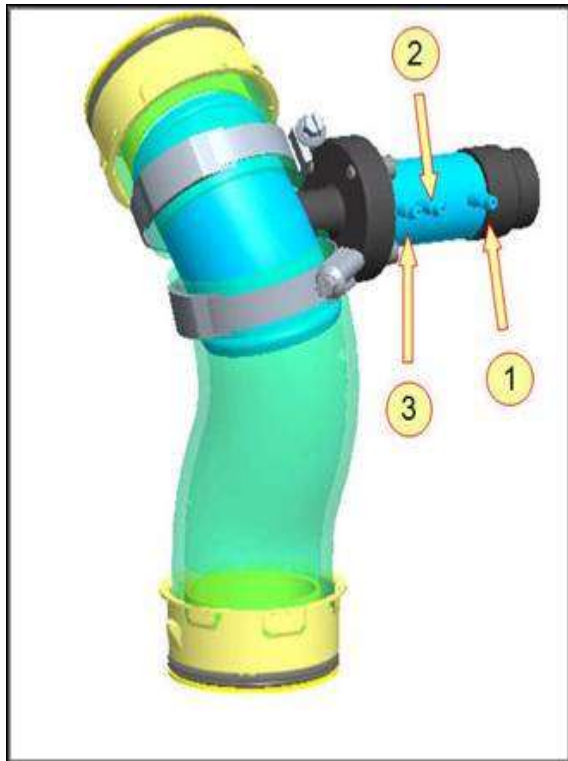
Figure 2

- Note the vacuum hose routing on the temperature switch (figure 2).

1. Ventilation hose to air cleaner
2. Hose to vacuum source
3. Hose to charge air cooler regulator flap

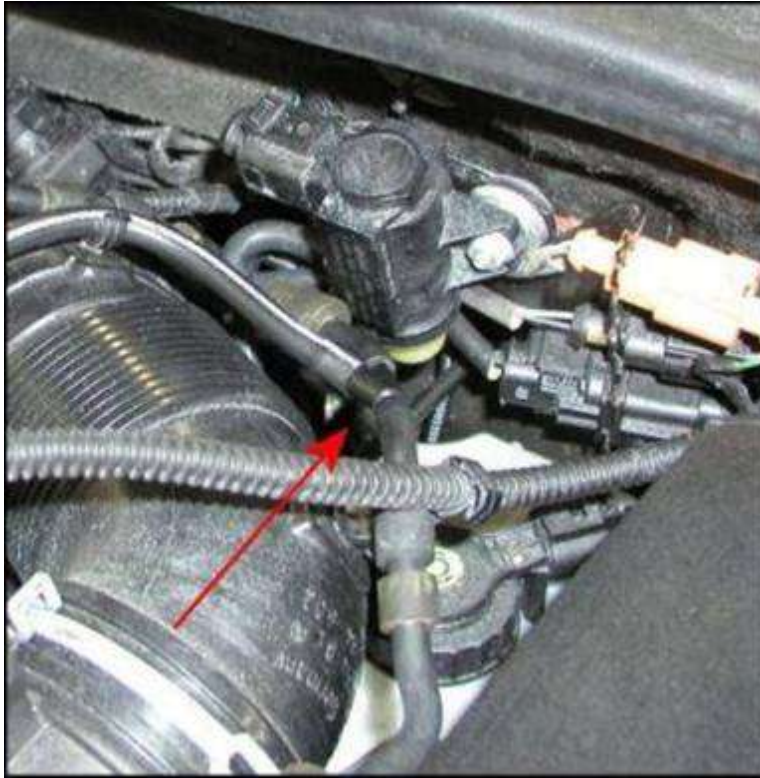
**Figure 6**

Note the white tracer on the vacuum hose in figure 6.

- Install splice as indicated in figure 6.
