# Technical Service Bulletin

## 90 Front camera for driver assist systems R242 fails to calibrate

90 24 80 2059971/2 March 8, 2024. Supersedes Technical Service Bulletin Group 90 number 20-56 dated July 2, 2020 for reasons listed below.

Model(s)	Year	VIN Range	Vehicle-Specific Equipment
A6, and A7	2019 – 2020	All	Front camera for driver's assist systems.
A6 allroad, S6, and S7	2020

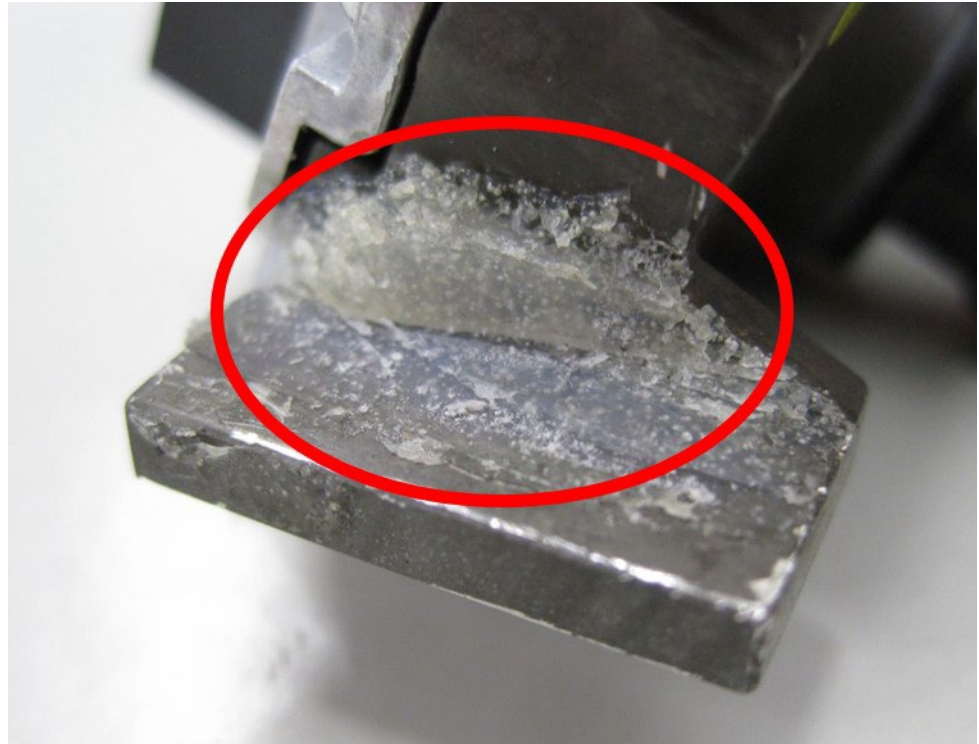
*Figure 1. Cleaning of the camera.*

There is a deviation in the mounting of the front camera for driver assist systems R242.

1. Remove any adhesive residues from the front camera, as adhesive may have been used for securing it in the holder.

**Tip: Protect the front camera against damage when removing the adhesive residues.**
