GENERAL MOTORS
DCS6824
URGENT - DISTRIBUTE IMMEDIATELY

Subject: REVISION: N242436240-01 – Customer Satisfaction Programming
Multiple Module Reprogramming
Revised Service Procedure

Models: 2024 Chevrolet Blazer EV

N242436240 Multiple Module Reprogramming

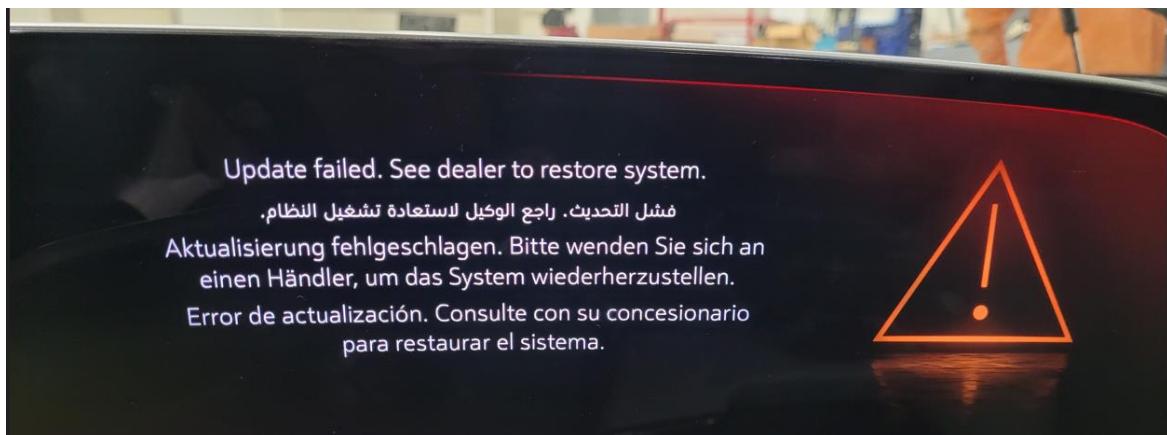
1. There is a chance for an error to be encountered during the USB update portion of the procedure right around 60% completed.
 - 1.1. This happens once the USB is in the vehicle and the progress bar can be seen on screen.
2. If the error occurs the screen will look like below

3. In this case pull the USB from the vehicle and reformat again as shown in step 7 under service procedure.
4. Access the Service Programming System (SPS) and follow the on-screen instructions.
5. On the SPS Supported Controllers screen, select A11 Radio – USB Copy/USB File Transfer.
6. Upon completion of the file transfer, properly eject the USB drive from the computer.
7. Connect the USB drive to the USB port in the vehicle.
 - 7.1. If the screen fails to show a progress bar once reinserted, pull out and reinsert again.
8. These steps should allow the progress bar to restart and complete successfully.
9. If you require further assistance or would like verbal instructions in addition to this part of the service procedure please contact Techline Customer Support Center 1-800-828-6860 for English or 1-800-503-3222 for French (Canadian) for assistance.
