GENERAL MOTORS  
DCS6825  
URGENT - DISTRIBUTE IMMEDIATELY

Subject: REVISION: N242436241-01 – Customer Satisfaction Programming  
Multiple Module Reprogramming  
Revised Service Procedure

Models: 2024 Chevrolet Blazer EV

## N242436241 Multiple Module Reprogramming

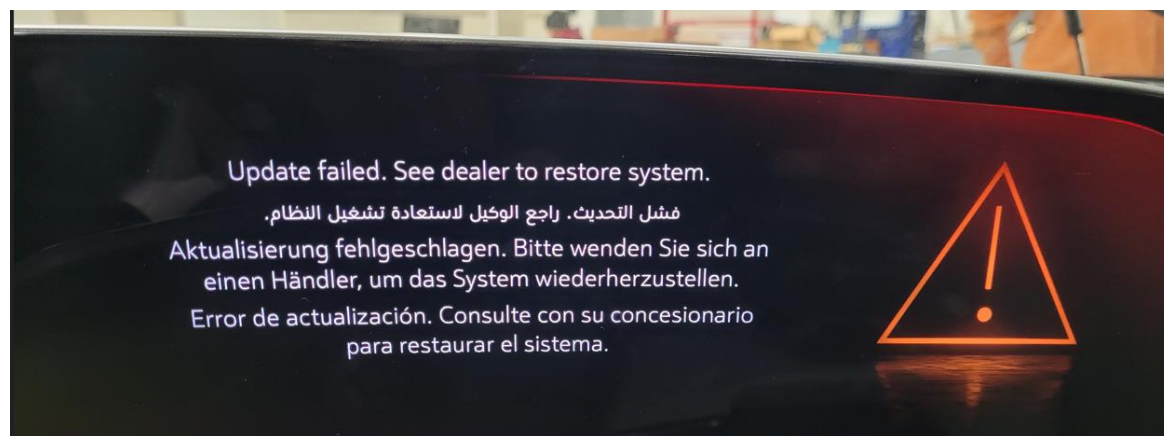
6554772

1. There is a chance for an error to be encountered during the USB update portion of the procedure right around 60% completed.
  - 1.1. This happens once the USB is in the vehicle and the progress bar can be seen on screen.
2. If the error occurs the screen will look like below

3. In this case pull the USB from the vehicle and reformat again as shown in step 7 under service procedure.
4. Access the Service Programming System (SPS) and follow the on-screen instructions.
5. On the SPS Supported Controllers screen, select A11 Radio – USB Copy/USB File Transfer.
6. Upon completion of the file transfer, properly eject the USB drive from the computer.
7. Connect the USB drive to the USB port in the vehicle.
  - 7.1. If the screen fails to show a progress bar once reinserted, pull out and reinsert again.
8. These steps should allow the progress bar to restart and complete successfully.
9. If you require further assistance or would like verbal instructions in addition to this part of the service procedure please contact Techline Customer Support Center 1-800-828-6860 for English or 1-800-503-3222 for French (Canadian) for assistance.
