# 97 Radiator fans, alarm, wipers not working: P048000, P048100, U063200, U063300, U10F300, U10A300, P10EF00

97 24 07 2073305/1 March 9, 2024.

Model(s)	Year	VIN Range	Vehicle-Specific Equipment	
Q7	2017 - 2023	<b>A</b> 11	Not Appliaghte	
SQ7	2020 - 2023	All	Not Applicable

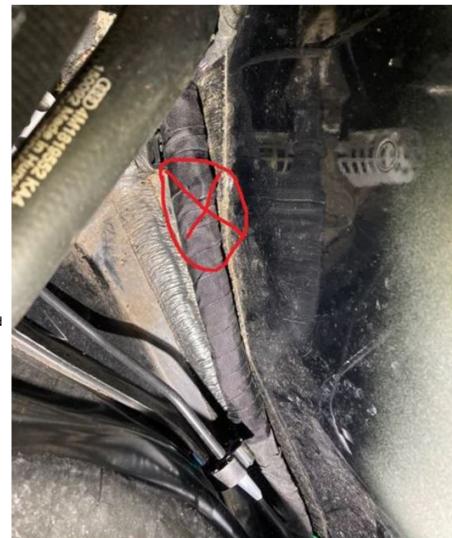
On vehicles manufactured within a specific period, wire damage/chaffing may occur on circuits routed through the plenum chamber. Sometimes, this damage may only be visible under the harness wrapping.

Figure 1. No external damage to the wiring harness can be seen.

- 1. Check the affected circuit for high resistance, open circuits ,and short circuits using a DVOM.
- 2. Moving/flexing the wiring harness throughout the plenum chamber will aid in locating the area of concern.
- Repair affected wires using wiring harness repair set VAS1978.

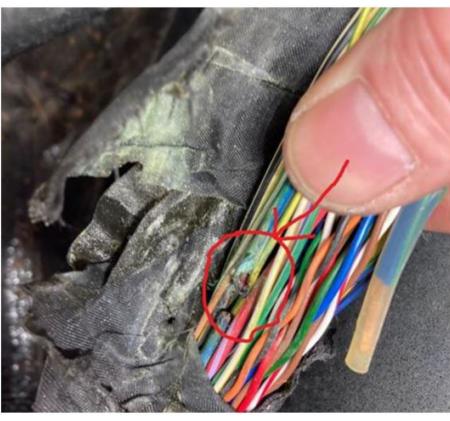
Figure 2. The damaged wire is only visible once the wrapping has been removed.

- Wrap the repaired wiring harness using fabric adhesive tape N 10592002.
  - If the wire strands are not clean and shining, the wire MUST be cut back and lengthened as needed.
