# Technical Service Bulletin

## 27 48V vehicle electrical system warning, DTC U046900 stored in the ECM

27 24 69 2058831/13 March 12, 2024. Supersedes Technical Service Bulletin Group 27 number 24-65 dated January 18, 2024 for reasons listed below.

Model(s)	Year	VIN Range	Vehicle-Specific Equipment
A6, A7, A8, and Q8	2019 - 2023	All	48V electrical system
A6 allroad, S8, and Q7	2020 - 2023

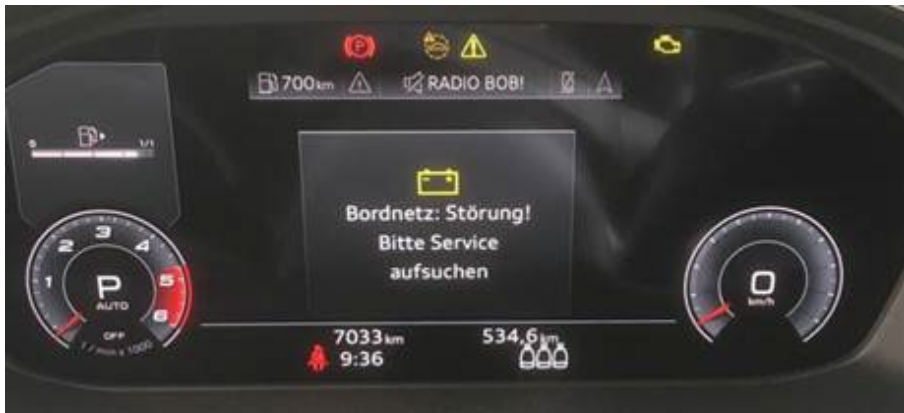
- The message “Electrical system: Malfunction. See owner’s manual” is displayed on the instrument cluster (Figure 1).
- A yellow or red battery warning symbol is displayed on the instrument cluster.

Figure 1. Cluster Warning Message.
