# Technical Service Bulletin

## 94 Exterior lights have moisture accumulation

94 24 73 2012749/17 March 9, 2024. Supersedes Technical Service Bulletin Group 94 number 23-64 dated May 9, 2023 for reasons listed below.

Model(s)	Year	VIN Range	Vehicle-Specific Equipment
All Audi Vehicles	2016 - 2025	All	Not Applicable

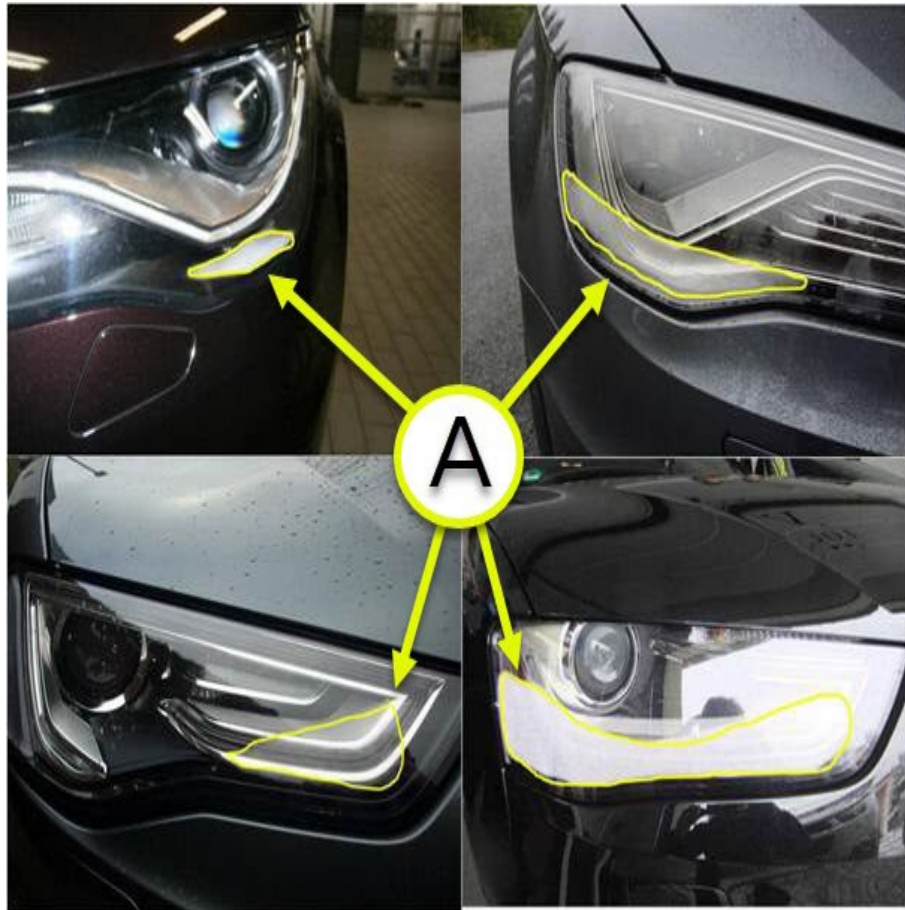
Workshop is able to confirm the customer concern. *Figure 1* provides examples of **NORMAL** amounts of moisture that may be visible. The level of moisture buildup may vary car-to-car or even between lamps on the same vehicle.

*Figure 1. Normal condensation/moisture on the inside of the lights.*

If the amount of moisture/condensation is deemed normal, please explain this to the customer. Parts replacement **will not** correct the concern and the customer will likely still experience the same issue.

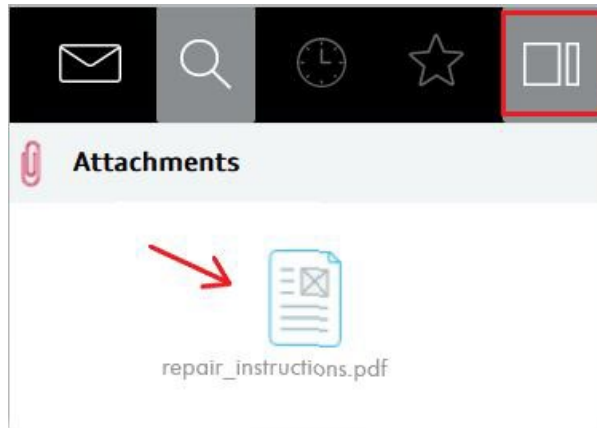
**Figure 2.** In ElsaPro, attachments can be found in the attachment tab at the bottom of the screen.

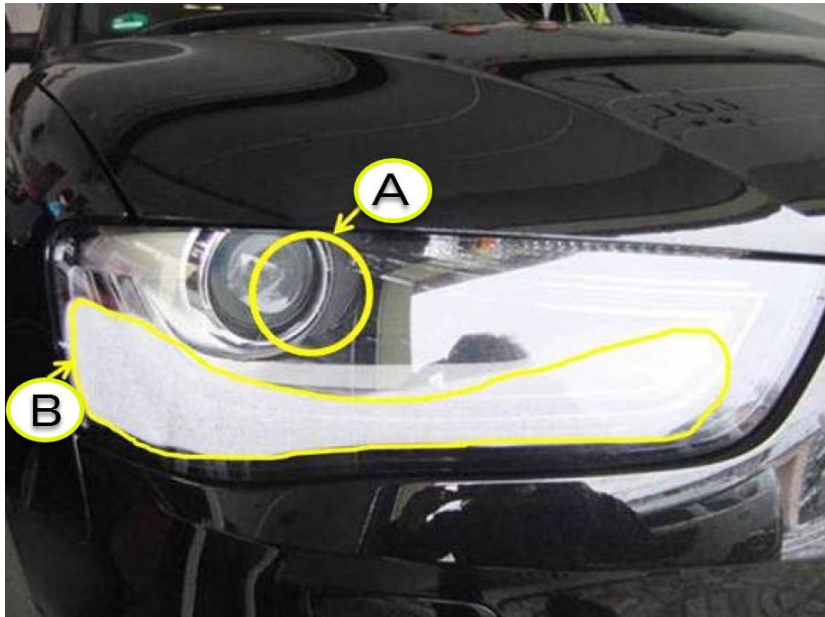
The light emission surface (Figure 4A) of the main beam should be clear after driving for approximately 10 minutes with the main beam on.

- Driving speeds must be consistently over 45mph for the ventilation system to properly function.
- Residual condensation (Figure 2B) may be present depending on

ambient conditions, this is normal.

*Figure 4. A: Main beam light emission surface. B: Condensation of the headlamp.*

If water drops or condensation are present on the light emission surface (Figure 2A) after performing the steps in the “*flowchart*”, inspect the headlamp assembly for the root cause:

- Missing cover.
- Damaged seal.
- Clogged drain.
- Outside influence.
- Vent tube disconnected from the headlamp.

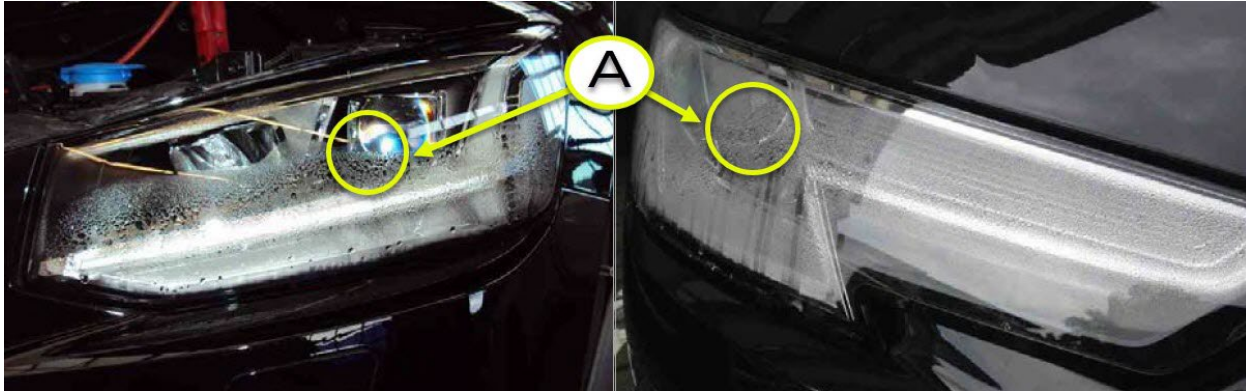
Abnormal amounts of moisture can be seen in figures 5 and 6 below. These are examples of excessive moisture still present **AFTER a thorough test drive** with lamps on.

*Figure 5. A: Example of a compromised headlamp. Moisture is still present in the light emission surface after a test drive.*

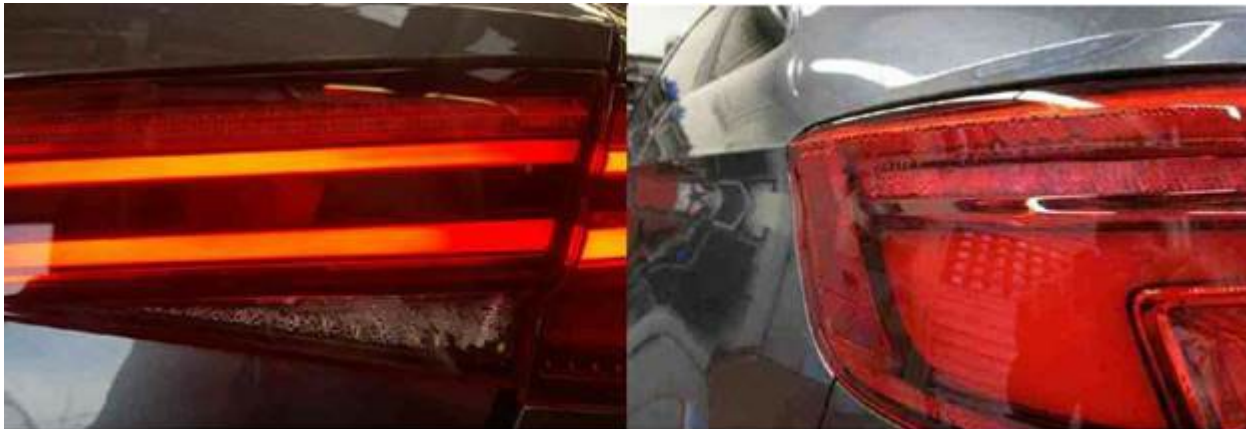
*Figure 6: Example of compromised tail lamps after a sufficient test drive.*
