### PIC5704H Diagnostic Tip - Traction and Stability Control Indicator on with Code C0131 Set After BPMV Replacement

Brand:	Model:	Model Years:	VIN:		Engine:	Transmissions:
			from	to		
Buick	Encore	2013 - 2022	All	All	All	All
Chevrolet	Sonic	2012 - 2022	All	All	All	All
Chevrolet	Spark	2013 - 2022	All	All	All	All
Chevrolet	Trax	2013 - 2022	All	All	All	All

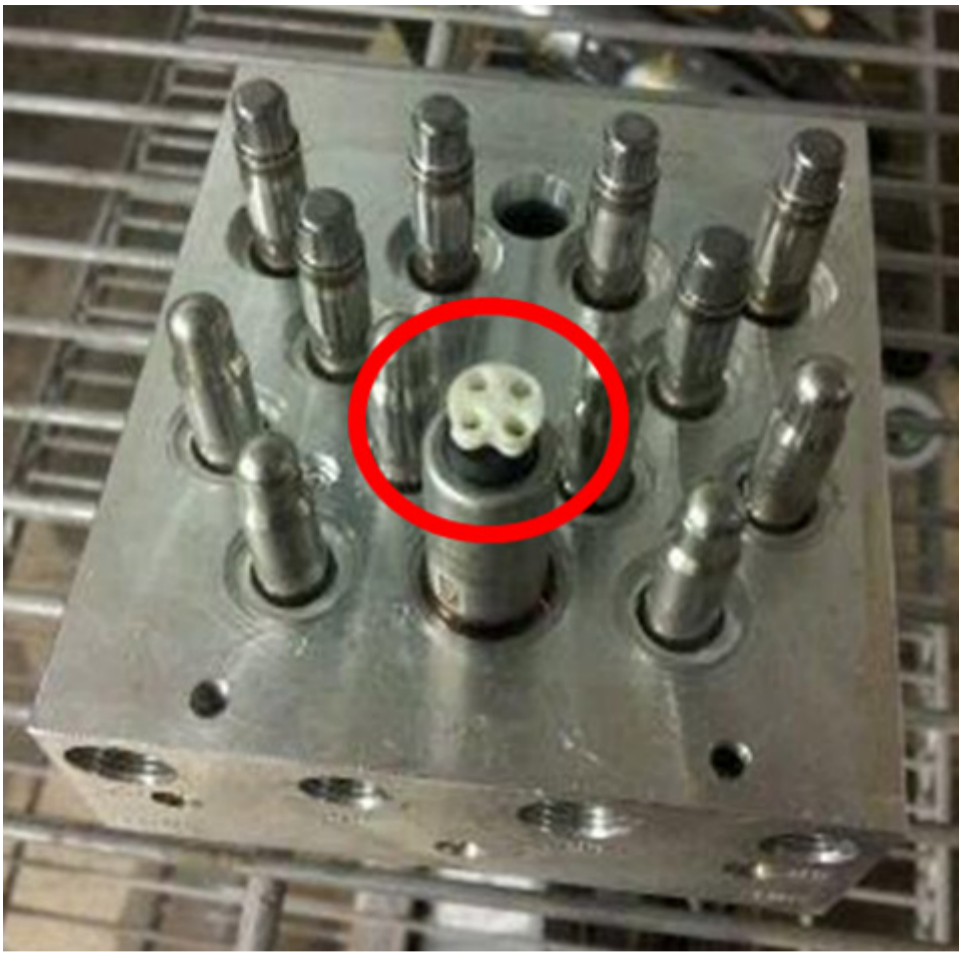
**A technician may run into a scenario in which the BPMV (Brake Pressure Modulator Valve) has been replaced and there is a Service Traction and/or Stability Control message on in the IPC. Upon a GDS2 scan check, DTC C0131 SYM00 is set current in the K17 Electric Brake Control Module. During diagnosis the technician may notice that the brake pressure sensor voltage is reading 5 volts at all times with brake pedal released or depressed.**

**Technicians are advised to remove BPMV assembly and inspect the brake pressure sensor assembly and make sure all shipping material has been removed before installation. If shipping material is not removed, this will cause code C0131 to set, and or possibly cause damage to both the EBCM and the BPMV. Please reference the following photo.**
