# Preliminary Information

## PIT5989A Diagnostic Tip: Police Tahoe With Service Power Steering Message Or Multiple IPC Messages And CAN Bus 1 DTCs

Brand:	Model:	Model Years:	VIN:		Engine:	Transmissions:
			from	to		
Chevrolet	Tahoe	2021 - 2024	All	All	All	All

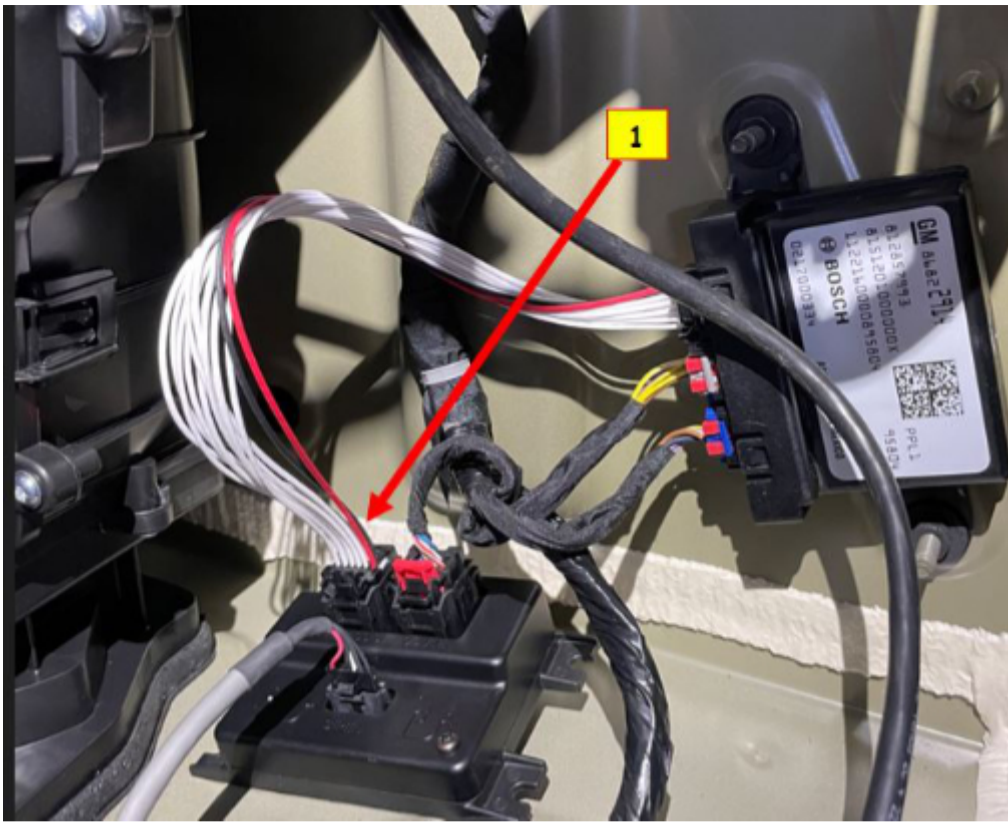
Involved Region or Country	North America
<b>Additional Options (RPO)</b>	9C1 or 5W4
Condition	<p>Some customers may experience one or more of the following concerns:</p> <ol style="list-style-type: none"> <li>1) Service Power Steering Message</li> <li>2) Multiple IPC messages</li> <li>3) Vehicle will not crank</li> <li>4) Multiple CAN bus 1 DTCs which may include DTCs: U0075, U160F, U1002, U0131, and U2205</li> <li>5) Issue's may be intermittent at times.</li> </ol>
Cause	<p>This may be due to the installation of an aftermarket police lighting control module plugged into the CAN bus 1 data line network.</p> <p>The Upfitter will unplug connector X1 from the K182 Park assist module and install it into their upfitted lighting module and then a jumper harness is used to connect their aftermarket module to the Park Assist Module.</p> <p>Most cases the connector from the aftermarket lighting module will have mostly all white wiring. See Picture below #1</p>

If you experience this concern, please inspect for an after market module installed in the CAN Bus 1 Data line near the park assist module.

If an after-market module is equipped, ensure connector to module is fully seated at both ends and evaluate for CAN BUS 1 data line concern.

If connector is fully seated, put the vehicle back to factory by removing after-market module and see if concern goes away.

If there are no longer any concerns with after-market module removed, the vehicle will have to be returned to the upfitter for repairs or possible module replacement.
