STAR ONLINE PUBLICATION

Case Number: S1408000384 Rev. D

Release Date: January 2024

Symptom/Vehicle Issue: Start Stop Charging Warning Lamp Illuminated On, Intelligent Battery Sensor (IBS) State of Charge (SOC) Inaccurate, Battery Charging Message, Presence of IBS related Diagnostic Trouble Codes (DTCs), or Battery Warning Lamp On

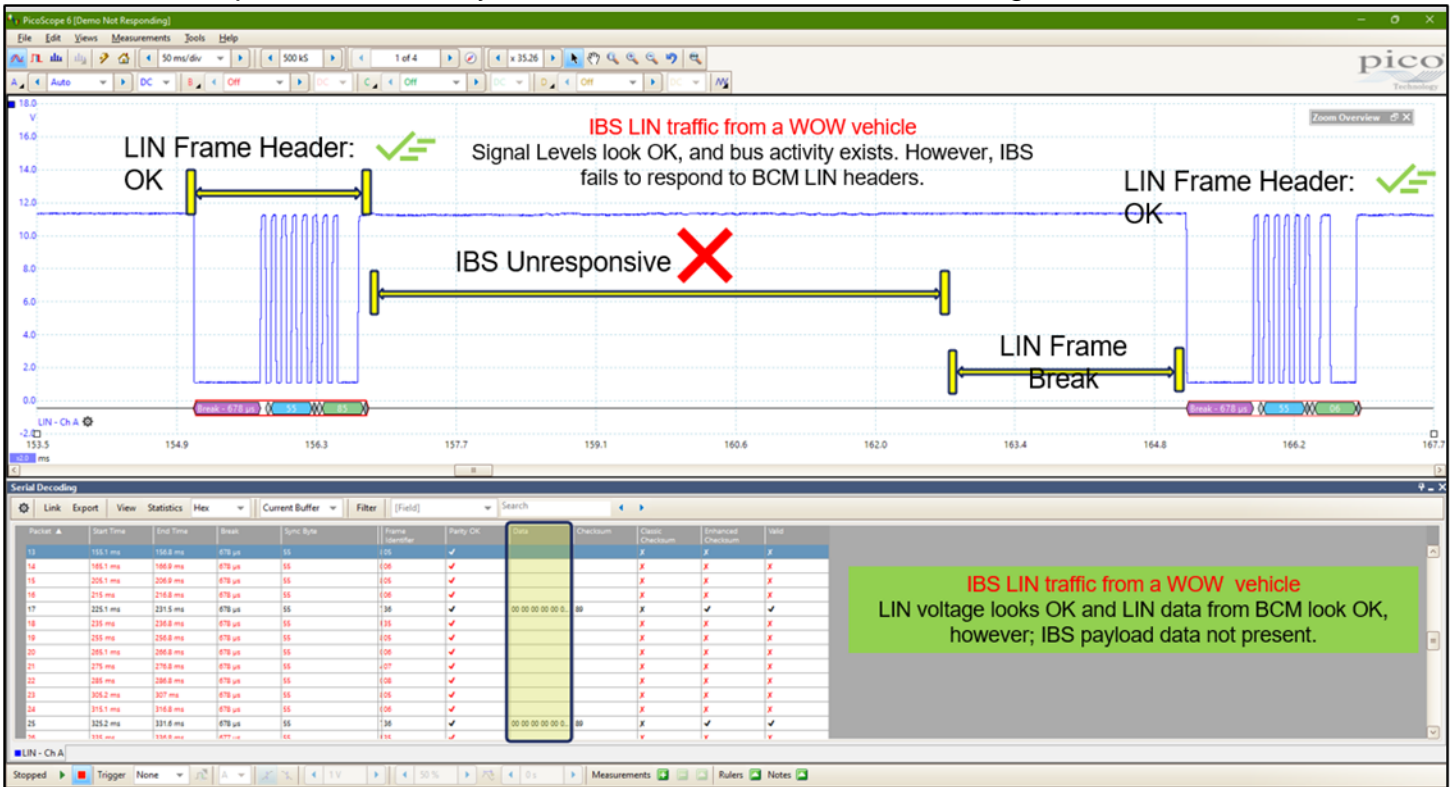
5. Verify LIN bus activity with Mopar scope.
 - o Config scope to LIN monitor if feasible.
 - o Replace the IBS only based confirmation from the LIN diagnostic.

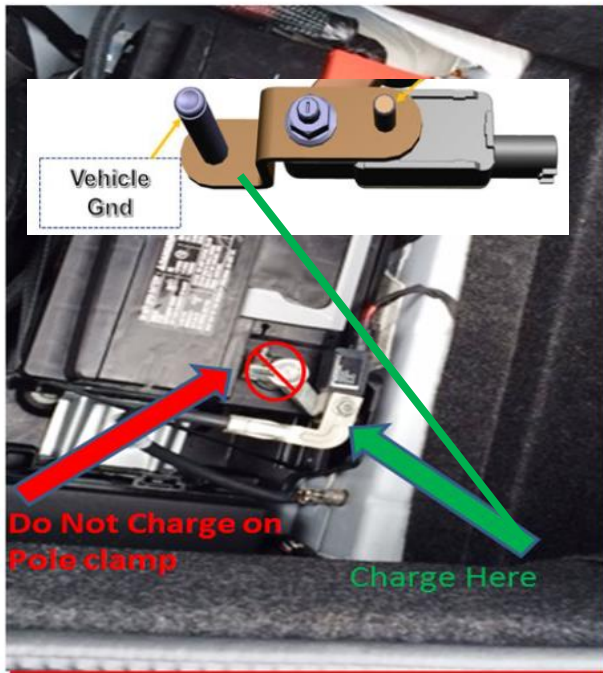
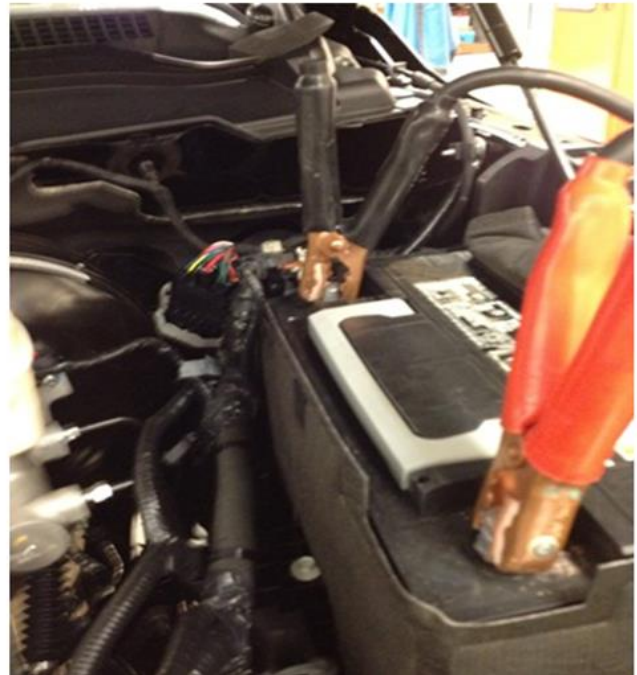
Improper IBS Charging

In-Vehicle systems is not an issue. Please note to charge through the IBS or tie negative clamp to Body/engine ground. Customers, Dealers, Mechanics, and Engineers usually want to place the negative clamp on the pole of the battery. This creates Blind charging. **“DO NOT BLIND CHARGE”** See below proper connections for charging.

Do not put Negative clamp on IBS Pole clamp

Do not remove IBS for charging

- IBS SOC adaptation is needed after charging the batteries.
- Note IBS will self-adapt in the next available quiescent state.
- A common misdiagnosis is Battery light illuminated. The IBS has NOTHING to do with this light. The battery Light is indicative of a “CHARGING SYSTEM and condition of the battery”
