STAR ONLINE PUBLICATION

Case Number: S2323000003 Rev A.

Symptom/Vehicle Issue: Wind Noise From Windshield Or Front Instrument Panel Area At Highway Speed.

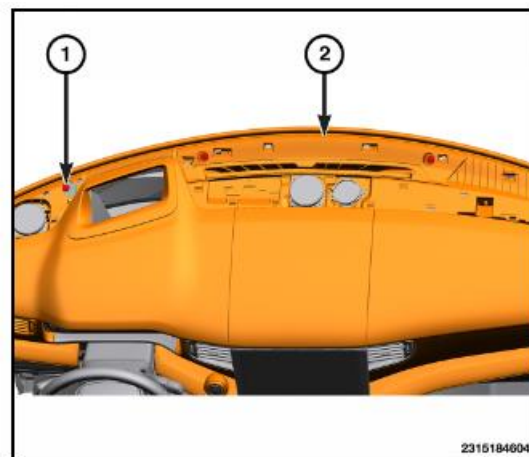
1 - Fence Line Bolts

2 - Instrument Panel

Discussion: Inspect the instrument panel fence line screws. These fasteners are at the front of the dash pad at the windshield (Fig 1). Remove the screws 1 by 1 and reinstall to torque specification of 10 n.m or 7 Ft. Lbs.

To access the fence line screws use a trim stick to remove the instrument panel grille cover closest to where the noise was heard during the test drive. Replace the snap in cover. Perform a verification drive to confirm the wind noise is resolved. For further information refer to Service Library service information, 23 - Body / Instrument Panel / PANEL, Instrument / Removal and Installation.
