## STAR ONLINE PUBLICATION

**Case Number:** S2408000005

**Symptom/Vehicle Issue:** Vehicle Staying Awake Intermittently Causing Battery Drain, BCM DTC B23D7-14 Gated Park Control-Circuit Short to Ground or Open

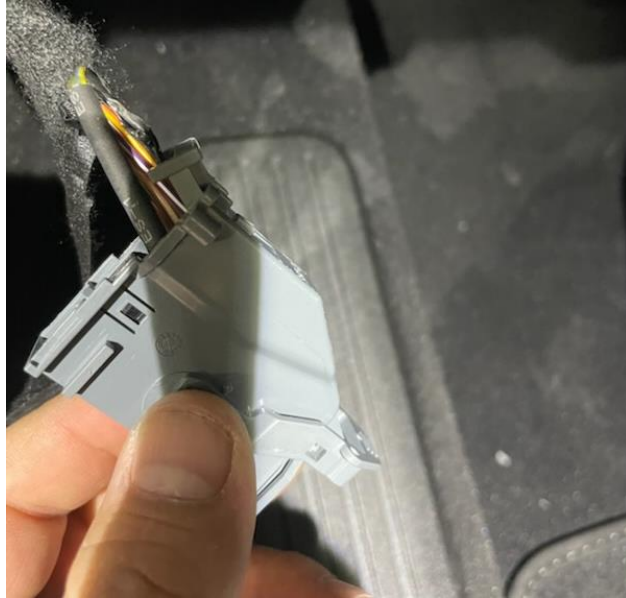
**BCM C4**

This may be caused by a tightly routed T824 TRS Park Signal circuit causing terminal pull out at the BCM C4 Pin 1. This excessive tension may also cause the connector lock to fail. If the Radio Frequency Hub loses the TRS Park Signal it will cause the vehicle to wake up, draining the battery.

**Diagnosis:** Attempt to verify this is the cause by applying pressure to the BCM C4 connector to fully seat it into the BCM, the B23D7-14 status should change to Stored. Inspect BCM C4 connector (Gray 32pin) and determine if it is fully locked and secured.

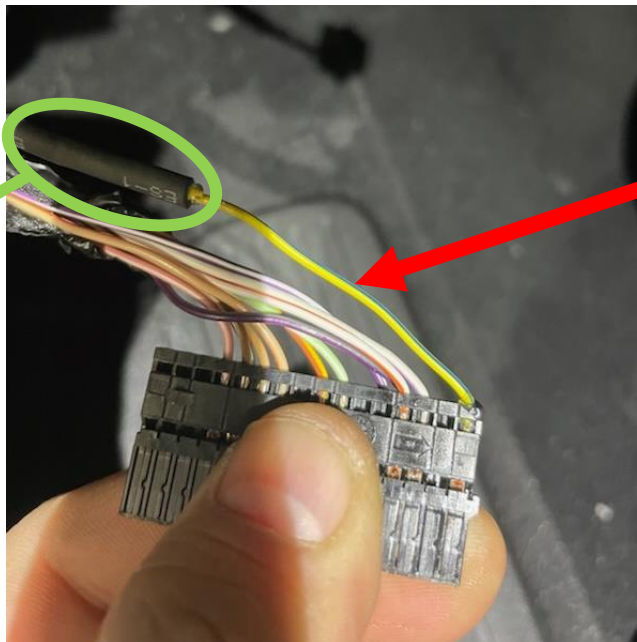
**C4 Gray Connector Housing Removed**

Remove the gray connector housing to gain access to the main connector body and terminals. Inspect T824 (YE/DB) in cavity 1 for excessive tension.

**Circuit Lengthening  
Repair**

**Circuit T824  
(YE/DB)**

**Repair:** If terminal or connector pull out is found, attempt to reroute the harness in a way to reduce tension on the T824 circuit. Alternatively, it may be necessary to lengthen the T824 circuit using wiring repair best practices.

When tension is removed from the T824 circuit, the connector housing should be able to remain locked. If you are still unable to fully lock and secure the C4, it will be necessary to replace the connector housing. 1326140-1 is the connector housing part number at time of publication. You should always reference wiring diagrams for the most up to date connector part numbers prior to ordering.
