<b>REFERENCE:</b>	<b>TSB:</b> 08-003-24 <b>GROUP:</b> 08 - Electrical	<b>Date:</b>	January 3, 2024	<b>REVISION:</b>	-
<b>VEHICLES AFFECTED:</b>	<b>2024 (JL) Jeep Wrangler</b> <b>2024 (JT) Jeep Gladiator</b> This bulletin applies to vehicles built on or after January 28, 2023 (MDH 0128XX) and on or before February 20, 2023 (MDH 0220XX).			<b>MARKET APPLICABILITY:</b>	
				<input checked="" type="checkbox"/> NA	<input checked="" type="checkbox"/> MEA
				<input checked="" type="checkbox"/> SA	<input checked="" type="checkbox"/> IAP
				<input checked="" type="checkbox"/> EE	<input checked="" type="checkbox"/> CH
<b>CUSTOMER SYMPTOM:</b>	<b>Customers or technicians may experience one ore more of the following:</b> <ul style="list-style-type: none"> <li>• Horn is inoperative.</li> <li>• Horn sound is very low.</li> <li>• Horn is physically dissembling.</li> </ul>				
<b>CAUSE:</b>	Manufacturing Issue.

This bulletin involves inspecting both horn date codes and replacing the horn(s) if needed.

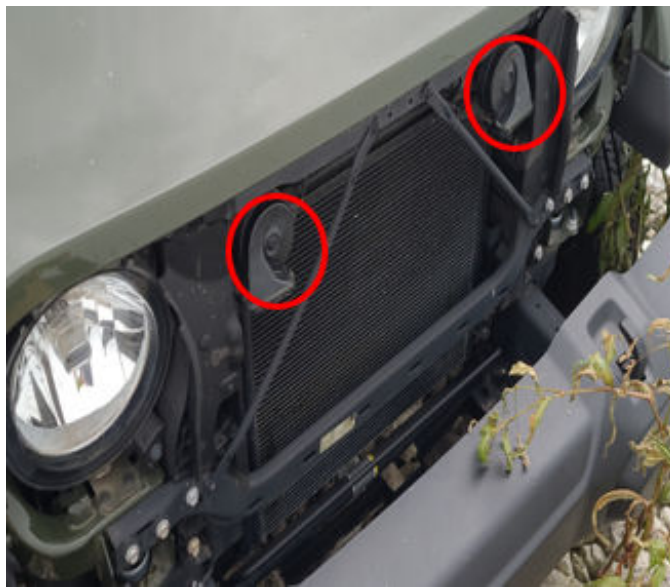
**Fig. 1**  
Horn Locations

1. Remove the front grille to gain access to the horns [Fig. 1](#). Refer to the detailed service procedures available in DealerCONNECT/ Service Library under: Service Info > 23 - Body / Exterior / Grille / Removal.

6. Replace one or both horns as needed. Refer to the detailed service procedures available in DealerCONNECT/ Service Library under: Service Info > 08 - Electrical / 8H - Horn / Horn / Removal and Installation.

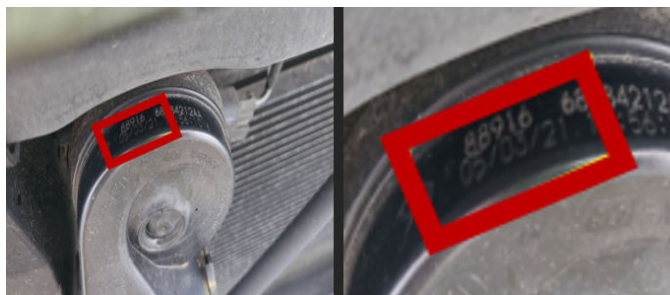
**Fig. 2**  
Build Date Location

2. Inspect the build date codes on each horn [Fig.2](#).

3. Is the build date shown on either horn 01/25/2023?
  - YES>>> Proceed to [Step 6](#).
  - NO>>> Proceed to [Step 4](#).
4. Install the front grille. Refer to the detailed service procedures available in DealerCONNECT/ Service Library under: Service Info > 23 - Body / Exterior / Grille / Installation.
5. This bulletin has been completed, use inspect LOP (08-40-01-93) to close the active RSU.

**NOTE: Only replace the horn(s) that are built on 01/25/2023.**
