REFERENCE:	TSB: 23-002-24 GROUP: 23 - Body	Date:	January 5, 2024	REVISION:	23-093-23
VEHICLES AFFECTED:	2023 (WS) Grand Wagoneer/Wagoneer This bulletin applies to vehicles built on or after **January 18, 2023 (MDH 0118XX) and on or before May 10, 2023 (MDH 0510XX)** equipped with Middle East Equipment Group (Sales Code ABD).	MARKET APPLICABILITY:			
		<input type="checkbox"/> NA <input type="checkbox"/> CH <input type="checkbox"/> EE <input type="checkbox"/> IAP <input type="checkbox"/> SA <input checked="" type="checkbox"/> MEA			
CUSTOMER SYMPTOM:	Customers may comment on the following: <ul style="list-style-type: none"> The front fascia may be damaged during off road driving/driving over obstacles (air dam sits too low allowing for sand intrusion) Fig. 1. 				
CAUSE:	Incorrect air dam installed.

This bulletin supersedes Technical Service Bulletin (TSB) 23-093-23, date of issue August 29, 2023, which should be removed from your files. All revisions are highlighted with ****asterisks**** and include updated build dates, RSU number and part number.

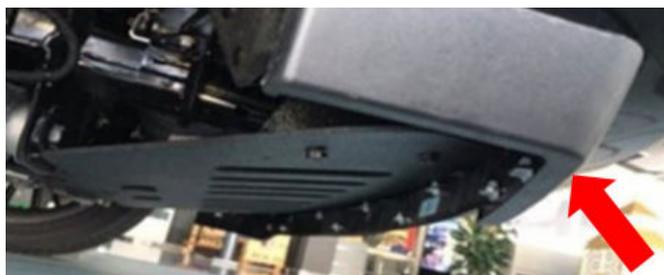
Fig. 1
Incorrect Air Dam Installed

This bulletin involves replacing the front air dam.
