## Technical Service Bulletin (TSB)

### Radio Over The Air Update to U29.42 Software Version

| REFERENCE: | TSB: 08-007-24<br>GROUP: 08 - Electrical | Date: | January 6, 2024 | REVISION: | - |
| VEHICLES AFFECTED: | 2024 (RU) Chrysler Pacifica<br>This bulletin applies to vehicles built on or before November 15, 2023 (MDH 1115XX) equipped with a Global Telematics Box Module (TBM) (Sales Code RDG) and one of the following radios: <ul style="list-style-type: none"><li>Uconnect 5 NAV W 8.4" Display (Sales Codes UBL or UEL).</li><li>Uconnect 5 NAV W 10.1" Display (Sales Codes UBN or UEN).</li></ul> | | | MARKET APPLICABILITY:<br><div><input checked="" type="checkbox"/> NA<input type="checkbox"/> MEA<br/><input type="checkbox"/> SA<input type="checkbox"/> IAP<br/><input type="checkbox"/> EE<input type="checkbox"/> CH</div> | |

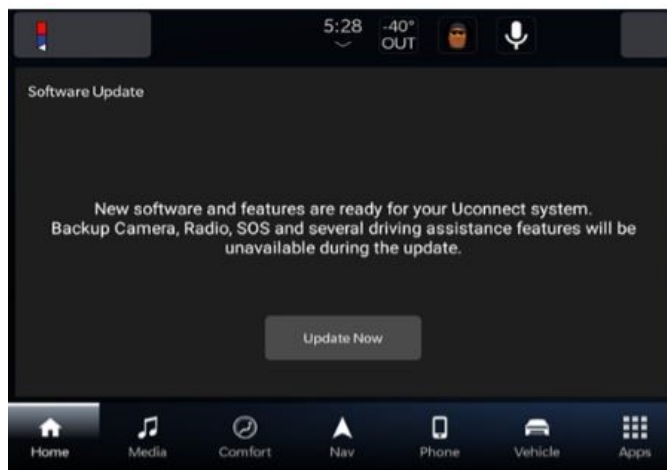
**Fig. 1**

Software Acceptance Screen

1. The vehicle needs to be in 'Park'. The ignition needs to be in the off position.
2. If the customer selects “Update Now” [Fig. 1](#) they can shut off the vehicle and leave. The update will be completed automatically.

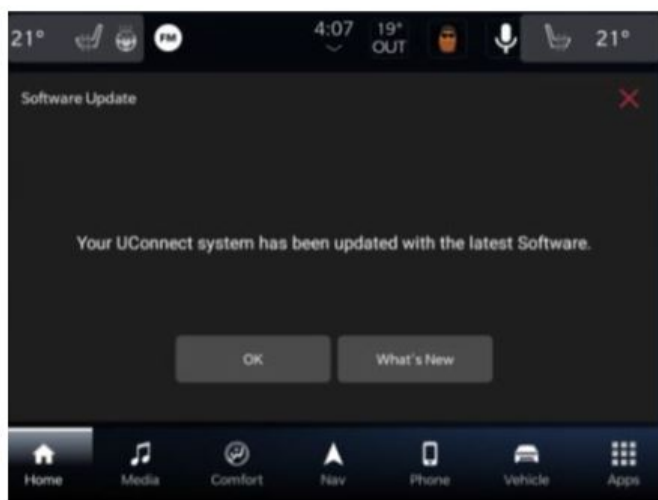
**Fig. 2**

Software Update Confirmation Screen

3. Upon completion of update, the radio will display a confirmation message [Fig. 2](#).
