REFERENCE:	TSB: 08-008-24 GROUP: 08 - Electrical	Date:	January 6, 2024	REVISION:	-						
VEHICLES AFFECTED:	2024 (WS) Grand Wagoneer/Wagoneer This bulletin applies to vehicles built on or before November 15, 2023 (MDH 1115XX) equipped with a Global Telematics Box Module (TBM) (Sales Code RDG) and one of the following radios: <ul style="list-style-type: none"> Uconnect 5 NAV W 8.4" Display (Sales Codes UBL or UEL). Uconnect 5 NAV W 10.1" Display (Sales Codes UBN or UEN). 			MARKET APPLICABILITY:

REPAIR SUMMARY:

This bulletin provides information regarding the latest Firmware Over The Air (FOTA) update and provides the service technician an overview of the steps a customer will need to take to complete the update. The radio software will be updated from T27.39 or U29.28 to U29.42.

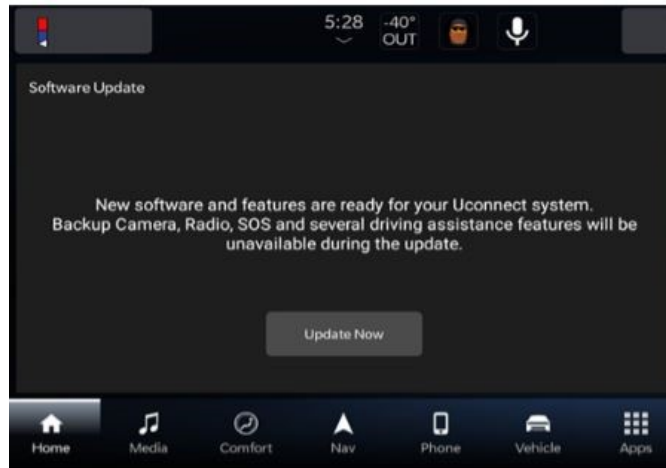
Fig. 1

Software Acceptance Screen

1. The vehicle needs to be in 'Park'. The ignition needs to be in the off position.
2. If the customer selects “Update Now” [Fig. 1](#) they can shut off the vehicle and leave. The update will be completed automatically.

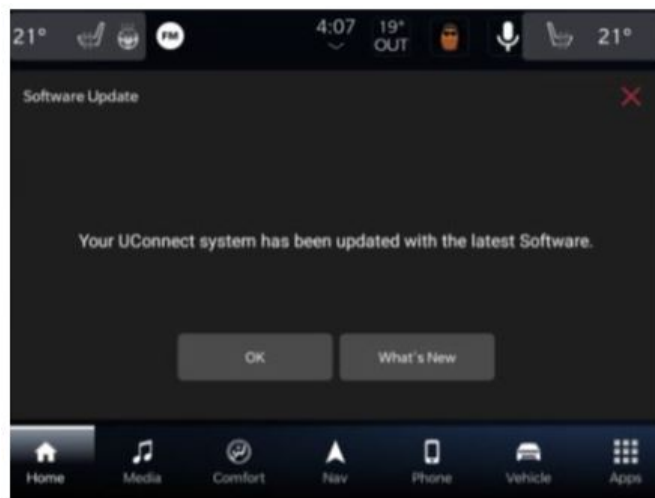
Fig. 2

3. Upon completion of update, the radio will display a confirmation message [Fig. 2](#).

Software Update Confirmation Screen
