REFERENCE:	TSB: 23-003-24 GROUP: 23 - Body	Date:	January 6, 2024	REVISION:	-
VEHICLES AFFECTED:	2023 - 2024 (DJ) RAM 2500 Pickup This bulletin applies to vehicles built on or after April 27, 2023 (MDH 0427XX) and on or before September 14, 2023 (MDH 0914XX) equipped with Gloss Black Instrument Panel Bezels (Sales Code JES).			MARKET APPLICABILITY:	
				<input checked="" type="checkbox"/> NA	<input type="checkbox"/> CH
				<input type="checkbox"/> EE	<input type="checkbox"/> IAP
				<input type="checkbox"/> SA	<input type="checkbox"/> MEA
CUSTOMER SYMPTOM:	The customer may experience the following: <ul style="list-style-type: none"> Visible bubbling/delamination on the instrument panel base panel (cover). 				
CAUSE:	Faulty adhesive.

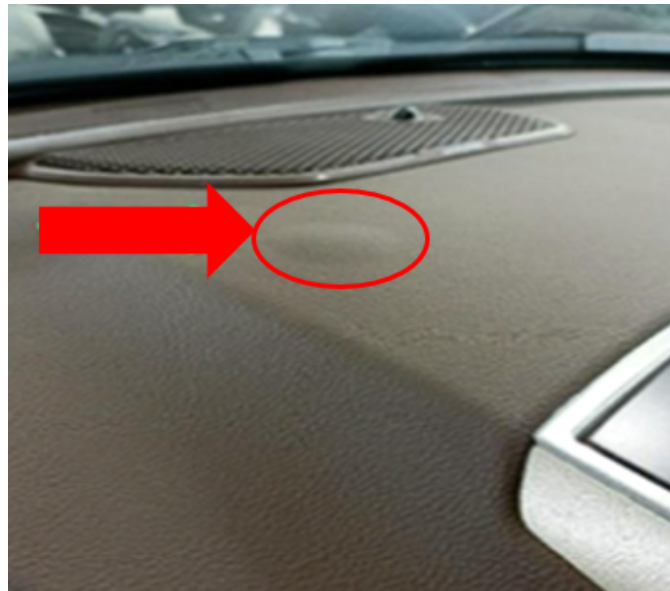
**Fig. 1**

1. Inspect the instrument panel base panel for bubbling/delamination [Fig. 1](#).
2. Is bubbling/delamination detected?
 - YES>>> Proceed to [Step 3](#).
 - NO>>> Proceed to This bulletin has been completed. Use Inspect LOP (23-11-14-9E) to close this active RSU.

Instrument Panel Base Panel Bubbling/Delamination

3. Replace the instrument panel base panel. Refer to the detailed service procedures listed in DealerCONNECT> Service Library under: 23 - Body / Instrument Panel / Cover, Instrument Panel / Removal and Installation.
