Technical Service Bulletin (TSB)
Seat Belt Height Adjuster

REFERENCE:	TSB: 10-001-24 GROUP: 10 - Restraints	Date:	January 13, 2024	REVISION:	10-002-23
VEHICLES AFFECTED:	**2023 (MV) Jeep Compass** This bulletin applies to vehicles built on or after August 23, 2023 (MDH 0823XX) and on or before **September 30, 2023 (MDH 0930XX)**.			MARKET APPLICABILITY:	
				<input type="checkbox"/> NA	<input checked="" type="checkbox"/> MEA
				<input type="checkbox"/> SA	<input type="checkbox"/> IAP
				<input checked="" type="checkbox"/> EE	<input type="checkbox"/> CH
CUSTOMER SYMPTOM:	Customers may experience the seat belt position adjuster will not adjust to the maximum height position.				
CAUSE:	Incorrectly installed upper B-Pillar trim panel retaining clip.

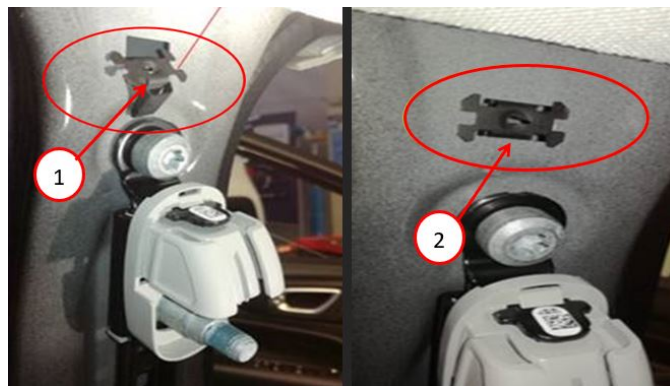
Fig. 1
B-Pillar Clip

NOTE: Confirm the upper B-Pillar trim panel clips are installed properly [Fig. 1](#).

- 1 - Improperly Installed B-Pillar Clip
2 - Properly Installed B-Pillar Clip

1. Inspect the seat belt height adjuster on both the front driver and passenger side for the proper adjustment range.
2. Does the seat belt height adjuster exhibit full range when adjusting on both the front driver and passenger side?
 - YES>>>> This bulletin has been completed. Use Inspection LOP (23-19-21-90) to close the active RSU.
 - NO>>>> Proceed to [Step 3](#).
3. Replace the affected upper B-Pillar trim panel. Refer to the detailed service procedure listed in DealerCONNECT> Service Library under: 23 - Body / Interior / Panel, B-Pillar Trim, Upper / Removal and Installation.
