## Technical Service Bulletin (TSB) Cold Engine Ticking Noise

<b>REFERENCE:</b>	<b>TSB:</b> 09-001-24 <b>GROUP:</b> 09 - Engine	<b>Date:</b>	January 20, 2024	<b>REVISION:</b>	09-011-22
<b>VEHICLES AFFECTED:</b>	<b>**2019 - 2024** (DT) Ram 1500 Pickup</b> This bulletin applies to vehicles equipped with a 5.7L V8 Hemi MDS VVT Etorque Engine (Sales Code EZL) and a 5.7L V8 Hemi MDS VVT Engine (Sales Code EZH).			<b>MARKET APPLICABILITY:</b> <input checked="" type="checkbox"/> NA <input checked="" type="checkbox"/> MEA <input checked="" type="checkbox"/> SA <input checked="" type="checkbox"/> IAP <input checked="" type="checkbox"/> EE <input type="checkbox"/> CH	
<b>CUSTOMER SYMPTOM:</b>	The customer may describe a ticking noise from the exhaust manifold location(s) when cold.				
<b>CAUSE:</b>	Exhaust manifold.

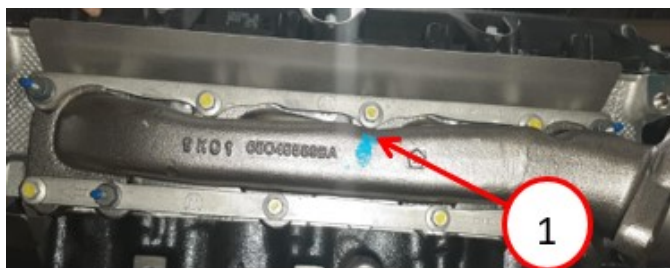
**Fig. 1**  
Exhaust Manifold Area

1. Start the vehicle cold. Listen for ticking noise that stops after engine is warmed up.
2. Shut engine off and allow engine to cool.
3. Remove exhaust manifold heat shield(s) from the side that is suspect to be leaking for manifold inspection .
4. Re-start cold engine and listen for noise source at exhaust manifold area.
5. Visually inspect for a cracked manifold and confirm it is not a casting parting line or casting fin in location shown. [Fig. 1](#)

1- Manifold Crack Area

6. If a cracked manifold is found, replace the exhaust manifold(s) that are cracked. Refer to the detailed service procedures available in DealerCONNECT>Service Library under: 09 - Engine, 5.7L / Manifolds / Manifold, Exhaust / Removal and Installation.
