REFERENCE:	TSB: 18-007-24 GROUP: 18 - Vehicle Performance	Date:	January 25, 2024	REVISION:	18-056-22 REV. A
VEHICLES AFFECTED:	2019 (DD) RAM 3500 Cab Chassis 2019 (DP) RAM 4500/5500 Cab Chassis This bulletin applies to vehicles equipped with a 6.7L I6 Cummins Turbo Diesel Engine (Sales Code ETN).			MARKET APPLICABILITY: <input checked="" type="checkbox"/> NA <input type="checkbox"/> MEA <input type="checkbox"/> SA <input type="checkbox"/> IAP <input type="checkbox"/> EE <input type="checkbox"/> CH	
CUSTOMER SYMPTOM:	<p>Customers may experience a Malfunction Indicator Lamp (MIL) illumination. Upon further investigation the technician may find one or more of the following Diagnostic Trouble Codes (DTCs) have been set:</p> <ul style="list-style-type: none"> ● P0506-00 - Idle Control System RPM - Lower Than Expected. ● P0607-00 - ECU Internal Performance. ● P20E8-00 - Reductant Pressure Too Low. ● P0301-00 - Cylinder 1 Misfire. ● P0302-00 - Cylinder 2 Misfire. ● P0303-00 - Cylinder 3 Misfire. ● P0304-00 - Cylinder 4 Misfire. ● P0305-00 - Cylinder 5 Misfire. ● P0306-00 - Cylinder 6 Misfire. ● P0299-00 - Turbocharger Underboost. ● P1D73-00 - AGS Performance. ● P0626 - Generator Field Con

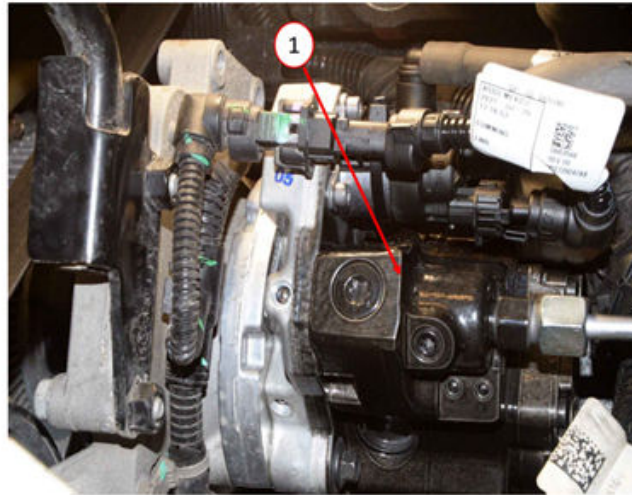
Fig. 1

New Design CP3.3 Design Fuel Injection Pump

1 - New ICP3.3 Design High-Pressure Fuel Injection Pump From Top View

1. Inspect the high-pressure fuel injection pump **Fig. 1** to verify which pump is currently installed on the vehicle. **Also review the vehicle VIP report to see if campaign Y78 has been performed.**
