Technical Service Bulletin (TSB)
Radio Over The Air Update from
LR34.51 to LR35.41 Software Version

REFERENCE:	TSB: 08-029-24 GROUP: 08 - Electrical	Date:	January 30, 2024	REVISION:	-
VEHICLES AFFECTED:	<p>2020 - 2021 (DF) RAM 3500 10k Lb. Cab Chassis 2020 - 2021 (DP) RAM 4500/5500 Cab Chassis 2020 - 2021 (DT) RAM 1500 Pickup 2020 - 2021 (DJ) RAM 2500 Pickup 2020 - 2021 (D2) RAM 3500 Pickup 2020 - 2021 (DD) RAM 3500 Cab Chassis This bulletin applies to vehicles equipped with Uconnect 12.0 with Navigation (Sales Codes UAX and UCX).</p>	MARKET APPLICABILITY:			
		<input checked="" type="checkbox"/> NA		<input type="checkbox"/> MEA	
		<input type="checkbox"/> SA		<input type="checkbox"/> IAP	
		<input type="checkbox"/> EE		<input type="checkbox"/> CH	
CUSTOMER SYMPTOM:	<p>Customer may experience one or more of the following:</p> <ul style="list-style-type: none"> • Mobile Wi-Fi inoperative upon start up. • Hotspot gives "No Internet" connection message on phone when trying to connect to a device.

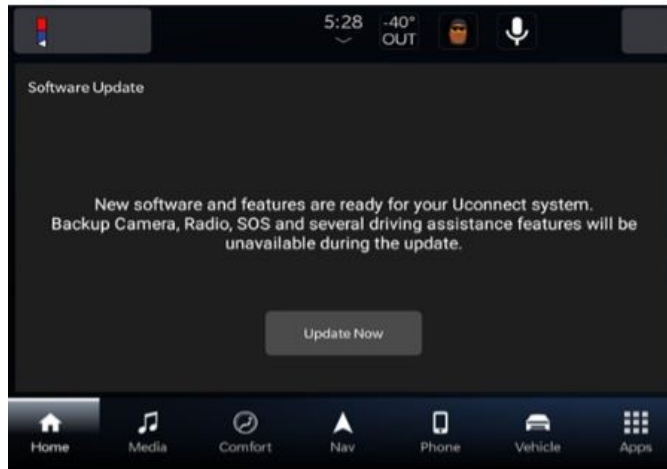
Fig. 1
Software Acceptance Screen

1. The vehicle needs to be in ‘Park’. The ignition needs to be in the off position.
2. If the customer selects “Update Now” they can shut off the vehicle and leave. The update will be completed automatically [Fig. 1](#).

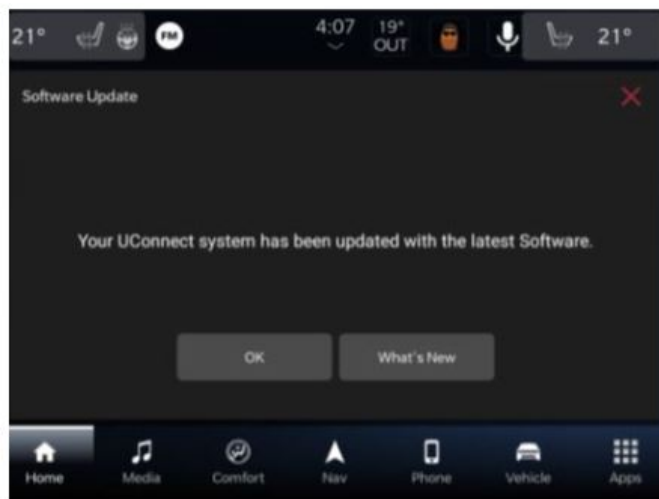
Fig. 2
Software Update Confirmation Screen

3. Upon completion of update, the radio will display a confirmation message [Fig. 2](#).
