**Technical Service Bulletin (TSB)**  
**Radio Over The Air Update to U29.42 Software Version**

| REFERENCE: | TSB: 08-007-24 REV. A<br>GROUP: 08 - Electrical | Date: | January 31, 2024 | REVISION: | 08-007-24 |
| VEHICLES AFFECTED: | 2024 (RU) Chrysler Pacifica<br>This bulletin applies to vehicles built on or before November 15, 2023 (MDH 1115XX) equipped with a Global Telematics Box Module (TBM) (Sales Code RDG) and one of the following radios: <ul style="list-style-type: none"><li>Uconnect 5 NAV W 8.4" Display (Sales Codes UBL or UEL).</li><li>Uconnect 5 NAV W 10.1" Display (Sales Codes UBN or UEN).</li></ul> | | | MARKET APPLICABILITY:<br><div><input checked="" type="checkbox"/> NA<input type="checkbox"/> MEA<br/><input type="checkbox"/> SA<input type="checkbox"/> IAP<br/><input type="checkbox"/> EE<input type="checkbox"/> CH</div> | |

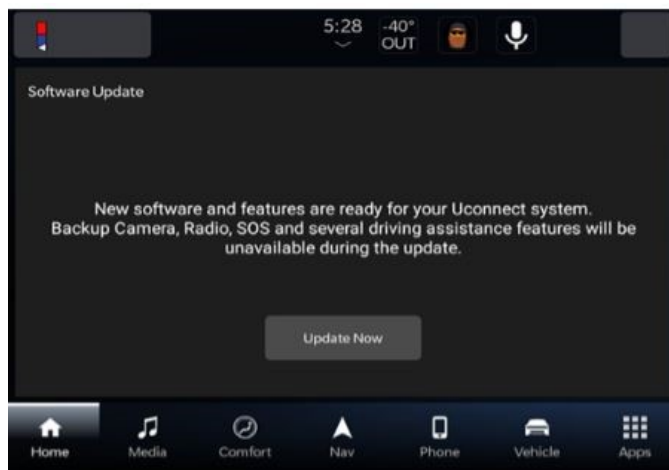
**Fig. 1**

Software Acceptance Screen

1. The vehicle needs to be in 'Park'. The ignition needs to be in the off position.
2. If the customer selects “Update Now” [Fig. 1](#) they can shut off the vehicle and leave. The update will be completed automatically.

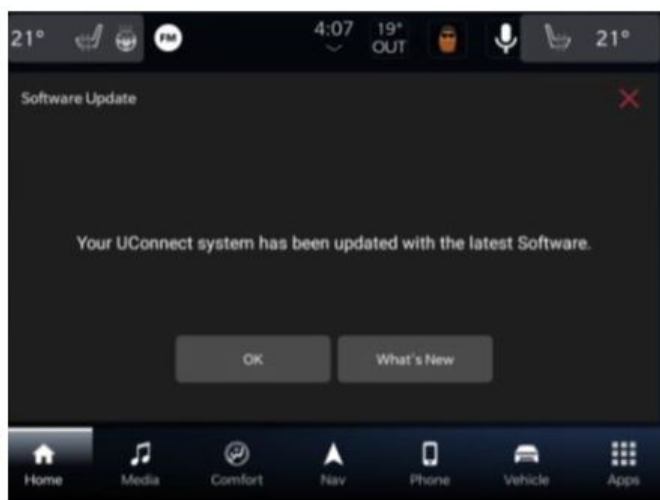
**Fig. 2**

Software Update Confirmation Screen

3. Upon completion of update, the radio will display a confirmation message [Fig. 2](#).
