March 12, 2024

Version 4

MIL is Flashing with Loss of Power

Supersedes 20-053, dated May 25, 2021, to revise the information highlighted in **yellow**.

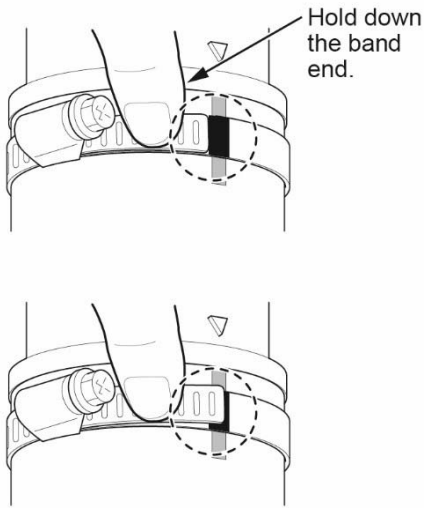
GOOD

The hose band end is **AT** or **WITHIN** the paint or hash mark on the hose band.

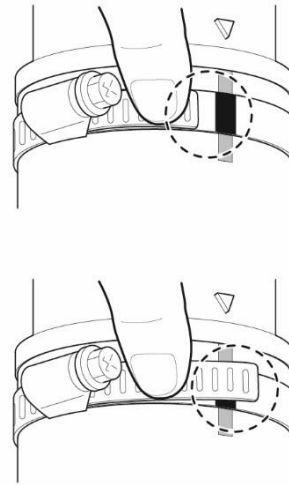
NO GOOD

The hose band end is **NOT AT** or **EXCEEDS** the paint or hash mark on the hose band.
