Service Bulletin

Bulletin No.: 23-NA-058

Subject: Cold Start Rattle Noise from the Engine Compartment, Malfunction Indicator Lamp (MIL) Illuminated - DTC P0299 Set

Brand:	Model:	Model Year:		VIN:		Engine:	Transmission:
		from	to	from	to		
Buick	Encore GX	2020	2023			1.2L (LIH)	
Chevrolet	Trailblazer	2021

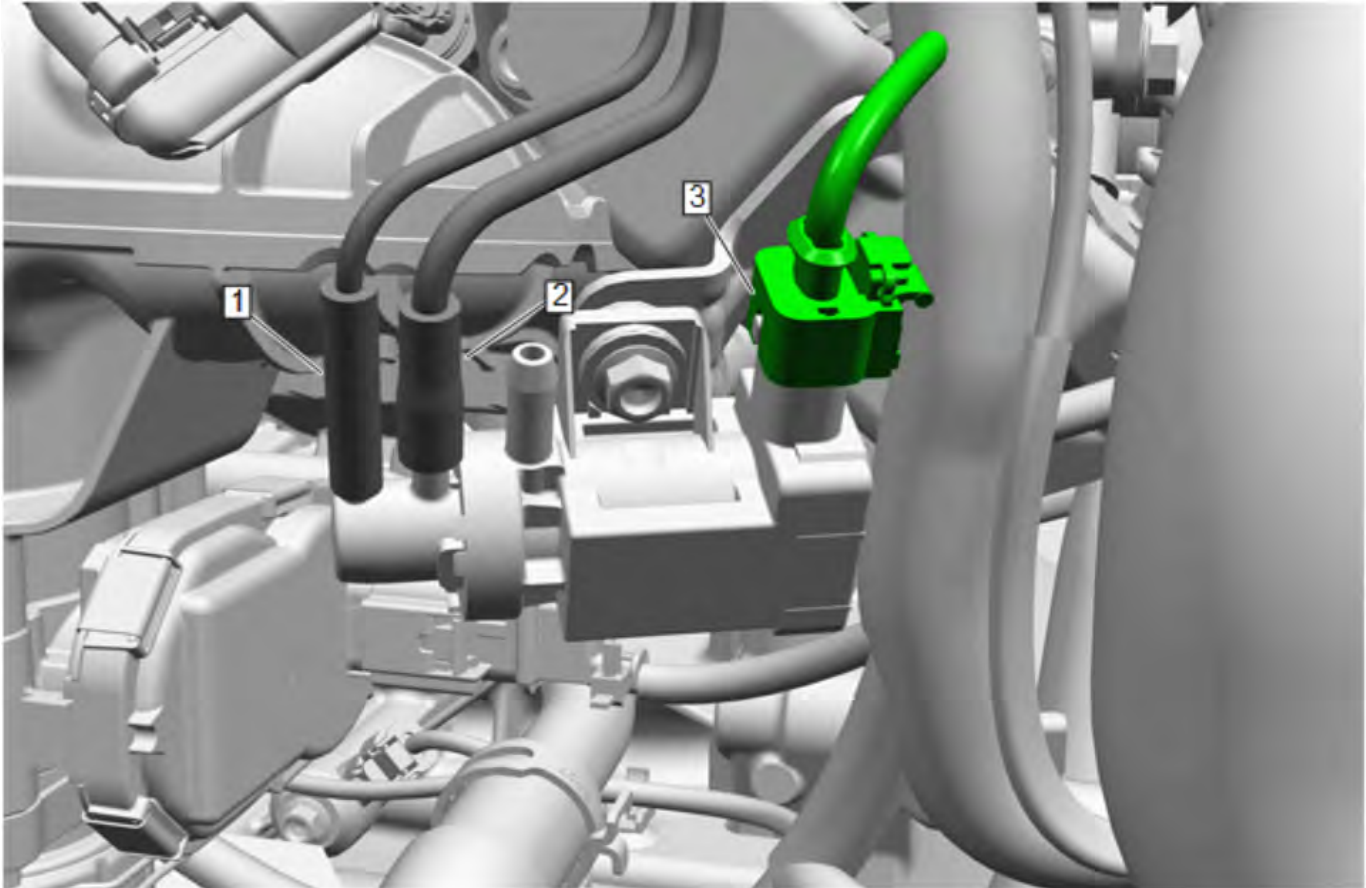
5392518

Check Vacuum Supply from the Vacuum Pump

1. Disconnect the Turbocharger Wastegate Actuator Vacuum Control Solenoid Valve Hose (1) from the Turbocharger Wastegate Regulator Solenoid Valve.
2. Utilizing EN-23738-A Vacuum Pump with an integral vacuum gauge, connect said pump to the Turbocharger Wastegate Actuator Vacuum Control Solenoid Valve Hose.

3. Engine at operating temperature at idle.
4. Verify the tool reading: EN-23738-A Vacuum Pump = -50 kPa (-0.5 bar, 15 in Hg).
 - If the desired pressure/vacuum cannot be achieved or does not hold steady:

- ⇒ Ignition/Vehicle » Off.
 - ⇒ Test or replace the component: Vacuum Pump Assembly and related hoses.
 - If the desired pressure/vacuum can be achieved and holds steady:

- Engine » Off.
 - Reconnect the Turbocharger Wastegate Actuator Vacuum Control Solenoid Valve Hose to the Turbocharger Wastegate Regulator Solenoid Valve and refer to Check Wastegate Vacuum Regulator Valve Function.
