Service Bulletin

Bulletin No.: 24-NA-042

Subject: Engine Misfire, Malfunction Indicator Lamp (MIL) Illuminated – DTCs P0300, P0030, P0031, P0032, P0053, P0135, P0155, P0171 and/or P0172

Brand:	Model:	Model Year:		VIN:		Engine:	Transmission:
		from	to	from	to		
Chevrolet	Silverado 2500HD/3500HD	2024	2024			6.6L (L8T)	
GMC	Sierra 2500HD/3500HD

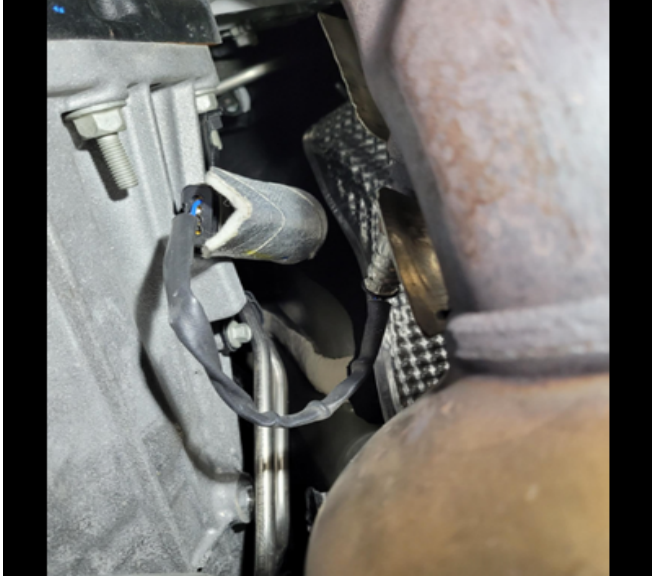
6563511

Involved Region or Country	North America, Middle East, Israel, Palestine, Australia/New Zealand
Condition	<p>Some customers may comment of one or more of the following conditions:</p> <ul style="list-style-type: none"> • Engine Misfire • MIL Illuminated <p>Some technicians may find one or more of the following DTCs set in the Engine Control Module (ECM):</p> <ul style="list-style-type: none"> • P0300: Engine Misfire Detected • P0030: HO2S Heater Control Circuit Bank 1 Sensor 1 • P0031: HO2S Heater Control Circuit Low Voltage Bank 1 Sensor 1 • P0032: HO2S Heater Control Circuit High Voltage Bank 1 Sensor 1 • P0053: HO2S Heater Resistance Bank 1 Sensor 1 • P0135: HO2S Heater Performance Bank 1 Sensor 1 • P0155: HO2S Heater Performance Bank 2 Sensor 1 • P0171: Fuel Trim System Lean • P0172: Fuel Trim System Rich
Cause	This condition may be caused by the mis-routed Bank 1 Sensor 1 oxygen sensor wiring harness, which is coming in contact with the exhaust pipe.

Correction	If you encounter a vehicle with the above concern, raise vehicle and inspect the oxygen sensor wiring. If oxygen sensor wire is contacting the exhaust pipe or heat shield, it will be necessary to replace the Bank 1 Sensor 1 oxygen sensor and ensure the sensor wiring is routed away from the exhaust.

Refer to *Heated Oxygen Sensor Replacement - Bank 1 Sensor 1* in the Service Manual.
