# Service Bulletin

Bulletin No.: 24-NA-052

**Subject: Radio Software Version Z171 – Multiple Updates for IOK**

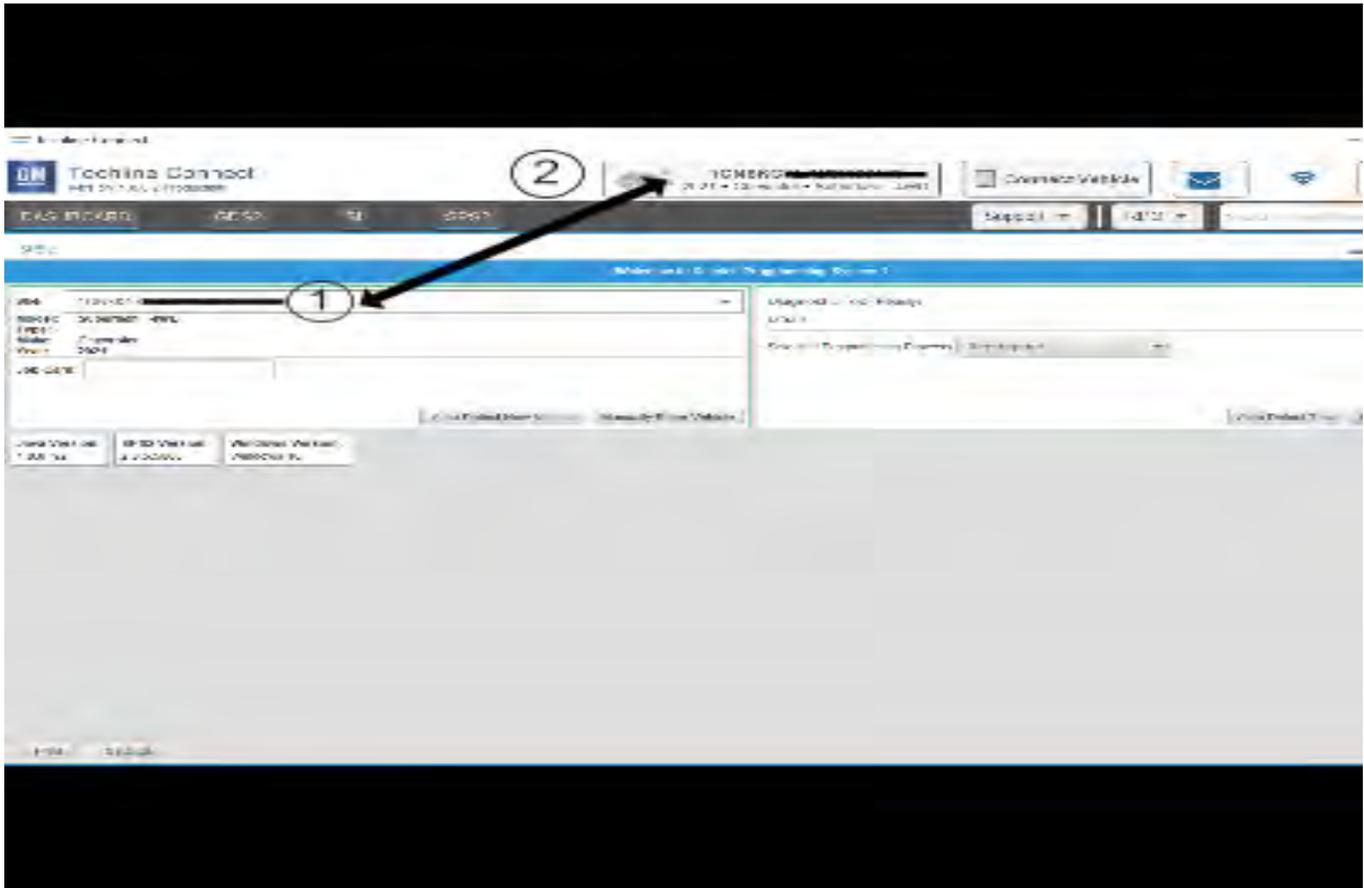
5743643

**Caution:** Be sure the VIN selected in the drop down menu (1) is the same as the vehicle connected (2) before beginning programming.

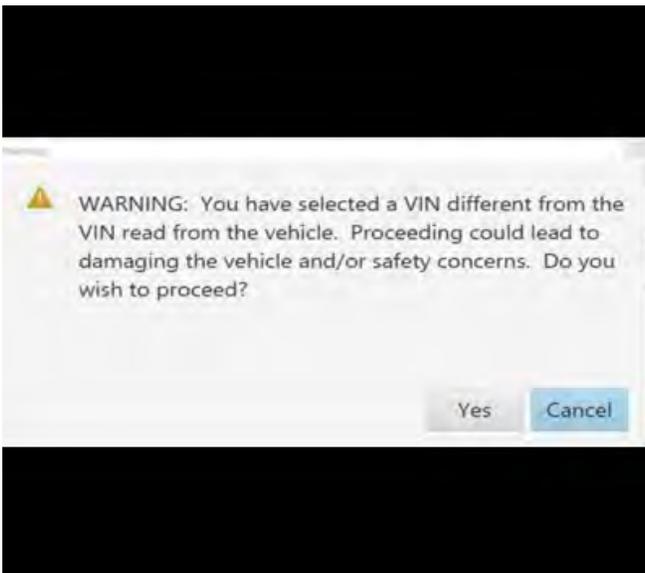
5877000

**Important:** If the vehicle VIN DOES NOT match, the message below will be shown.

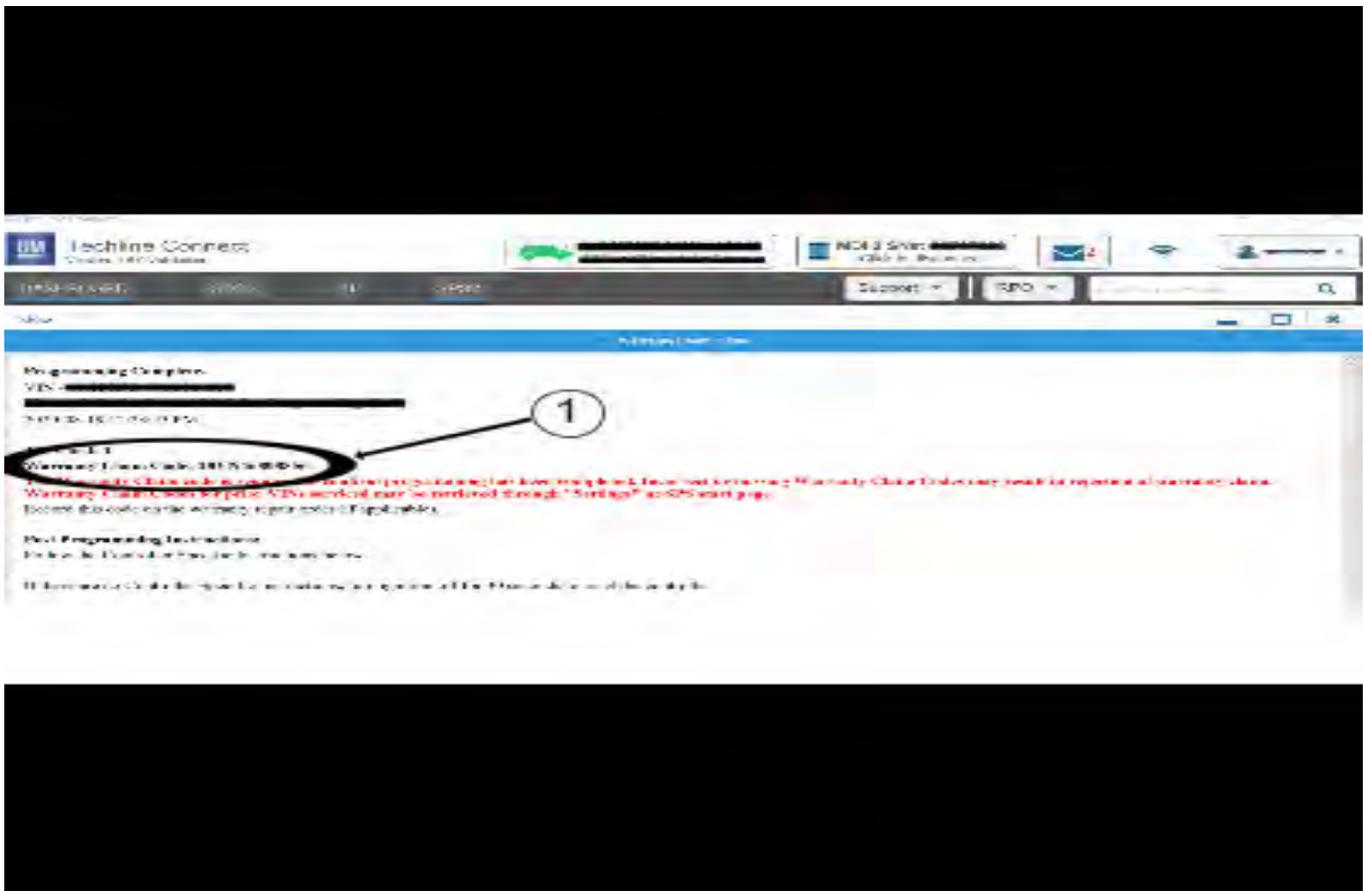
5644478

**Important:** To avoid warranty transaction rejections, you **MUST** record the warranty claim code provided on the Warranty Claim Code (WCC) screen shown above on the job card. Refer to callout 1 above for the location of the WCC on the screen.

2. Record the SPS Warranty Claim Code on the job card for warranty transaction submission.

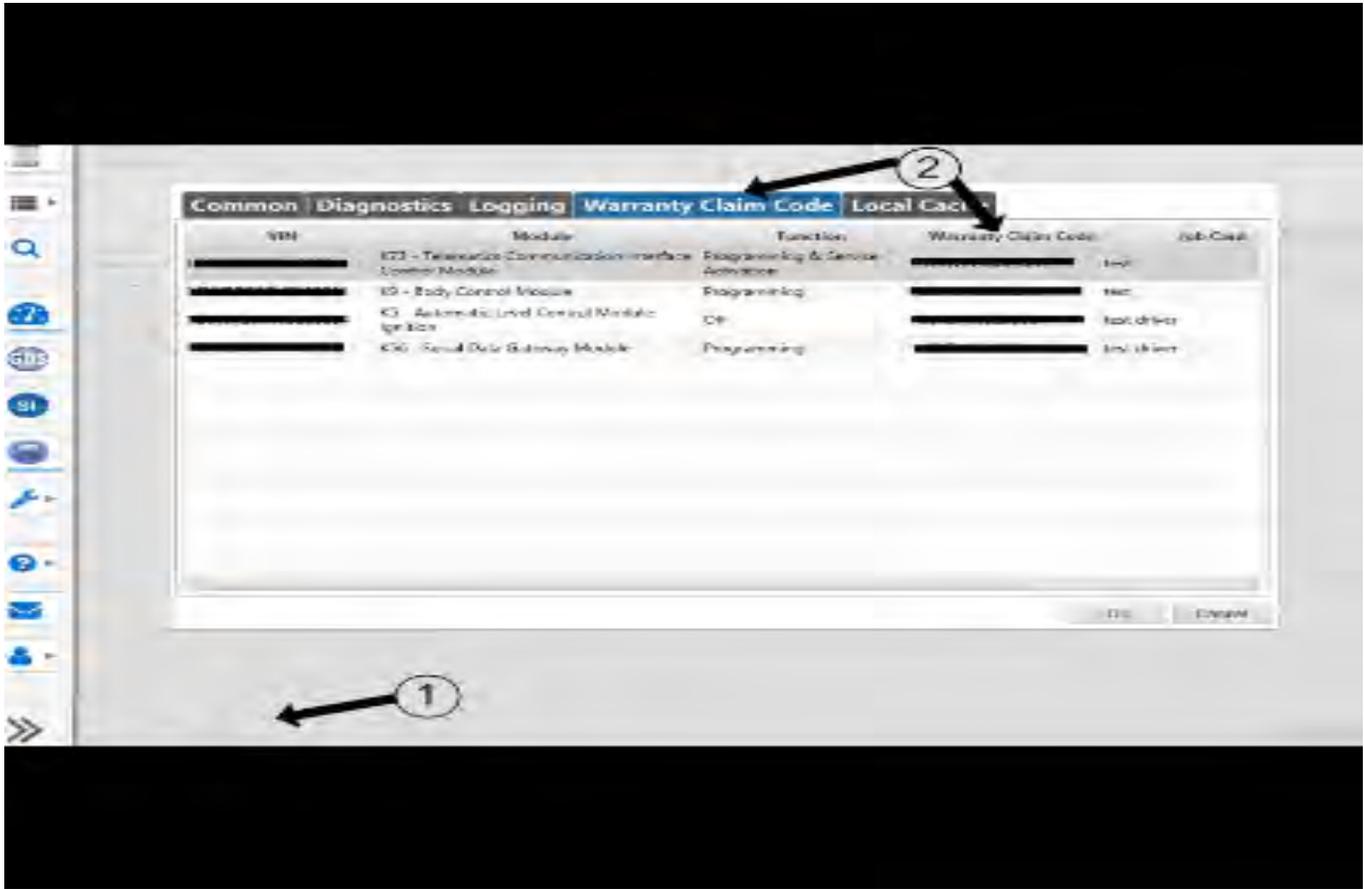
6125774

If the Warranty Claim Code was not recorded on the Job Card, the code can be retrieved in the SPS2 system as follows:

1. Open TLC on the computer used to program the vehicle.
2. Select and start SPS2.
3. Select Settings (1).
4. Select the Warranty Claim Code tab (2).
