# Service Bulletin

Bulletin No.: 23-NA-058

**Subject:** Cold Start Rattle Noise from the Engine Compartment, Malfunction Indicator Lamp (MIL) Illuminated - DTC P0299 Set

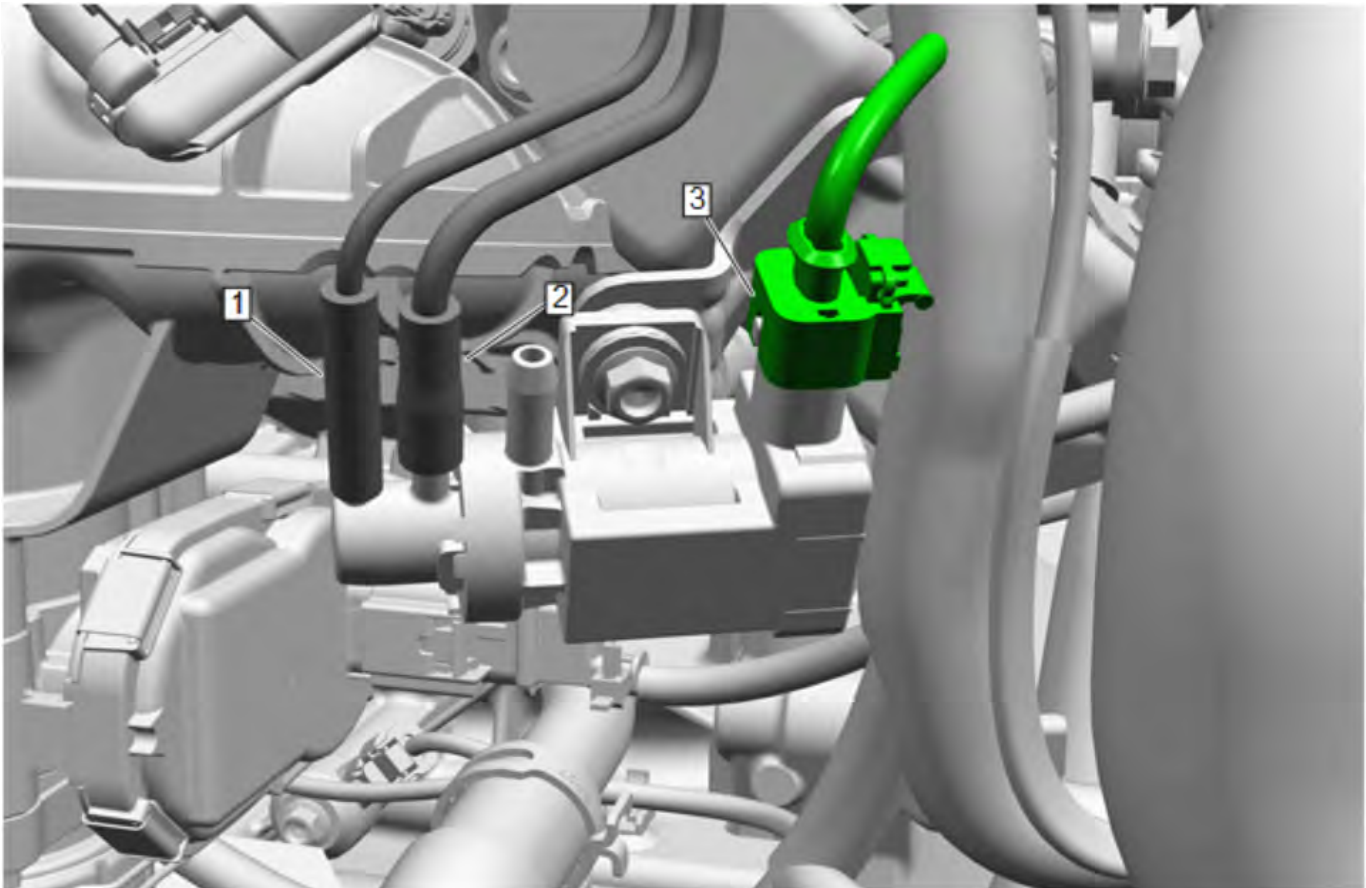
5392518

1. Disconnect the Turbocharger Wastegate Actuator Vacuum Control Solenoid Valve Hose (1) from the Turbocharger Wastegate Regulator Solenoid Valve.
  2. Utilizing EN-23738-A Vacuum Pump with an integral vacuum gauge, connect said pump to the Turbocharger Wastegate Actuator Vacuum Control Solenoid Valve Hose.

3. Engine at operating temperature at idle.
  4. Verify the tool reading: EN-23738-A Vacuum Pump = -50 kPa (-0.5 bar, 15 in Hg).
    - If the desired pressure/vacuum cannot be achieved or does not hold steady:

- ⇒ Ignition/Vehicle » Off.
- ⇒ Test or replace the component: Vacuum Pump Assembly and related hoses.
- If the desired pressure/vacuum can be achieved and holds steady:

- Engine » Off.
    - Reconnect the Turbocharger Wastegate Actuator Vacuum Control Solenoid Valve Hose to the Turbocharger Wastegate Regulator Solenoid Valve and refer to Check Wastegate Vacuum Regulator Valve Function.

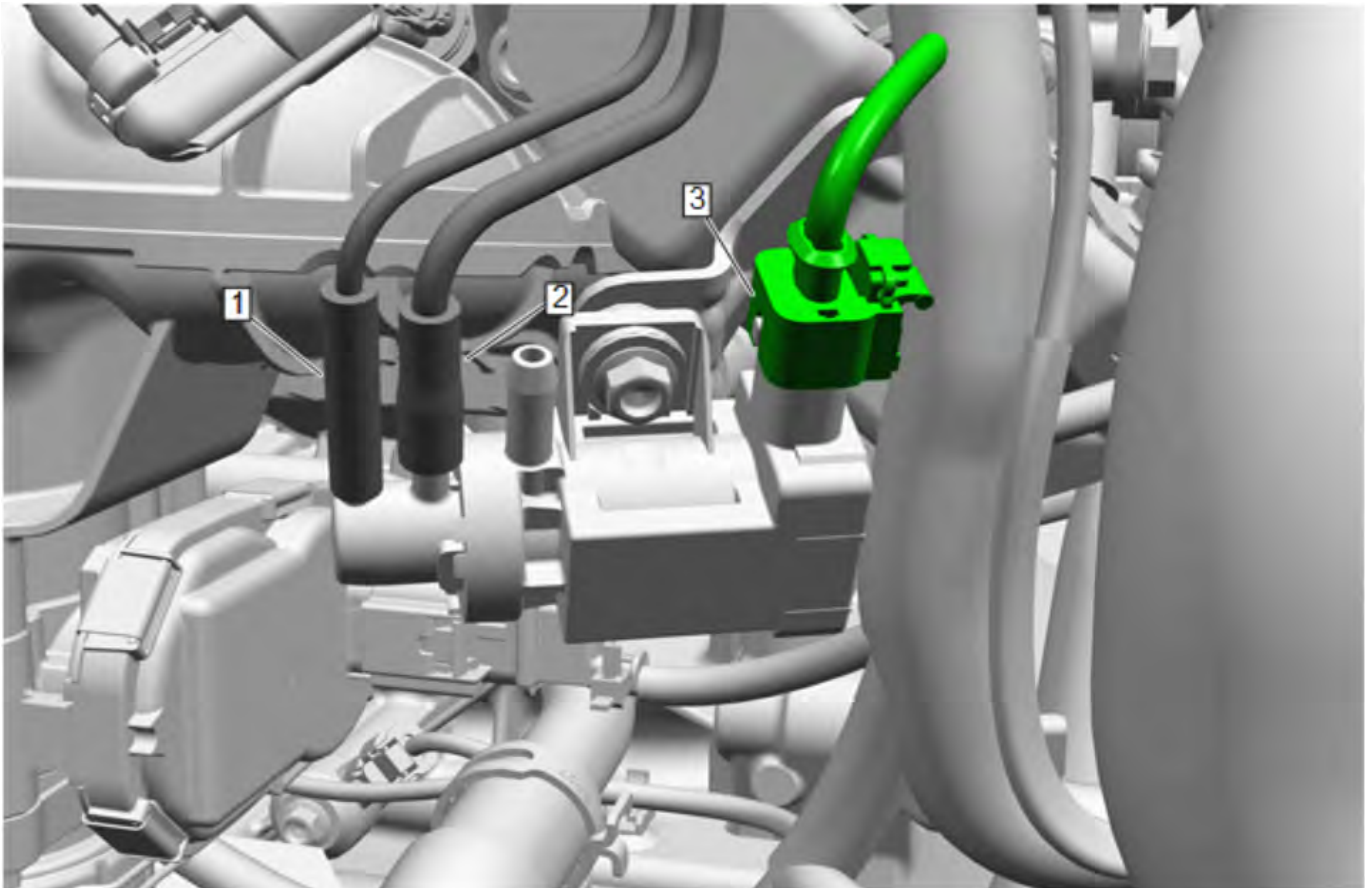
5392518

1. Disconnect the Turbocharger Wastegate Actuator Vacuum Tank Solenoid Valve Tub (2) from the Turbocharger Wastegate Regulator Solenoid Valve.
  2. Connect the EN-23738-A Vacuum Pump to the Turbocharger Wastegate Solenoid Valve Actuator supply port.

3. Engine at operating temperature at idle.
  4. Verify the tool reading: EN-23738-A Vacuum Pump = Less than  $-17$  kPa ( $-0.17$  bar, 5 in Hg).
    - If  $-17$  kPa ( $-0.17$  bar, 5 in Hg) or greater.

- If less than  $-17$  kPa ( $-0.17$  bar, 5 in Hg).
- ⇒ Engine Speed Greater than 4000 RPM — For 2 s.
- ⇒ Verify the tool reading: EN-23738-A Vacuum Pump = Greater than  $-50$  kPa ( $-0.5$  bar, 15 in Hg).

- ⇒ Test or replace the component: Turbocharger Wastegate Regulator Solenoid Valve. Refer to *Turbocharger Wastegate Regulator Solenoid Valve Removal* in the Service Manual and *Turbocharger Wastegate Regulator Solenoid Valve Installation* in the Service Manual.

- If less than  $-50$  kPa ( $-0.5$  bar, 15 in Hg).
- ⇒ Test or replace the component: Turbocharger Wastegate Regulator Solenoid Valve. Refer to *Turbocharger Wastegate Regulator Solenoid Valve*

- If Greater than  $-50$  kPa ( $-0.5$  bar, 15 in Hg). The Turbocharger Wastegate Regulator Solenoid Valve has been validated to be functioning correctly and proceed to Turbocharger Inspection.
