CADILLAC  
DCS6828  
URGENT - DISTRIBUTE IMMEDIATELY

Subject: UPDATE: N232428540 - Customer Satisfaction Program  
Multiple Module Reprogramming  
Population Expansion

Models: 2023 Cadillac LYRIQ

## N232428540 Multiple Module Reprogramming

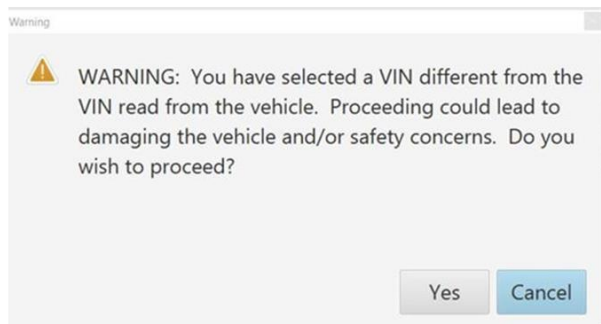
5877000

**Important:** If the vehicle VIN DOES NOT match, the message below will be shown.

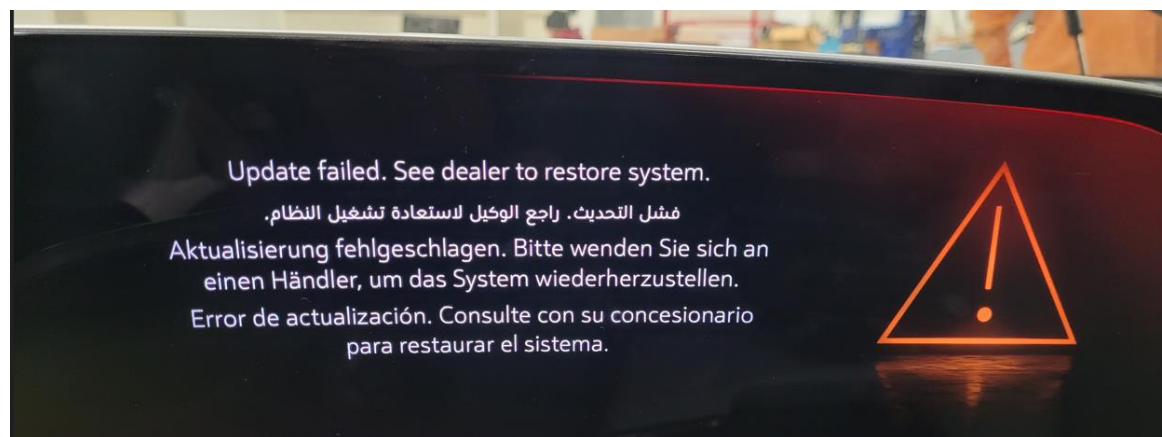
6554772

1. There is a chance for an error to be encountered during the USB update portion of the procedure right around 60% completed.
  - 1.1. This happens once the USB is in the vehicle and the progress bar can be seen on screen.
2. If the error occurs the screen will look like below

3. In this case pull the USB from the vehicle and reformat again as shown in step 7 under service procedure.
4. Access the Service Programming System (SPS) and follow the on-screen instructions.
5. On the SPS Supported Controllers screen, select A11 Radio – USB Copy/USB File Transfer.
6. Upon completion of the file transfer, properly eject the USB drive from the computer.
7. Connect the USB drive to the USB port in the vehicle.
  - 7.1. If the screen fails to show a progress bar once reinserted, pull out and reinsert again.
8. These steps should allow the progress bar to restart and complete successfully.
9. If you require further assistance, or would like verbal instructions in addition to this part of the service procedure please contact Techline Customer Support Center 1-800-828-6860 for English or 1-800-503-3222 for French (Canadian) for assistance.
