GROUP	MODEL
BOD	2019-2020MY Optima (JFa)
NUMBER	DATE
324	March 2024

TECHNICAL SERVICE BULLETIN

SIDE AIRBAG (SAB) INSPECTION AND REPLACEMENT FOR DTC(S) B1380/B1384

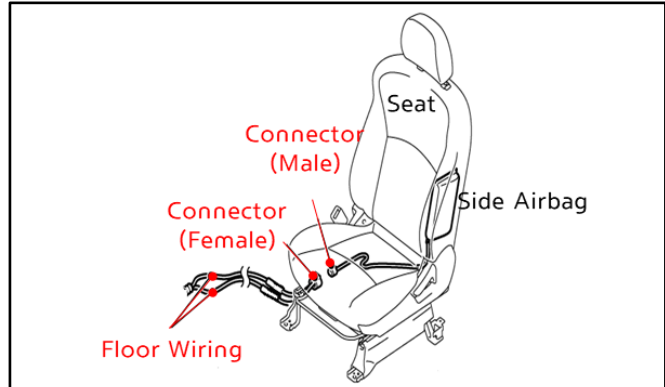
1. Confirm 'Airbag' warning indicator lamp is 'ON' and using KDS, scan for DTC(s):

- **B1380** - Side Airbag Front Driver Resistance Circuit Short to Ground
- **B1384** - Side Airbag Front Passenger Resistance Circuit Short to Ground.

- 2a. If the 'related' DTC is not present (other airbag concern) then this TSB is not applicable. 'Inspection Only' claim.
- 2b. If the 'related' DTC is stored (Driver or Passenger, or both) proceed to step 3. A Vehicle Diagnosis Number (VDN) must be created for DTC's B1380 and or B1384.

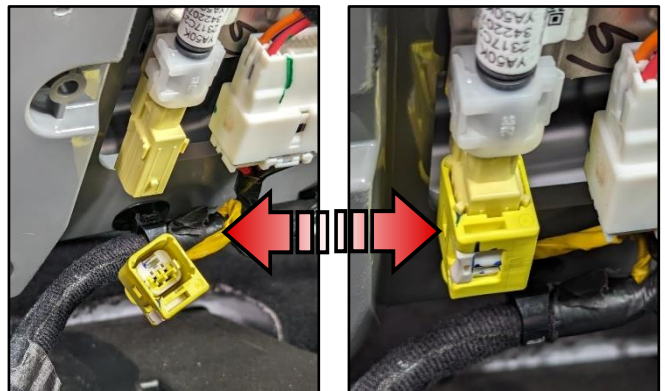
4. Disconnect the 12V battery negative (-) cable.
5. Tilt the seat upwards from the rear.
6. Disconnect and re-connect the yellow SAB connector. Ensure it is securely clipped/locked.
7. Lower the seat flat, reconnect the 12V battery negative (-) terminal and turn the ignition to the 'ON' position.
8. Using KDS, scan the vehicle and confirm if the previously stored DTC is still present:

- **No (OK)** - Reinstall the seat in the reverse order of removal. No further action is required.
- **Yes (NG)** - Proceed to the 'Repair Procedure' on page 3 to replace the affected SAB (Left, Right or Both).
