Technical Service Bulletin

48 DTC B116831 is stored in the ABS control module

48 24 65 2063526/3 March 21, 2024. Supersedes Technical Service Bulletin Group 48 number 22-32 dated April 28, 2022 for reasons listed below.

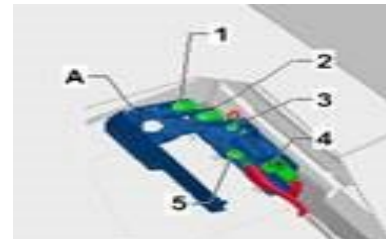
There is a voltage drop in power steering control module, J500 (address word 0044).

- This DTC is logged in the power steering control module, J500 (address word 0044) briefly, because it does not participate in the data bus communication during the start procedure.
 - This can be caused by a voltage drop in the power steering control module, J500 (address word 0044).
1. When the vehicle is started, the voltage should not drop by more than 1 Volt at contact 4 on the fuse carrier. This is the power supply to the power steering control module, J500 (address word 0044) (Figure 1).

Figure 1. Fuse carrier's power supply to the power steering control module, J500 (address word 0044).

2. If the voltage drops more than 1 Volt then the fuse carrier must be replaced. Replace the fuse carrier according to the instructions in the Elsa Repair Manual.

3. If this procedure does not lead to an improvement, continue the diagnosis on other components of the power supply for the power steering. Review the battery history data to help find the voltage drop.
