70 Noises from headliner/sunroof area

70 24 89 2044417/11 March 13, 2024. Supersedes Technical Service Bulletin Group 70 number 24-86 dated January 30, 2024 for reasons listed below.

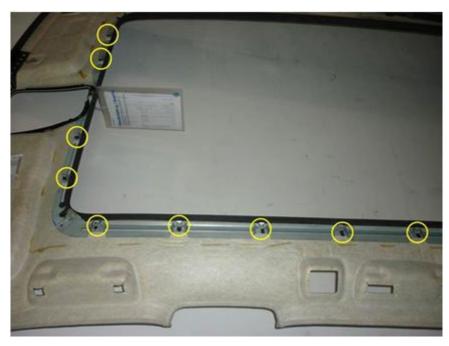
The noises can be caused by movement in the clips that attach the headliner to the sunroof frame or movement between components of the sunroof frame.

Figure 1. Location of the headliner to sunroof frame clips.

2. Remove the headliner. The clips shown in the illustration will need webbing adhesive tape (D 004350A2) (Figure 1).

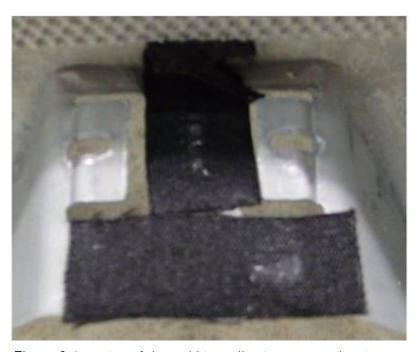
Figure 2. Location of the webbing adhesive tape application.

3. Remove the clips and apply the webbing adhesive tape underneath them, as shown (Figure 2).

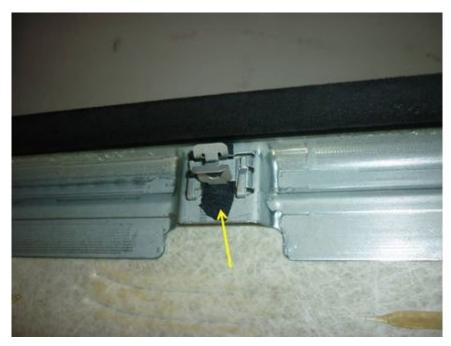
Figure 3. Clips reinstalled.

4. Reinstall the clips (Figure 3).

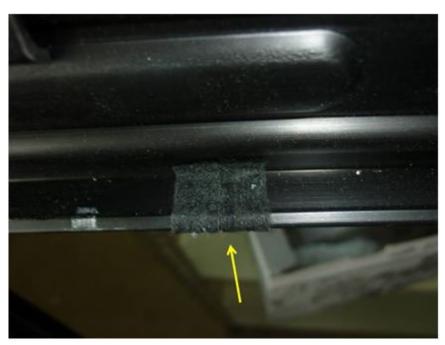
Figure 4. Application area on sunroof frame area of clip engagement.

5. Apply webbing adhesive tape to the sunroof frame lip at each clipping point (Figure 4).

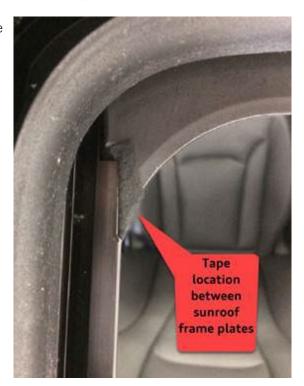
Figure 6. Webbing adhesive tape applied between the side and front sunroof frame plates.

7. Apply webbing adhesive tape between the sections of the sunroof frame plates on both the right and left sides as shown in the illustration (Figure 6).
