Technical Service Bulletin

96 Traffic sign dependent speed limit setting defaults to "On" after ignition cycle

96 24 94 2073371/1 March 14, 2024.

Model(s)	Year	VIN Range	Vehicle-Specific Equipment
Q4 e-tron, and Q4 Sportback e-tron	2024	All	Not Applicable

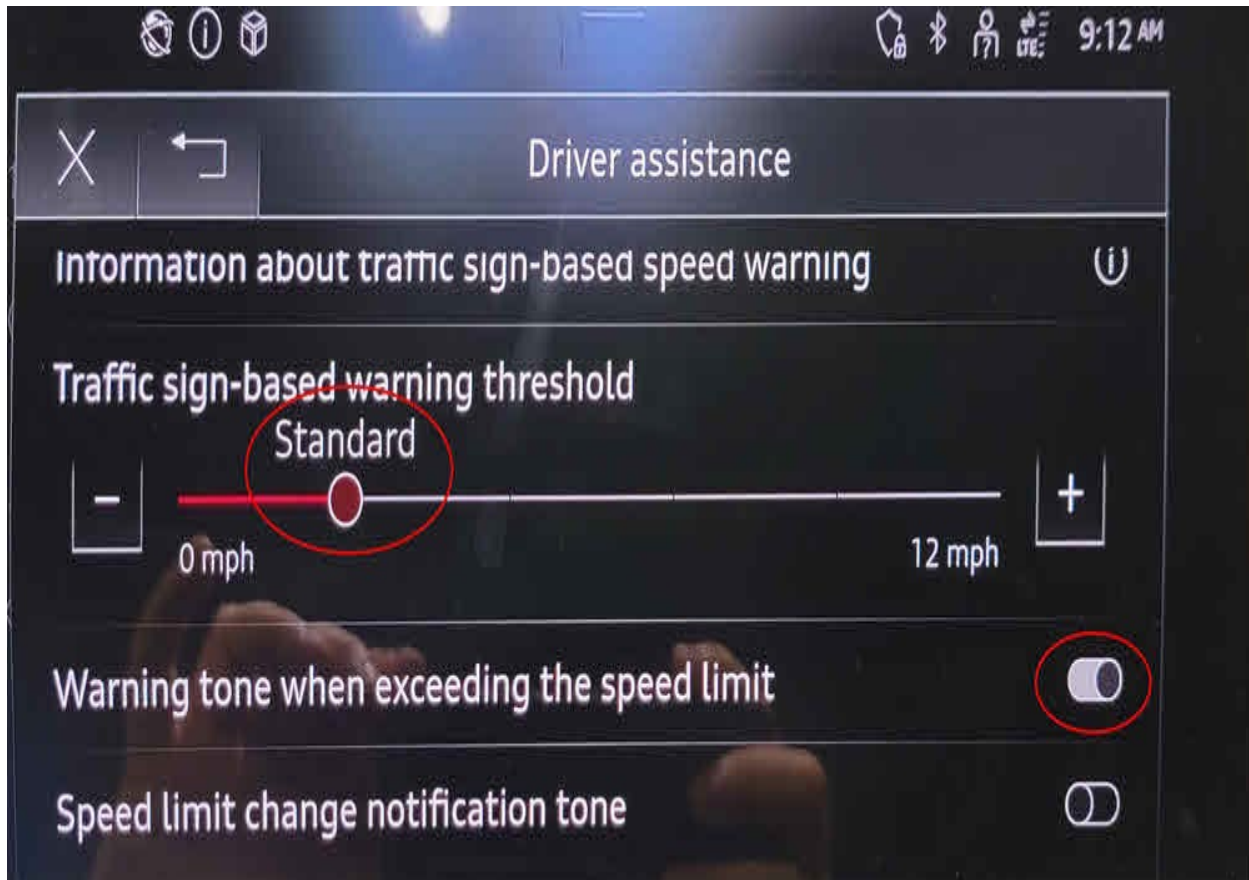
- The Traffic sign-dependent speed warning setting automatically defaults to audible warning at 1mph over the speed limit on every ignition cycle.
- A warning tone can be heard every time the speed limit is exceeded by one mph or more.

Figure 1: Traffic sign-based speed warning default settings.

A bug in the ZDC causes this complaint.

New Target Data Container (ZDC) update in the Front Camera, -R242- (address word 00A5) addressed the condition.

1. Follow all instructions in TSB 2011732: *00 Software Version Management (SVM), operating instructions*.
2. Update the Front Camera -R242- (address word 00A5) using the SVM action code as listed in the table below, if necessary:
