SIB 61 09 24

SERVICE ACTION: CHECKING AND, IF NECESSARY, REWORKING  
THE INVERTER SUPPLY LINE

E-Series	Model Description	Production Date
G05 PHEV	X5 Sports Activity Vehicle	February 23, 2023 – May15, 2023

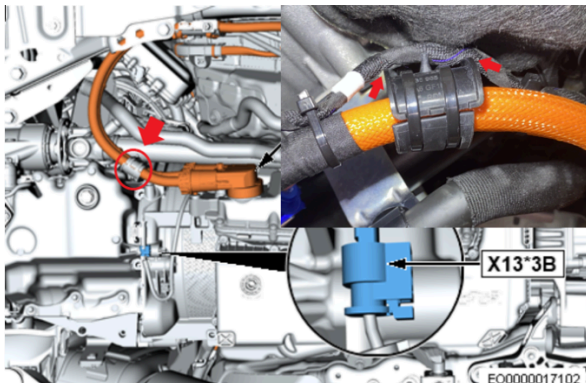
3. Improper routing and sharp edges of the High Voltage (HV) cable support bracket may damage the EGS-EME supply line harness.

4. Inspect the Inverter Supply line for damage. Is the EGS-EME harness damaged?

5. Repair any damage to the low voltage (LV) supply lines, per the “Notes on handling wiring harness and cables 61 00.. | REP-REP-RAF0161-6100\_KABELBAUM – V.26”.

6. After a wiring repair or inspection, cover the harness with fabric adhesive tape (abrasion-resistant) (e.g., P/N 61 13 6925452).

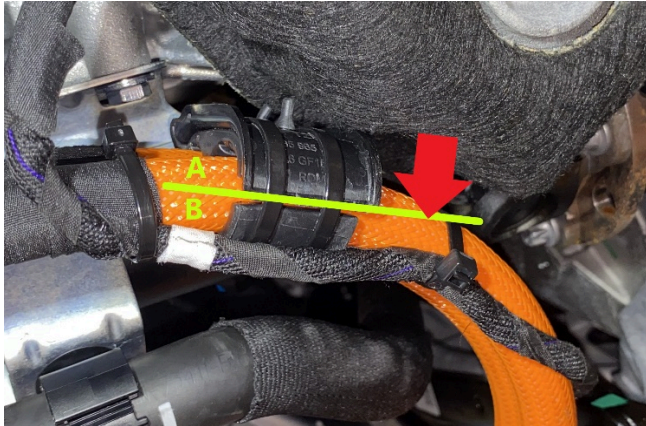
8. Is the EGS-EME harness routed on the (B) side of the HV cable support bracket as depicted in the image on the left?

7. Ensure the harness is properly routed and secure.
