87-24-01 - Various Issues with Heated Steering Wheel

Release date: 3/18/2024

Applicable Vehicles					
Model(s)	Year	Eng. Code	Trans. Code	VIN Range From	VIN Range To
GTI - Golf R	2022-2023	All	All	All	All

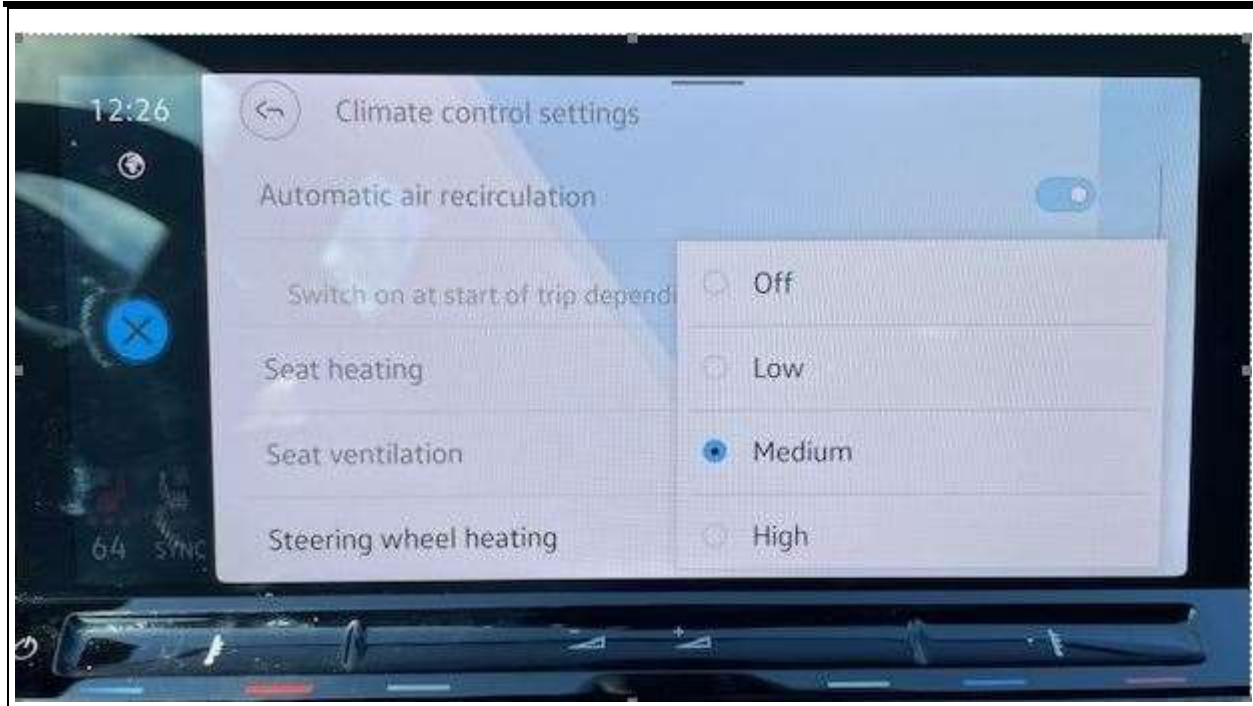
- The steering wheel heating:
 - Automatically switches itself on after the vehicle starts.
 - Switches itself on after a stationary period of the vehicle of more than 10 minutes.
 - Switches itself on again after deactivation.
- The heating level of the temperature-related steering wheel heating cannot be adjusted.
- The heating level of the temperature-related steering wheel heating cannot be saved.

- One or several of the customer statements can be reproduced.
- No relevant event entry indicating a complaint regarding the steering wheel heating is logged in the air conditioning and heating electronics (diagnosis address 0008).
