SIB 51 02 24

SQUEAKING SOUND FROM THE EXTERIOR MIRROR ASSEMBLY WHEN FOLDING IN OR OUT

E-Series	Model Description
G60	5 Series Sedan

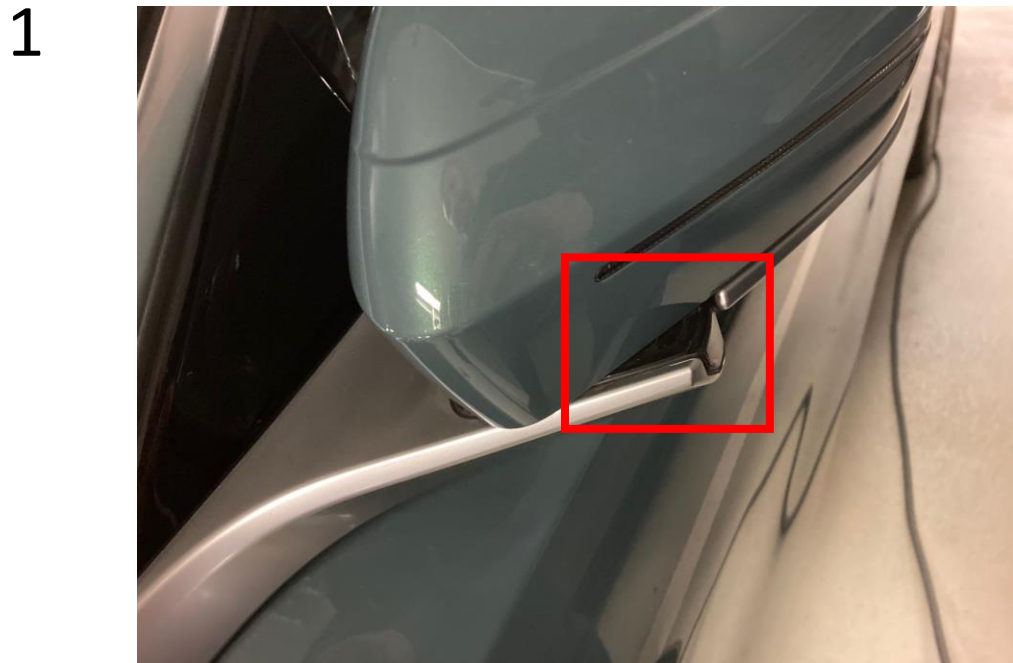
A squeaking sound is heard when folding either of the exterior mirrors assemblies in or out.

Unfavorable tolerance positions within the exterior mirror assembly.

1. Verify that the customer's vehicle has this issue.
2. Manually fold the exterior mirror assembly inwards (see photo 1 in the attachment).
3. Clean the sliding surface on the exterior mirror assembly and apply PF1 lubricant (see photo 2 in the attachment)
4. Manually fold the exterior mirror assembly outwards (see photo 3 in the attachment).
5. Clean the sliding surface on the exterior mirror assembly and apply PFI lubricant (see photo 4 in the attachment).
6. If the sound is still present, replace the affected exterior mirror assembly.
