## SIM 31 01 24 DIAGNOSING FRONT AXLE ISSUES

2024-03-04

F54 (Cooper Clubman, Cooper S Clubman)	F55 (Cooper, Cooper S 4-door Hardtop)	F56 (Cooper, Cooper S 2-door Hardtop)	F57 (Cooper Convertible, Cooper S Convertible)
F60 (Cooper, Cooper S, JCW Countryman)

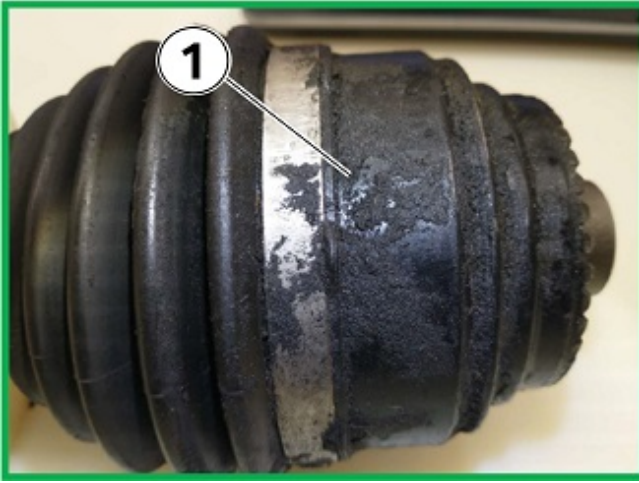
**A. The following are examples of good axles/boots. Do not replace.**

Example of dirt/contamination from outside influence (1).

**Surface contamination and/or grease build-up is normal. Do not replace the CV boot (inner) or axle half-shaft (outer).**

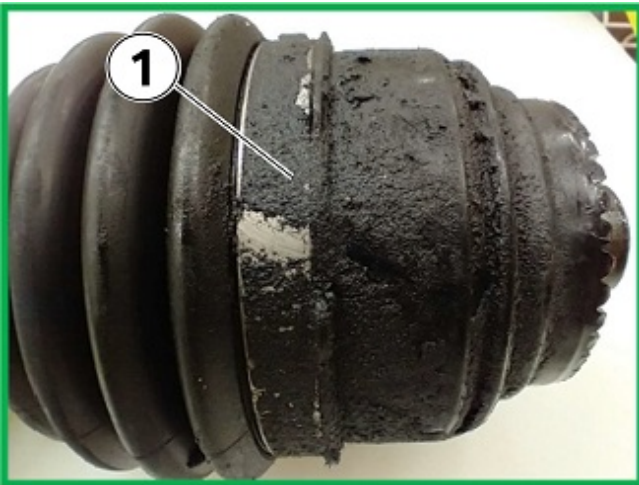
Example of dirt/contamination from outside influence (1).

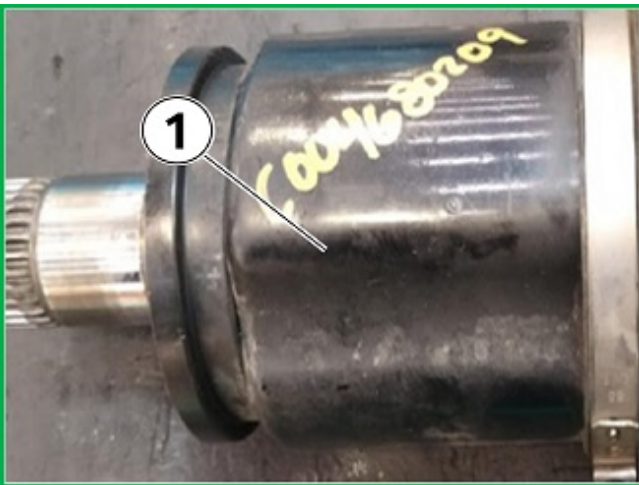
Example of dirt/contamination from outside influence (1).

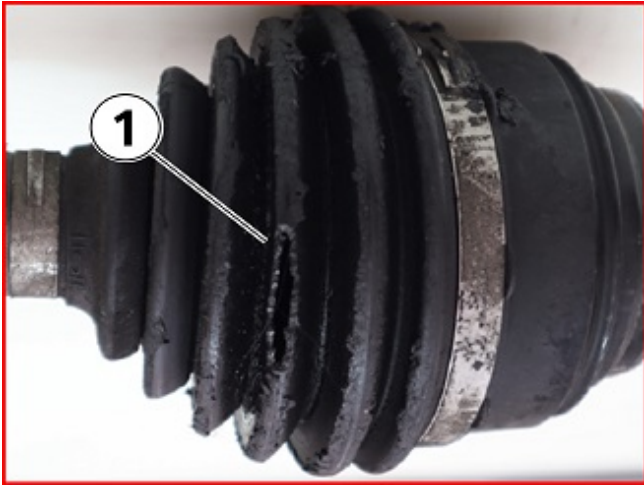
Tear in the boot (1).

**B. The following are examples of torn and/or leaking CV boots that require the necessary corresponding repair to be performed (CV boot/bellows repair kit installation or axle/output shaft replacement)**

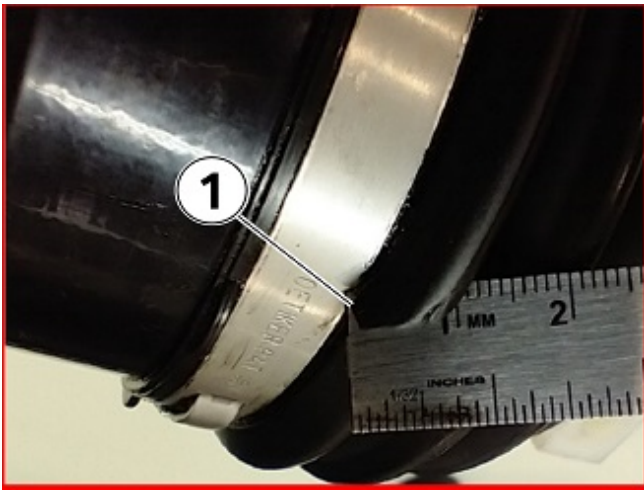
Tear or cut in the boot (1).

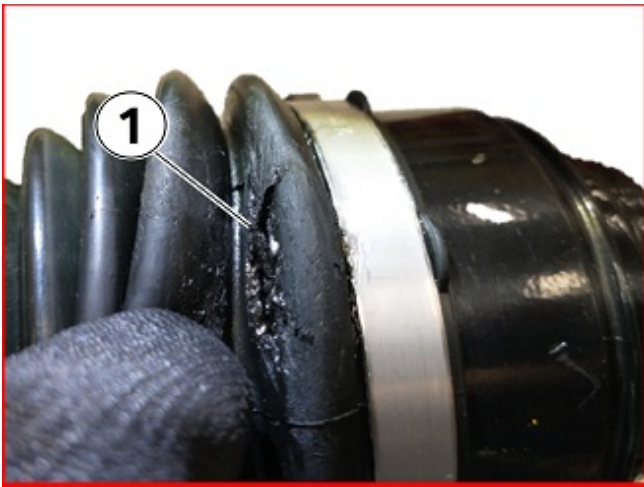
Tear or cut in the boot (1).

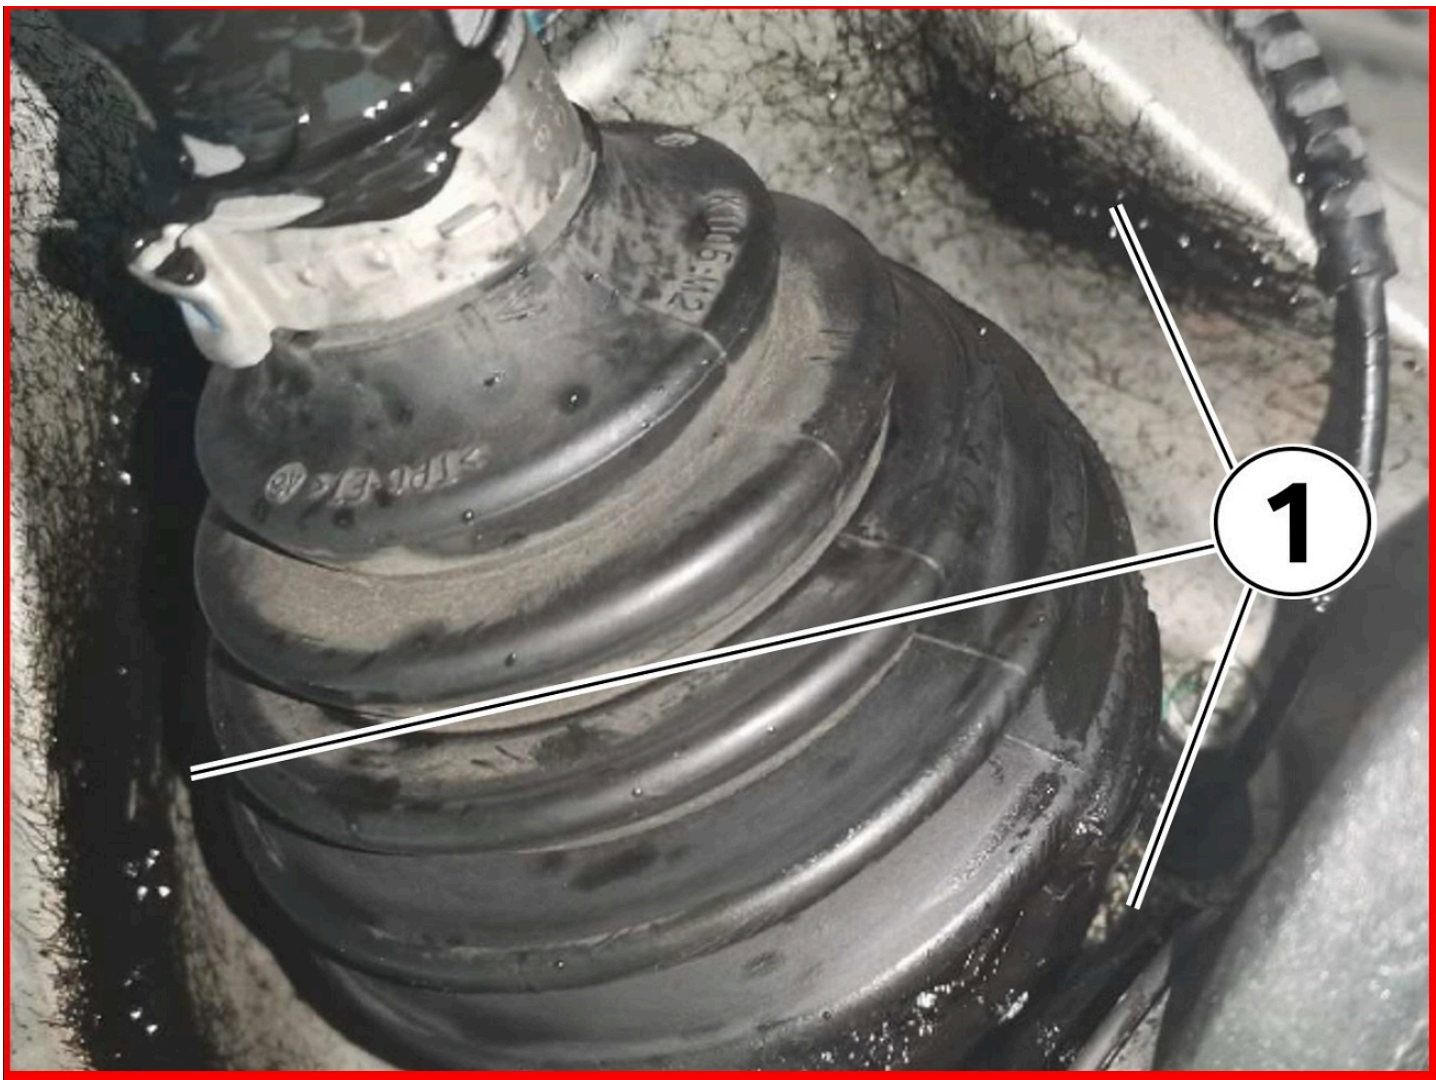
The below example is a boot that is dispersing grease around the outer carrier (1).
