SIB 12 07 21

B58C/D (48V SYSTEM): Belt Slip Fault 21B209

This Service Information Bulletin (Revision 3) replaces SI B12 07 21 **dated November 2023**.

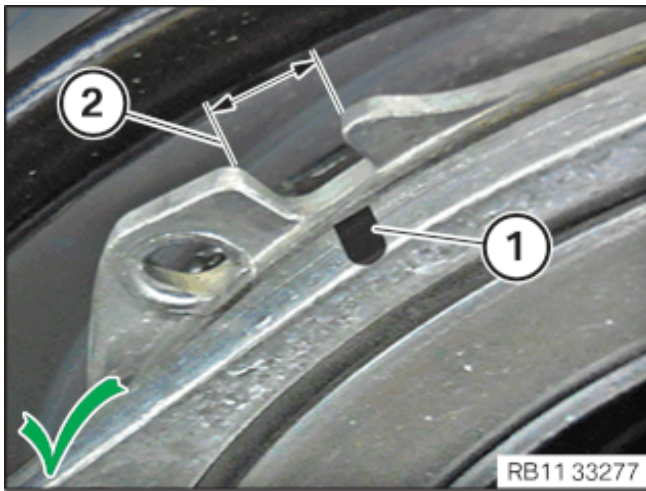
- Perform diagnosis with ISTA and follow any test plans related to the FC and 48V system
- Check the alignment marks on the belt tensioner

- Black mark (1) on tensioner needs to be centered in adjustment window (2)

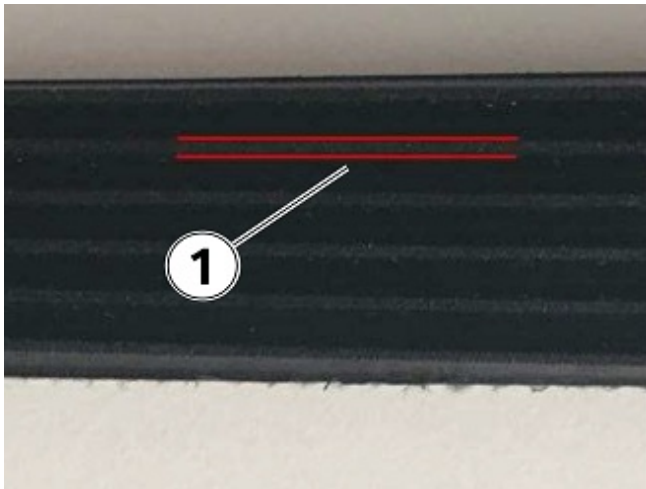
- Remove and visually inspect the drive belt (the belt will be replaced)
 - The drive belt may already show visible wear on the side with the ribs
 - The belt may be cut or missing ribs
 - There may be signs of oil contamination

- The ribs may be narrower or worn thin (1).

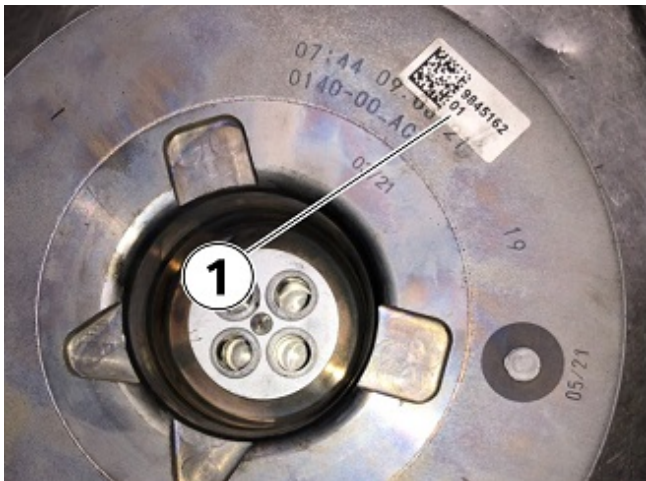
- Using a mirror, check the index number of the crankshaft damper

- Replace the damper if has an index number 01

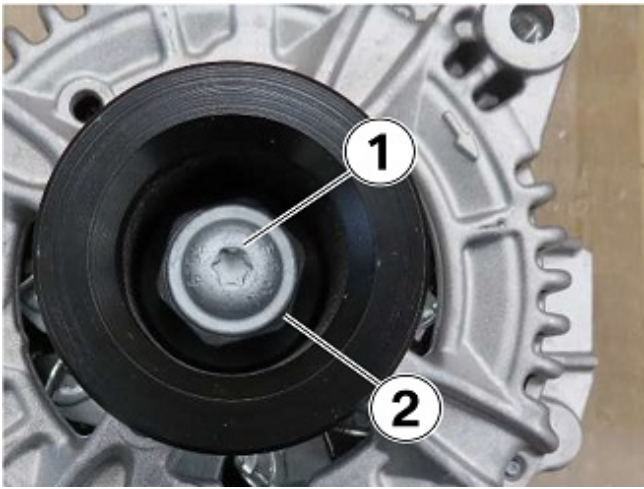
- Inspect the pulley on the starter generator for tightness

- Check the retaining screw (1) for the hexagon nut (2) on the SGR drive pulley.

- If the retaining screw is loose (finger tight) or missing, the starter generator must be replaced
- If the retaining screw is tight – Check the pulley grooves for belt material and clean any debris from the pulley with brake cleaner and a cloth rag (no wire brush)
- Check that the SGR pulley spins freely. Take a video of any binding of the pulley
- Check the pulley on the water pump
- Check for binding in the pump and ensure the pulley spins true
- Take a video of any issue with the water pump (if there is any) and replace the pump
- AC Compressor - Check the pulley grooves for belt material and clean any debris from the pulley with brake cleaner and a cloth rag (no wire brush)
- If there is any issue with the AC compressor or the pulley (damage or leaking), replace the AC compressor

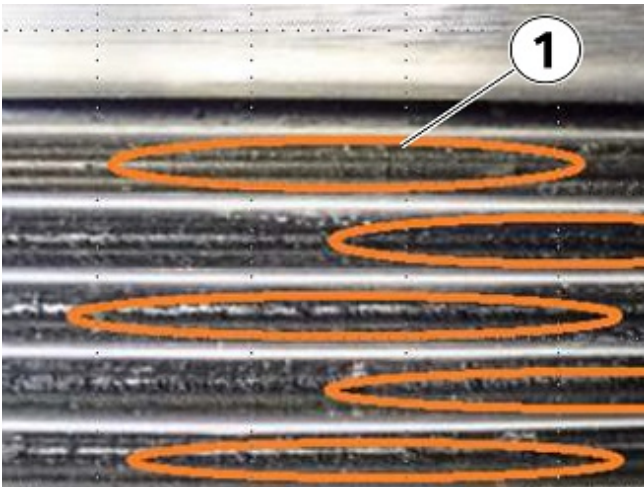
- Example: Belt debris in pulley grooves (1).
