SIB 64 04 24

2024-03-08

UNFAVORABLE HEAT AND AC WHEN THE DASHBOARD VENTS ARE CLOSED

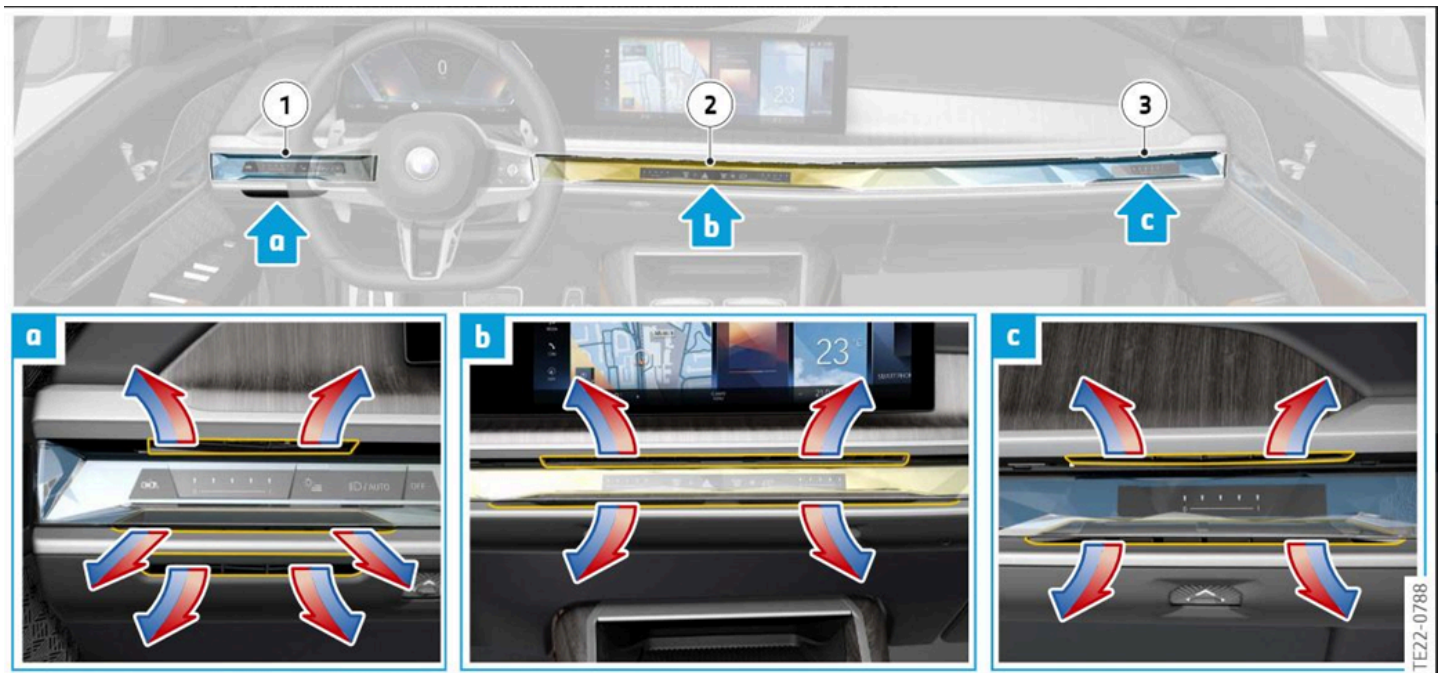
1. The center air vent on the left (a) is closed. All other air vents on the left side then only blow cold air into the passenger area.

2. Both center (b) air vents are closed. All other air vents then only blow cold air into the passenger area.

3. The center air vent on the right (c) is closed. All other air vents on the right side then only blow cold air into the passenger area.

- If the current I-level is lower than G070-24-07-500, program the vehicle using ISTA
- If the I-Level is already at G070-24-07-500 or higher than further diagnosis with ISTA is needed

- **Open all the center air vents again; the air conditioning will then be correctly regulated again**

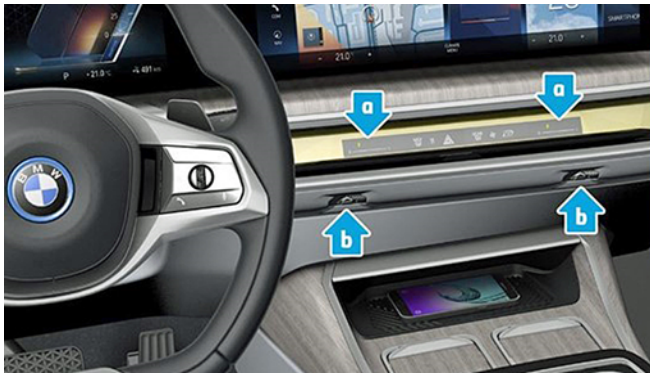
The temperature sensor of the center air vents communicates a false signal, because closing the air vents using the airflow touch controls (a) causes the warm air to build up at the temperature sensor. For this reason, the air conditioning system tries to cool the passenger area as quickly as possible by blowing cold air through the other vents which are not closed.

The air direction control rollers (b) have no influence on this situation.
